New Jersey Sports & Exposition Authority Drainage Ditch Inspection Report

**The National Flood Insurance Program
Community Rating System**

The New Jersey Sports and Exposition Authority

October 13, 2022

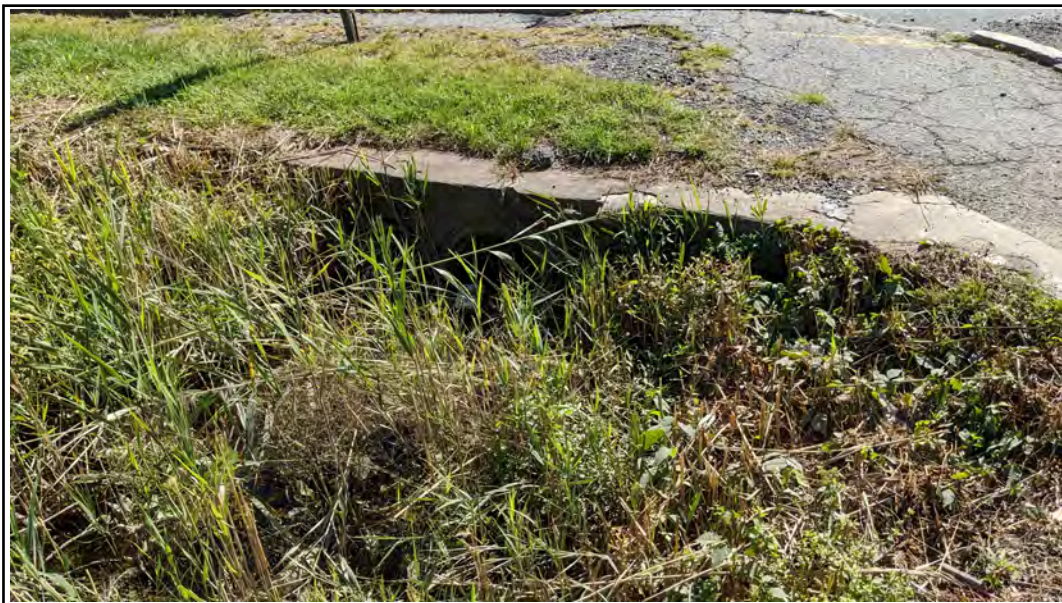
Type of Inspection:		Notes on Condition / Problems:	
<input checked="" type="checkbox"/> Yearly	<input checked="" type="checkbox"/> Ditch	Banks and ditches are overgrown.	
<input type="checkbox"/> Post-Storm	<input type="checkbox"/> Tide Gate	Ditch has very little depth.	
<input type="checkbox"/> Complaint	<input type="checkbox"/> Pump System		
System Designation:			
<input type="checkbox"/> Natural Stream	<input checked="" type="checkbox"/> Culvert		
<input checked="" type="checkbox"/> Manmade Channel	<input type="checkbox"/> Outfall		
<input type="checkbox"/> Catch Basin	<input type="checkbox"/> Other: _____	Notes on Maintenance:	
Overall Functionality:			
<input checked="" type="checkbox"/> Fully Functional			
<input type="checkbox"/> Functional with Restrictions			
<input type="checkbox"/> Non-Functional			
Maintenance Required:			
<input type="checkbox"/> Immediate		Other Notes:	
<input type="checkbox"/> Repair		Three culverts at driveway.

Figure 2: Downstream view of ditch at headwall

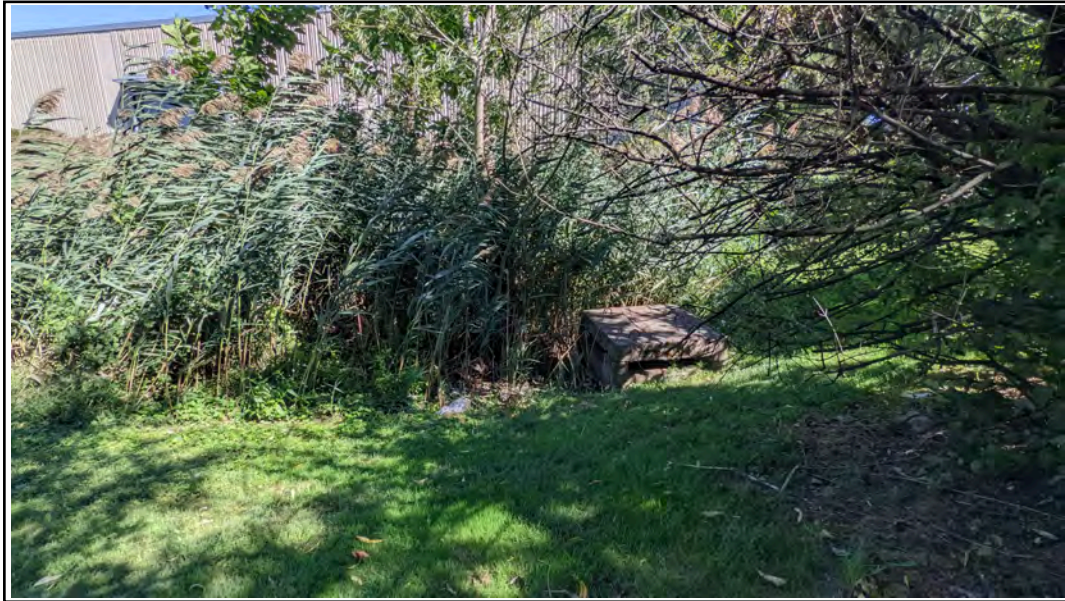
Type of Inspection:		Notes on Condition / Problems:	
<input checked="" type="checkbox"/> Yearly	<input checked="" type="checkbox"/> Ditch	Dense vegetation in detention basin.	
<input type="checkbox"/> Post-Storm	<input type="checkbox"/> Tide Gate	Outfall structure is clear of debris.	
<input type="checkbox"/> Complaint	<input type="checkbox"/> Pump System		
System Designation:			
<input type="checkbox"/> Natural Stream	<input type="checkbox"/> Culvert		
<input checked="" type="checkbox"/> Manmade Channel	<input type="checkbox"/> Outfall		
<input type="checkbox"/> Catch Basin	<input type="checkbox"/> Other: _____	Notes on Maintenance:	
Overall Functionality:			
<input checked="" type="checkbox"/> Fully Functional			
<input type="checkbox"/> Functional with Restrictions			
<input type="checkbox"/> Non-Functional			
Maintenance Required:		Other Notes:	
<input type="checkbox"/> Immediate			
<input type="checkbox"/> Repair

Figure 1: View of outfall structure

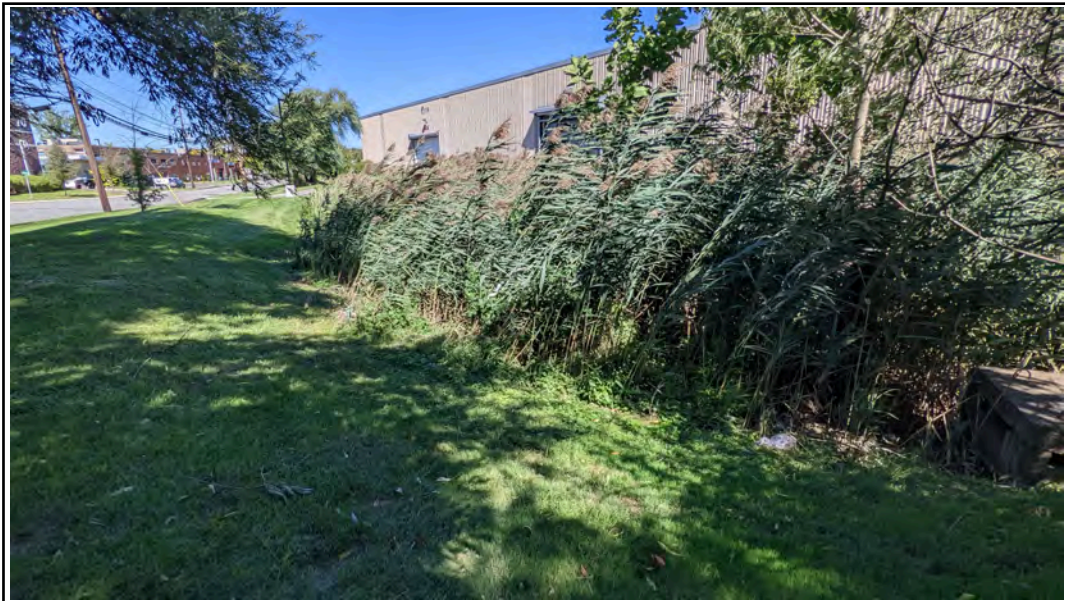
Figure 2: View of basin

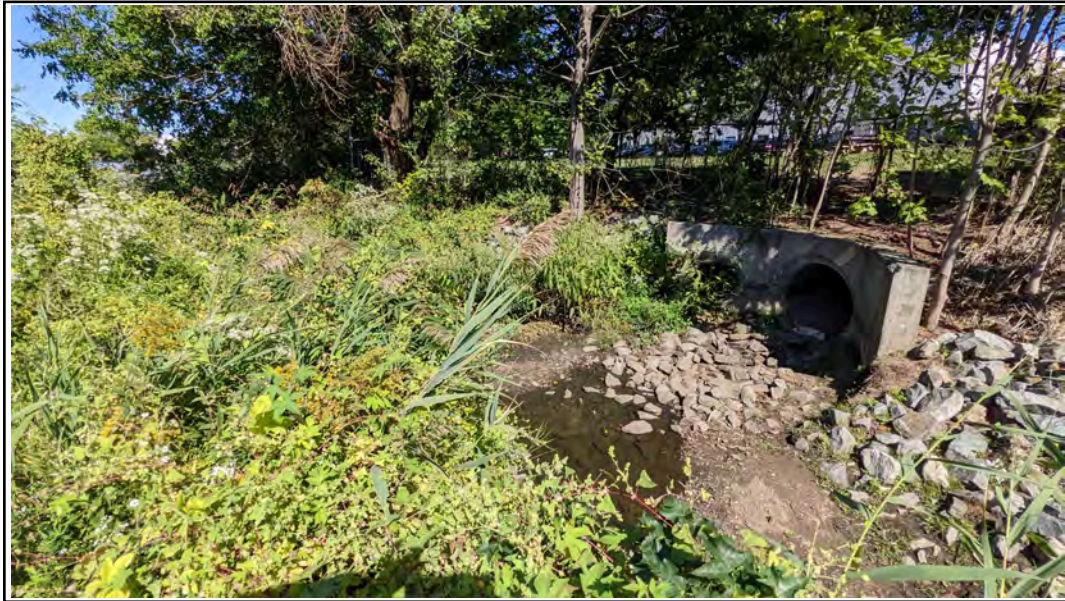
Notes on Condition / Problems:
Ditch is clear of debris.
Notes on Maintenance:
DPW has cleared vegetation and removed silt from two large culverts at this location.
Other Notes:

Figure 1: Upstream view of ditch at headwall

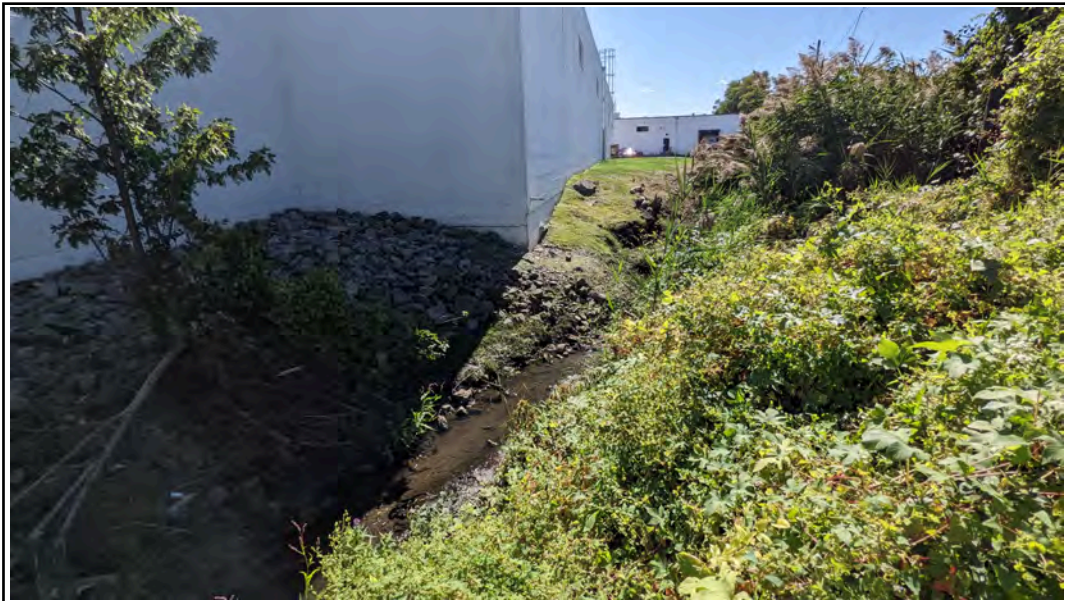
Figure 2: Downstream view of ditch at headwall

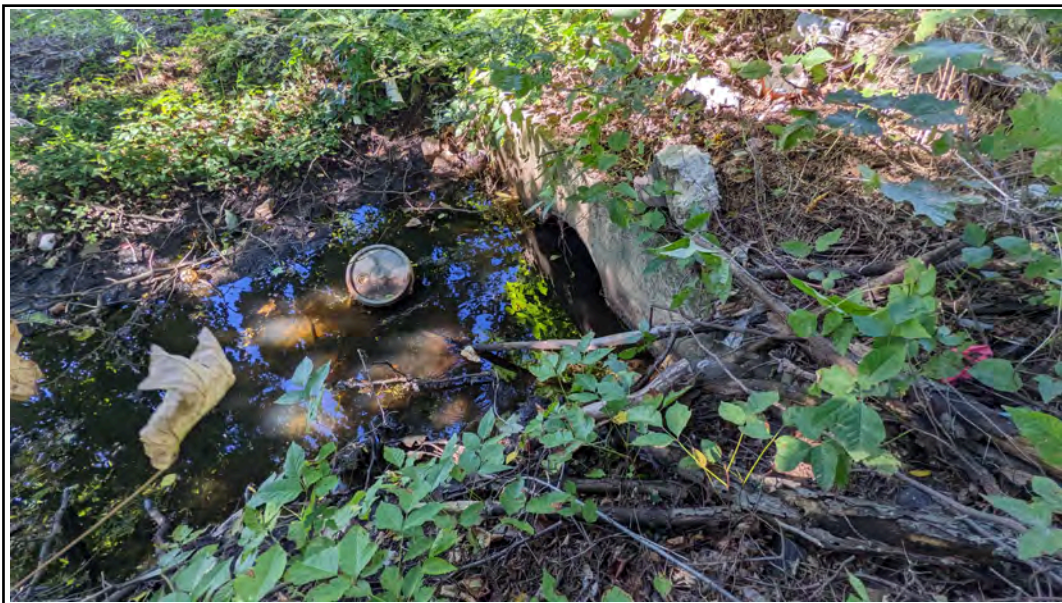
Type of Inspection:		Notes on Condition / Problems:	
<input checked="" type="checkbox"/> Yearly	<input checked="" type="checkbox"/> Ditch	Ditch is clear downstream, but overgrown upstream.	
<input type="checkbox"/> Post-Storm	<input type="checkbox"/> Tide Gate	Inlet silted to top of grate.	
<input type="checkbox"/> Complaint	<input type="checkbox"/> Pump System		
System Designation:			
<input checked="" type="checkbox"/> Natural Stream	<input checked="" type="checkbox"/> Culvert		
<input type="checkbox"/> Manmade Channel	<input type="checkbox"/> Outfall		
<input type="checkbox"/> Catch Basin	<input type="checkbox"/> Other: _____	Notes on Maintenance:	
Overall Functionality:		Contact Carlstadt DPW about silted inlet and roadway ponding.	
<input checked="" type="checkbox"/> Fully Functional			
<input type="checkbox"/> Functional with Restrictions			
<input type="checkbox"/> Non-Functional			
Maintenance Required:		Other Notes:

Figure 2: Downstream view of ditch

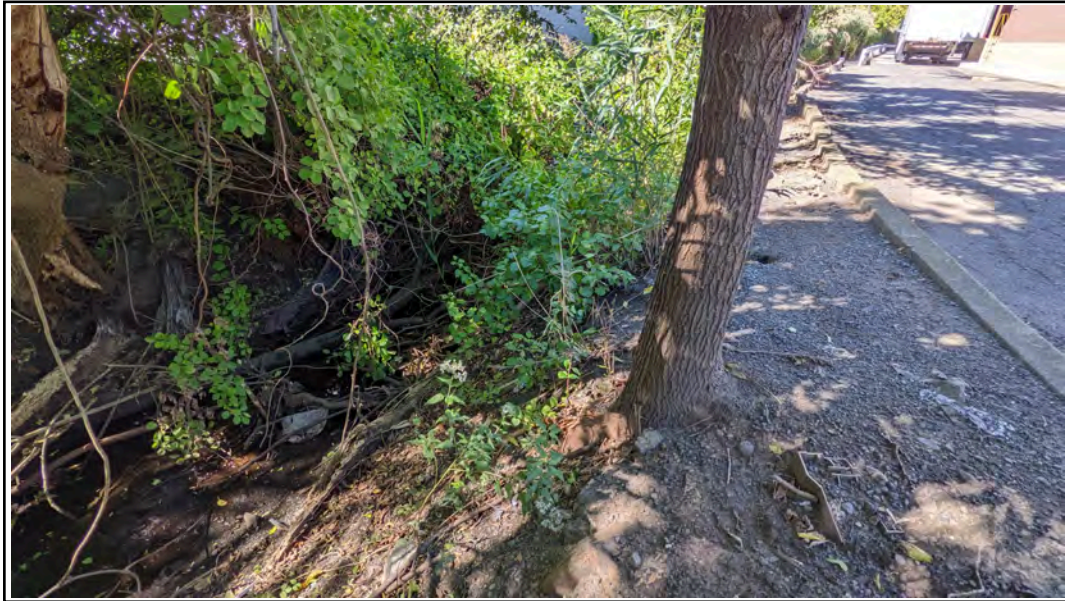
Type of Inspection:		Notes on Condition / Problems:	
<input checked="" type="checkbox"/> Yearly	<input checked="" type="checkbox"/> Ditch	Banks overgrown.	
<input type="checkbox"/> Post-Storm	<input type="checkbox"/> Tide Gate	Debris in ditch (pallets and lattice).	
<input type="checkbox"/> Complaint	<input type="checkbox"/> Pump System		
System Designation:			
<input checked="" type="checkbox"/> Natural Stream	<input type="checkbox"/> Culvert		
<input type="checkbox"/> Manmade Channel	<input type="checkbox"/> Outfall		
<input type="checkbox"/> Catch Basin	<input type="checkbox"/> Other: _____	Notes on Maintenance:	
Overall Functionality:			
<input checked="" type="checkbox"/> Fully Functional			
<input type="checkbox"/> Functional with Restrictions			
<input type="checkbox"/> Non-Functional			
Maintenance Required:		Other Notes:	
<input type="checkbox"/> Immediate			
<input type="checkbox"/> Repair

Figure 1: Upstream view of ditch

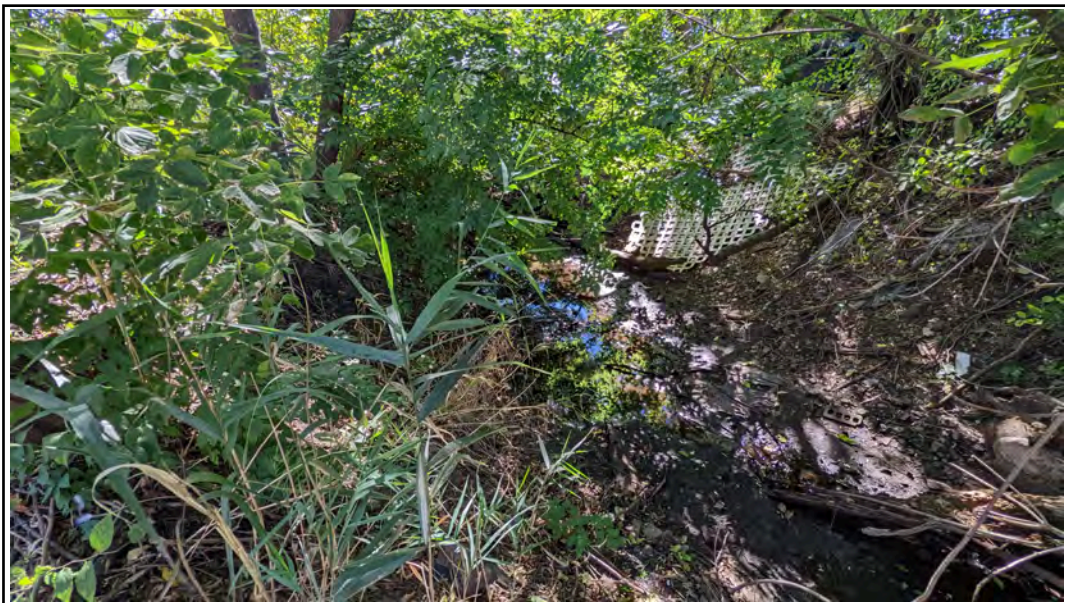
Figure 2: Downstream view of ditch

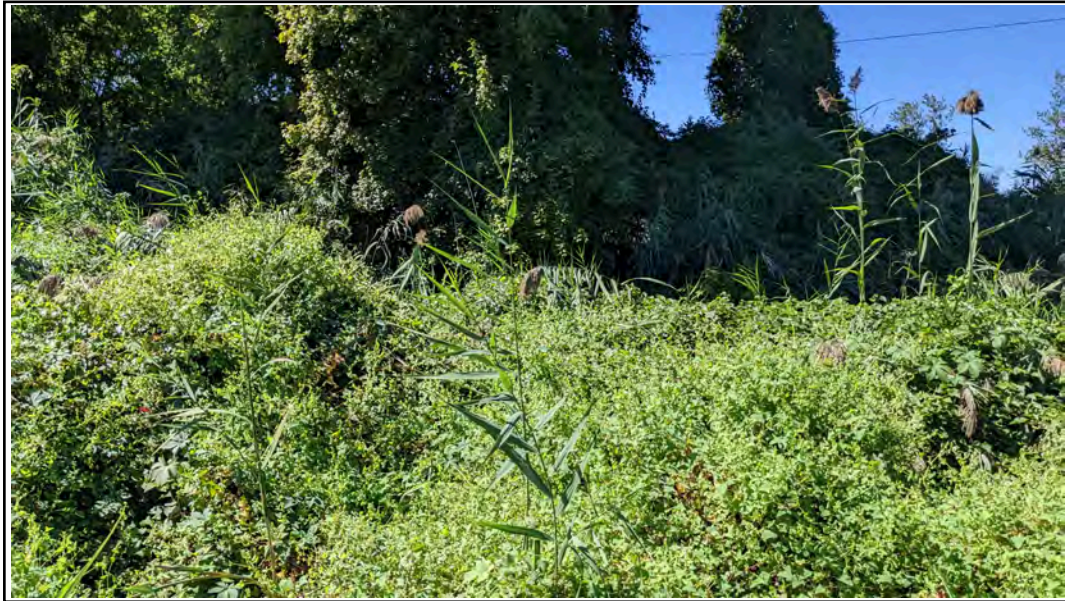
Type of Inspection:		Notes on Condition / Problems:	
<input checked="" type="checkbox"/> Yearly	<input checked="" type="checkbox"/> Ditch	Ditch is overgrown and water overflows into	
<input type="checkbox"/> Post-Storm	<input type="checkbox"/> Tide Gate	parking lot at high tide.	
<input type="checkbox"/> Complaint	<input type="checkbox"/> Pump System		
System Designation:			
<input checked="" type="checkbox"/> Natural Stream	<input type="checkbox"/> Culvert		
<input type="checkbox"/> Manmade Channel	<input type="checkbox"/> Outfall		
<input type="checkbox"/> Catch Basin	<input type="checkbox"/> Other: _____	Notes on Maintenance:	
Overall Functionality:			
<input checked="" type="checkbox"/> Fully Functional			
<input type="checkbox"/> Functional with Restrictions			
<input type="checkbox"/> Non-Functional			
Maintenance Required:		Other Notes:	
<input type="checkbox"/> Immediate			
<input type="checkbox"/> Repair

Figure 1: Upstream view of ditch

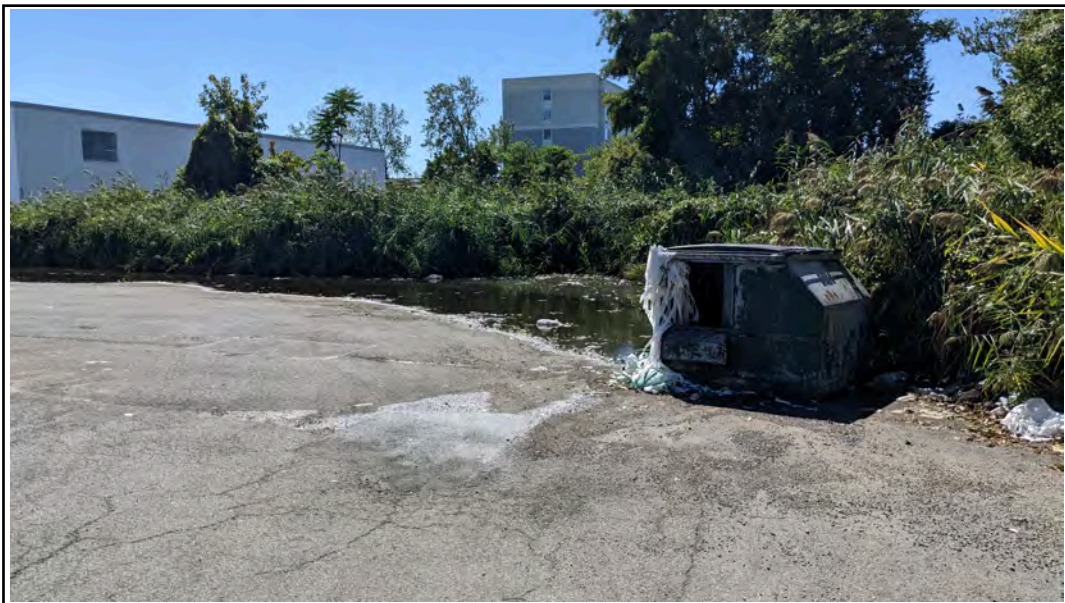
Figure 2: Downstream view of ditch

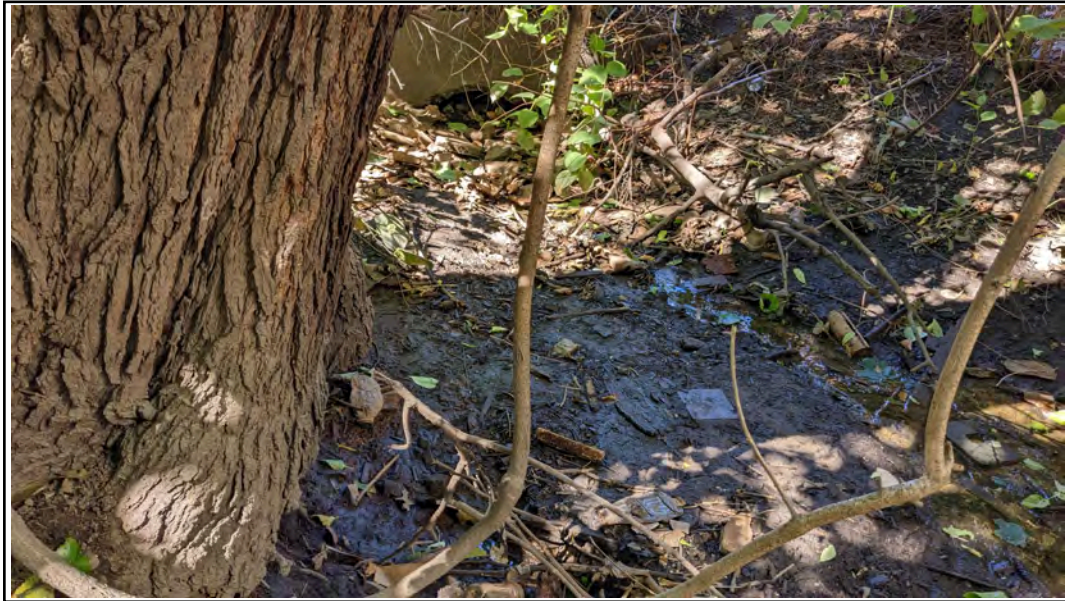
Type of Inspection:		Notes on Condition / Problems:	
<input checked="" type="checkbox"/> Yearly	<input checked="" type="checkbox"/> Ditch	Banks overgrown.	
<input type="checkbox"/> Post-Storm	<input type="checkbox"/> Tide Gate	Stagnant water.	
<input type="checkbox"/> Complaint	<input type="checkbox"/> Pump System		
System Designation:			
<input checked="" type="checkbox"/> Natural Stream	<input type="checkbox"/> Culvert		
<input type="checkbox"/> Manmade Channel	<input type="checkbox"/> Outfall		
<input type="checkbox"/> Catch Basin	<input type="checkbox"/> Other: _____	Notes on Maintenance:	
Overall Functionality:			
<input checked="" type="checkbox"/> Fully Functional			
<input type="checkbox"/> Functional with Restrictions			
<input type="checkbox"/> Non-Functional			
Maintenance Required:		Other Notes:	
<input type="checkbox"/> Immediate			
<input type="checkbox"/> Repair			
<input checked="" type="checkbox"/> Continued Upkeep

Figure 1: Upstream view of ditch

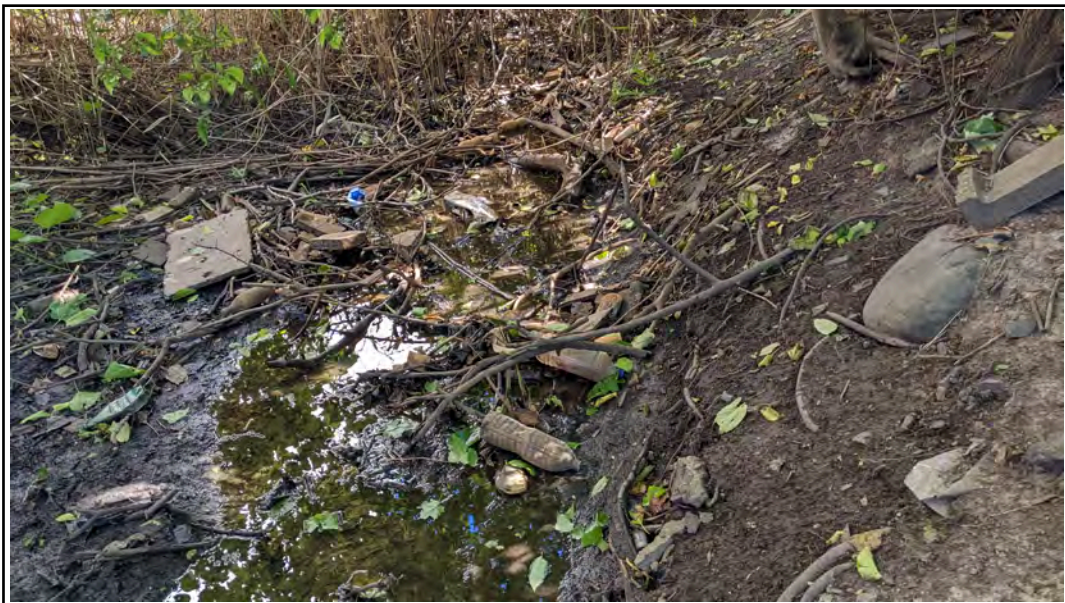
Figure 2: Downstream view of ditch
