New Jersey Sports & Exposition Authority Tide Gate Inspection Report

**The National Flood Insurance Program
Community Rating System**

The New Jersey Sports and Exposition Authority

October 13, 2022

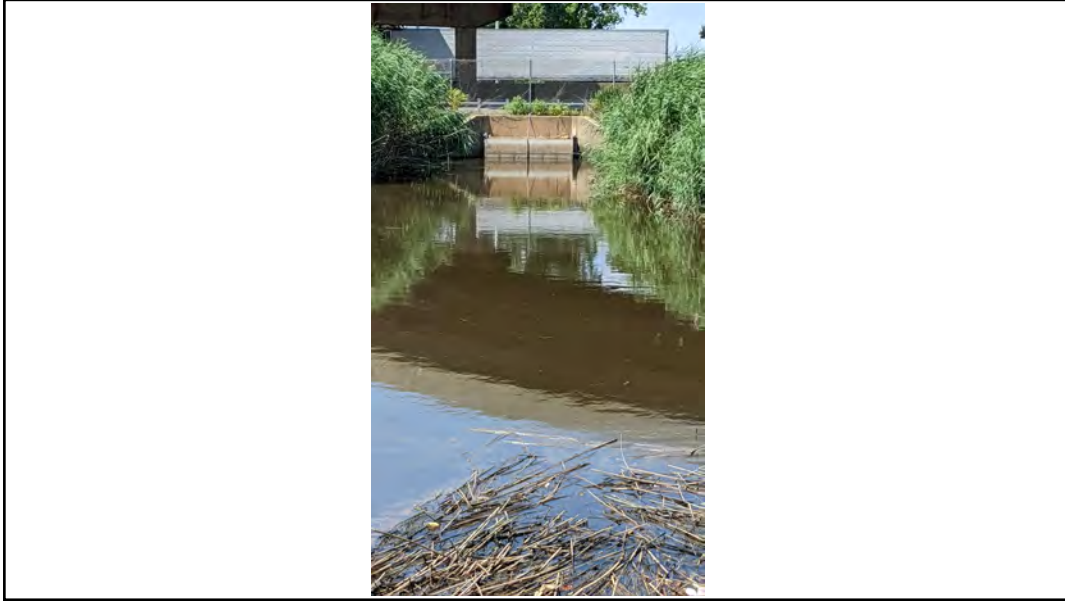
Type of Inspection:		Notes on Condition / Problems:	
<input checked="" type="checkbox"/> Yearly	<input checked="" type="checkbox"/> Ditch	Ditch is clear.	
<input type="checkbox"/> Post-Storm	<input checked="" type="checkbox"/> Tide Gate		
<input type="checkbox"/> Complaint	<input type="checkbox"/> Pump System		
System Designation:			
<input checked="" type="checkbox"/> Natural Stream	<input type="checkbox"/> Culvert		
<input type="checkbox"/> Manmade Channel	<input type="checkbox"/> Outfall		
<input type="checkbox"/> Catch Basin	<input type="checkbox"/> Other: _____	Notes on Maintenance:	
Overall Functionality:		Tide gate is functional.	
<input checked="" type="checkbox"/> Fully Functional			
<input type="checkbox"/> Functional with Restrictions			
<input type="checkbox"/> Non-Functional			
Maintenance Required:			
<input type="checkbox"/> Immediate		Other Notes:	
<input type="checkbox"/> Repair		Located on Transco property.

Figure 1: Upstream view at tide gate

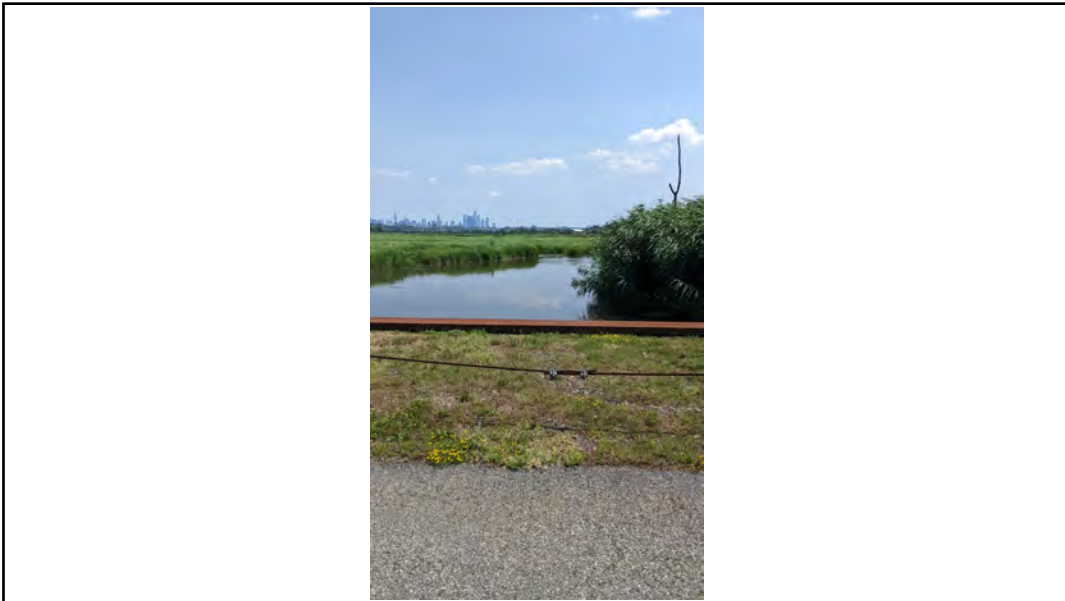
Figure 2: Downstream view of ditch at bridge

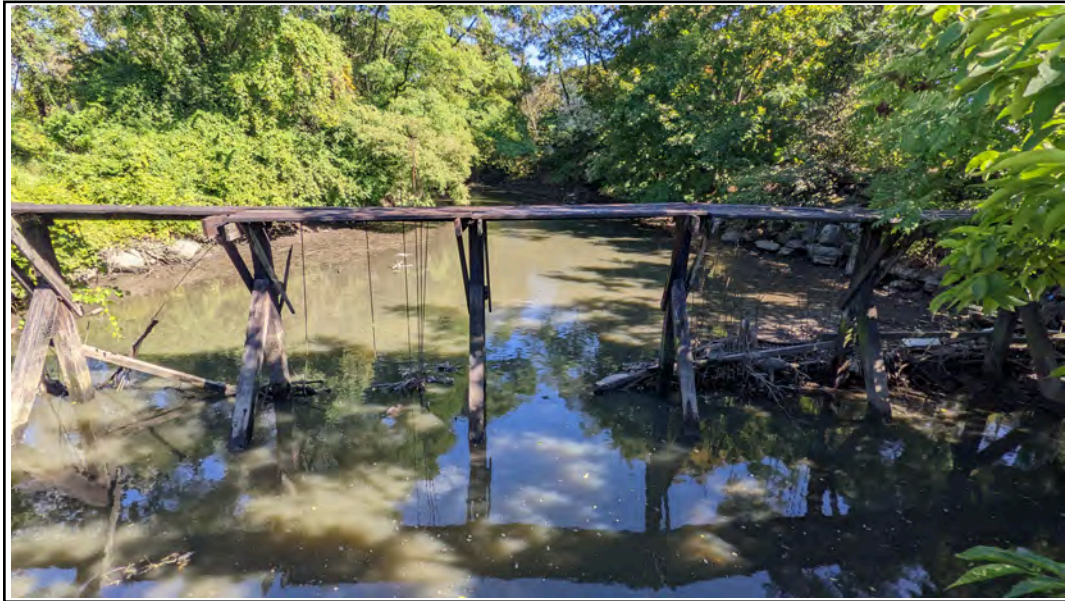
Type of Inspection:		Notes on Condition / Problems:	
<input checked="" type="checkbox"/> Yearly	<input checked="" type="checkbox"/> Ditch	Minor debris at trash rack.	
<input type="checkbox"/> Post-Storm	<input checked="" type="checkbox"/> Tide Gate	Tide gates are functioning.	
<input type="checkbox"/> Complaint	<input type="checkbox"/> Pump System		
System Designation:			
<input checked="" type="checkbox"/> Natural Stream	<input type="checkbox"/> Culvert		
<input type="checkbox"/> Manmade Channel	<input type="checkbox"/> Outfall		
<input type="checkbox"/> Catch Basin	<input type="checkbox"/> Other: _____	Notes on Maintenance:	
Overall Functionality:		One cable is missing from a tide gate.	
<input checked="" type="checkbox"/> Fully Functional			
<input type="checkbox"/> Functional with Restrictions			
<input type="checkbox"/> Non-Functional			
Maintenance Required:		Other Notes:	
<input type="checkbox"/> Immediate

Figure 1: Upstream view at tide gate

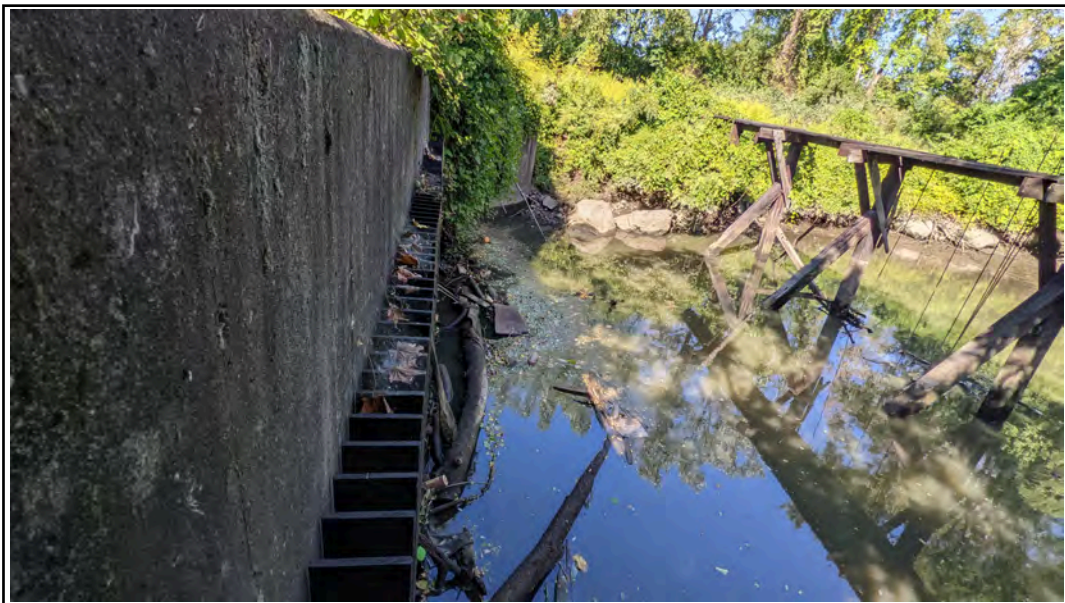
Figure 2: Downstream view at tide gate

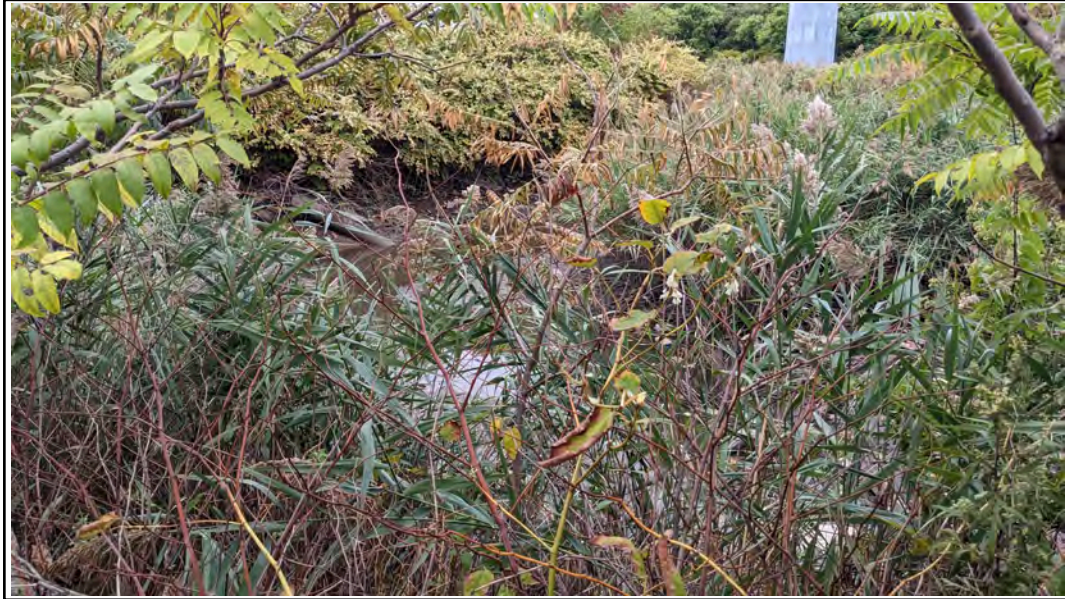
Type of Inspection:		Notes on Condition / Problems:	
<input checked="" type="checkbox"/> Yearly	<input checked="" type="checkbox"/> Ditch	Debris in ditch upstream of tide gate.	
<input type="checkbox"/> Post-Storm	<input checked="" type="checkbox"/> Tide Gate	Tide gate is completely off of its hinge.	
<input type="checkbox"/> Complaint	<input type="checkbox"/> Pump System		
System Designation:			
<input checked="" type="checkbox"/> Natural Stream	<input checked="" type="checkbox"/> Culvert		
<input type="checkbox"/> Manmade Channel	<input type="checkbox"/> Outfall		
<input type="checkbox"/> Catch Basin	<input type="checkbox"/> Other: _____	Notes on Maintenance:	
Overall Functionality:			
<input type="checkbox"/> Fully Functional			
<input type="checkbox"/> Functional with Restrictions			
<input checked="" type="checkbox"/> Non-Functional			
Maintenance Required:		Other Notes:	
<input type="checkbox"/> Immediate		Continue to monitor upstream properties.

Figure 1: Upstream view at tide gate

<input checked="" type="checkbox"/> Repair			
<input type="checkbox"/> Continued Upkeep			
<input type="checkbox"/> None

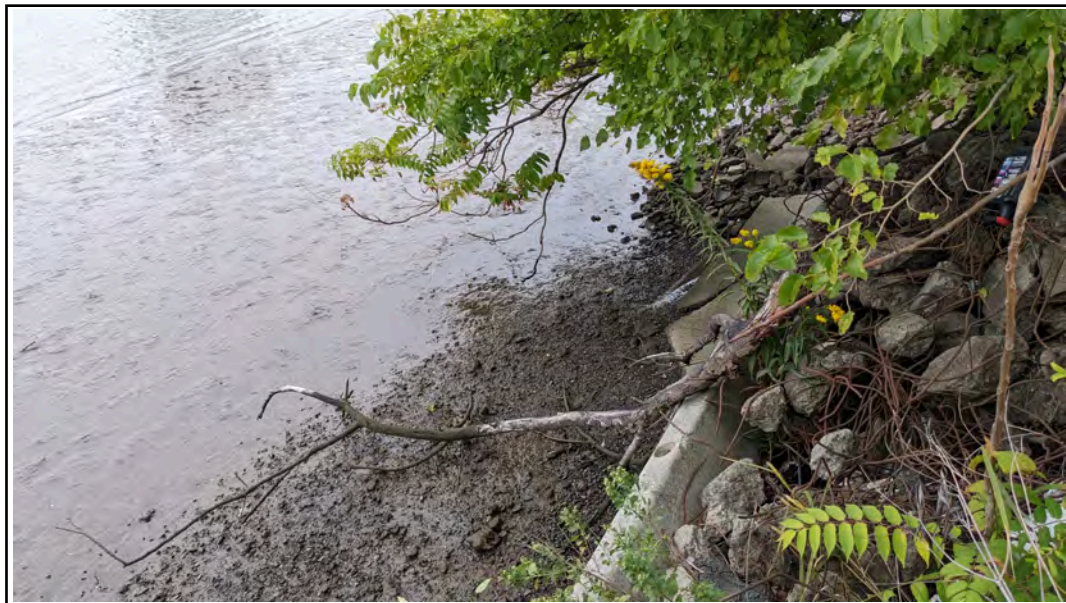
Figure 2: Downstream view at tide gate

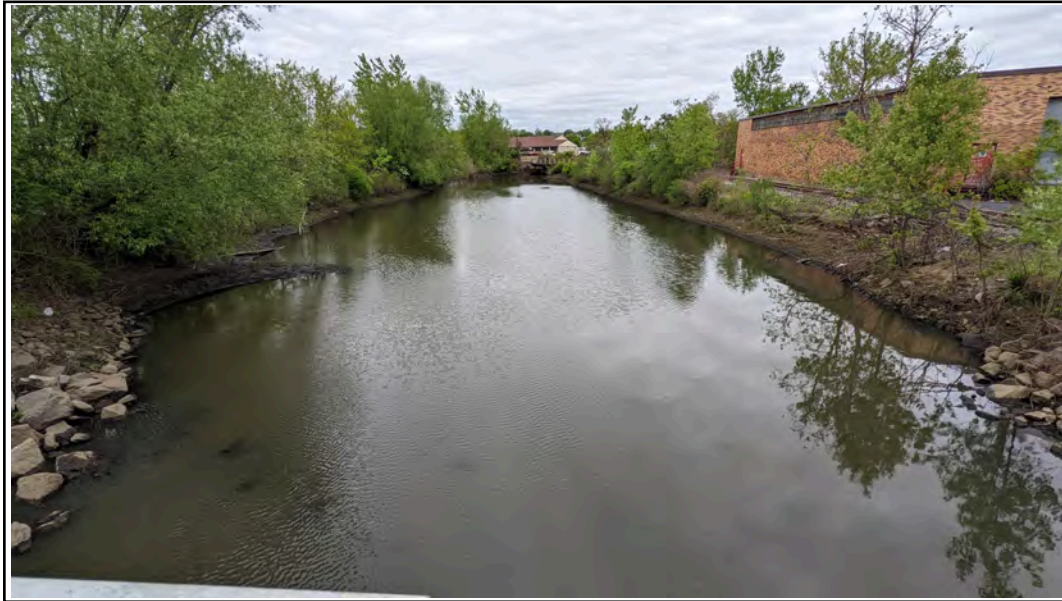
Type of Inspection:		Notes on Condition / Problems:	
<input checked="" type="checkbox"/> Yearly	<input checked="" type="checkbox"/> Ditch	Light debris at trash rack.	
<input type="checkbox"/> Post-Storm	<input checked="" type="checkbox"/> Tide Gate	Tide gates are functioning.	
<input type="checkbox"/> Complaint	<input type="checkbox"/> Pump System		
System Designation:			
<input checked="" type="checkbox"/> Natural Stream	<input type="checkbox"/> Culvert		
<input type="checkbox"/> Manmade Channel	<input type="checkbox"/> Outfall		
<input type="checkbox"/> Catch Basin	<input type="checkbox"/> Other: _____	Notes on Maintenance:	
Overall Functionality:		Long reach excavator is onsite, and Bergen County has been clearing debris.	
<input checked="" type="checkbox"/> Fully Functional			
<input type="checkbox"/> Functional with Restrictions			
<input type="checkbox"/> Non-Functional			
Maintenance Required:		Other Notes:

Figure 1: Upstream view at tide gate

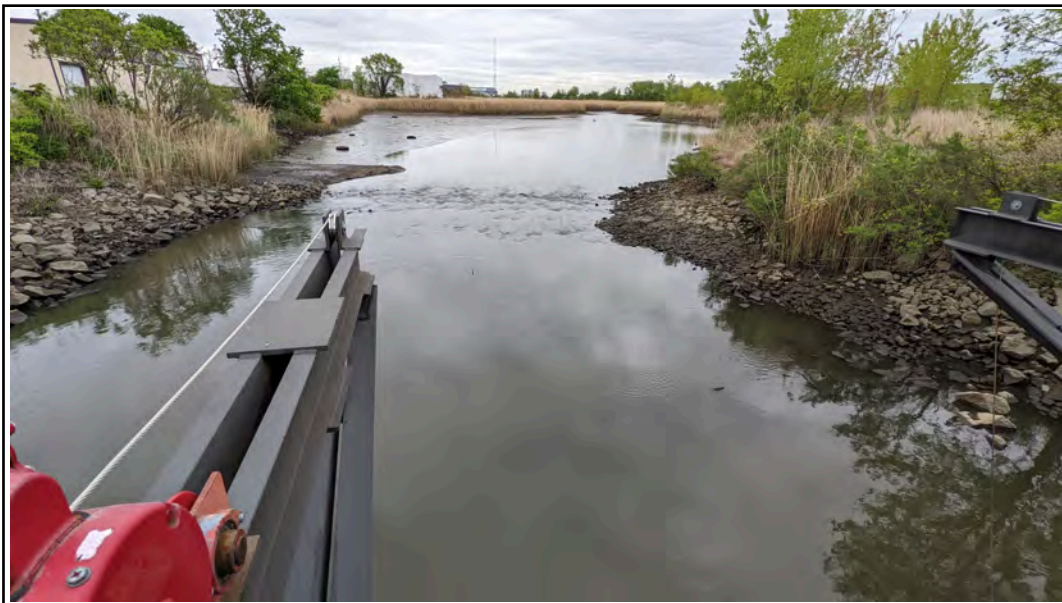
Figure 2: Downstream view at tide gate

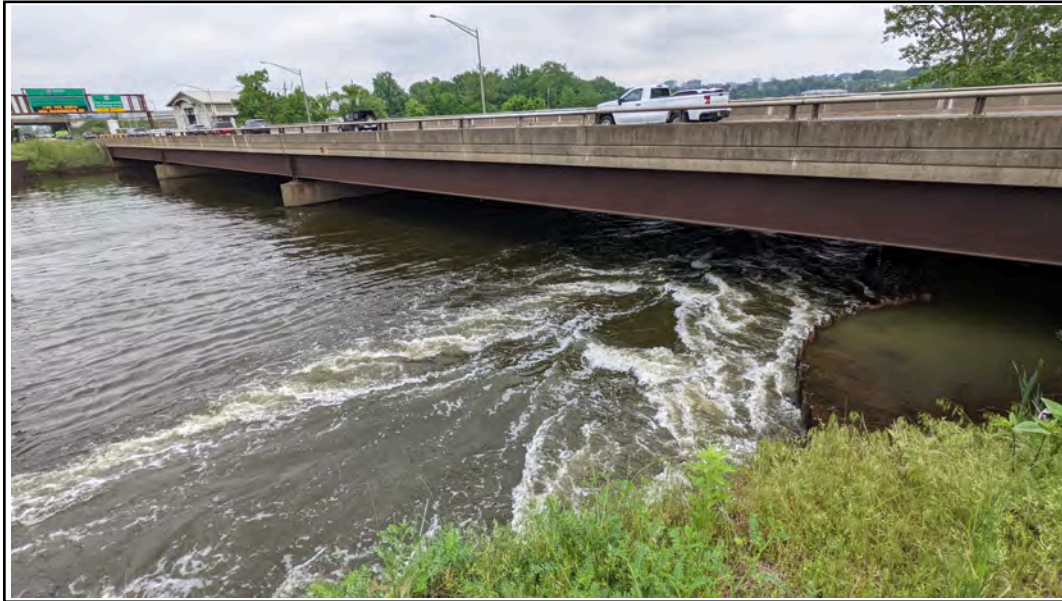
Figure 1: View of tide gate

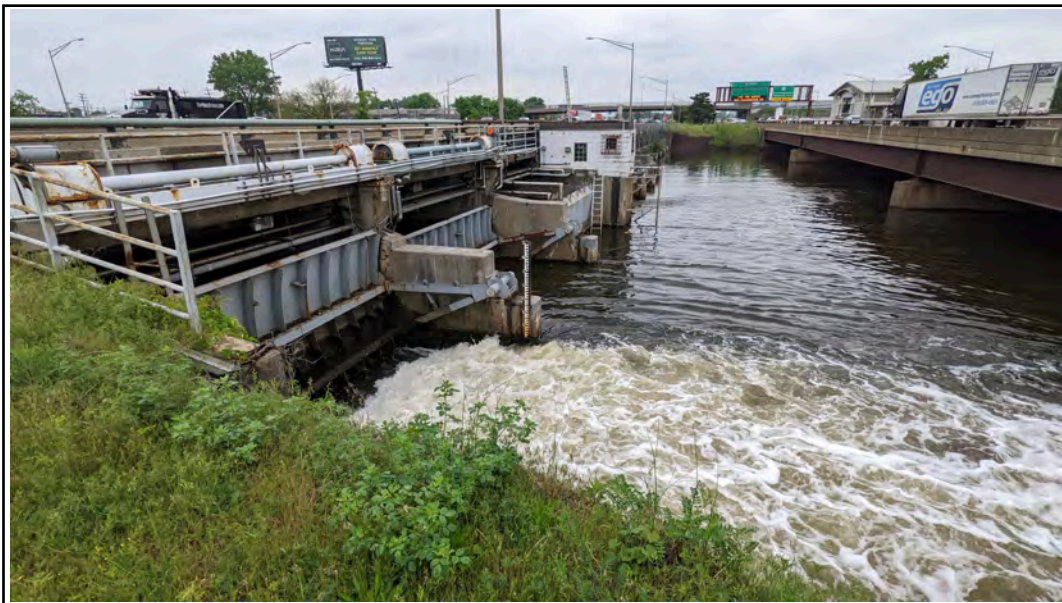
Type of Inspection: <input checked="" type="checkbox"/> Yearly <input type="checkbox"/> Post-Storm <input type="checkbox"/> Complaint <input checked="" type="checkbox"/> Ditch <input checked="" type="checkbox"/> Tide Gate <input type="checkbox"/> Pump System	Notes on Condition / Problems: River and creek are clear of debris. 6 tide gates. No trash racks required. Tide gates 3 & 4 are non-operational.
System Designation: <input checked="" type="checkbox"/> Natural Stream <input type="checkbox"/> Manmade Channel <input type="checkbox"/> Catch Basin <input type="checkbox"/> Culvert <input type="checkbox"/> Outfall <input type="checkbox"/> Other:	Notes on Maintenance: Bergen County DPW maintains facility weekly.
Overall Functionality: <input type="checkbox"/> Fully Functional <input checked="" type="checkbox"/> Functional with Restrictions <input type="checkbox"/> Non-Functional	Other Notes: FIOS/SCADA system installed. Water tight doors to be installed at the control buildings.

Figure 2: View of control room

Maintenance Required: <input type="checkbox"/> Immediate <input checked="" type="checkbox"/> Repair <input checked="" type="checkbox"/> Continued Upkeep <input type="checkbox"/> None

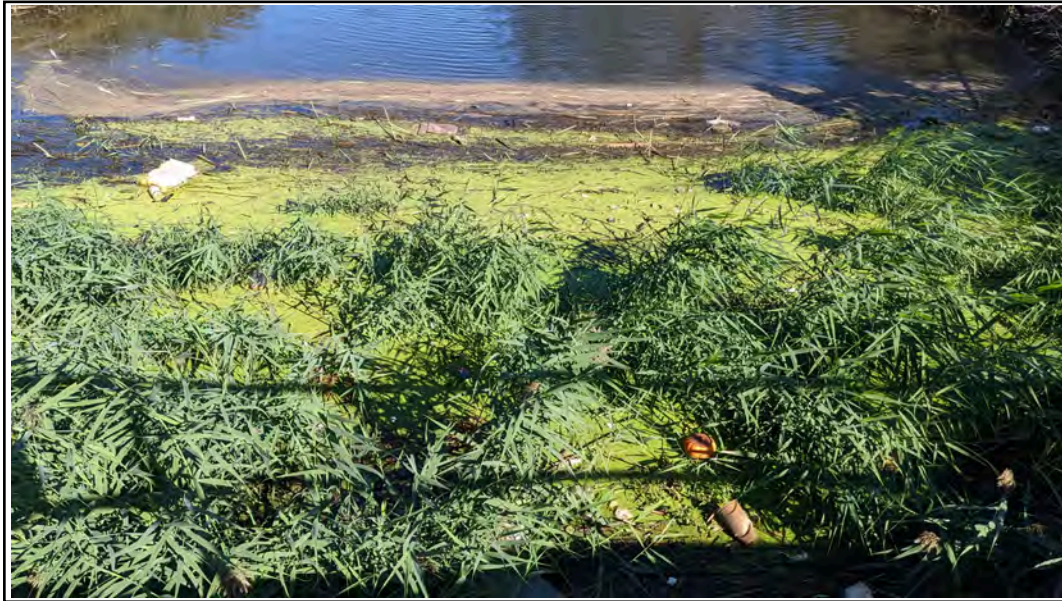
Type of Inspection:		Notes on Condition / Problems:	
<input checked="" type="checkbox"/> Yearly	<input checked="" type="checkbox"/> Ditch	Ditch is clear.	
<input type="checkbox"/> Post-Storm	<input checked="" type="checkbox"/> Tide Gate	Debris and algae is present at trash rack.	
<input type="checkbox"/> Complaint	<input type="checkbox"/> Pump System		
System Designation:			
<input checked="" type="checkbox"/> Natural Stream	<input checked="" type="checkbox"/> Culvert		
<input type="checkbox"/> Manmade Channel	<input type="checkbox"/> Outfall		
<input type="checkbox"/> Catch Basin	<input type="checkbox"/> Other: _____		
Overall Functionality:		Notes on Maintenance:	
<input checked="" type="checkbox"/> Fully Functional		Contact Bergen County to remove the algae and debris.	
<input type="checkbox"/> Functional with Restrictions			
<input type="checkbox"/> Non-Functional			
Maintenance Required:			
<input type="checkbox"/> Immediate

<input type="checkbox"/> Repair		Six tide gates are functional.	
<input checked="" type="checkbox"/> Continued Upkeep		Chain missing for one tide gate.	
<input type="checkbox"/> None

Figure 1: Upstream view at tide gate

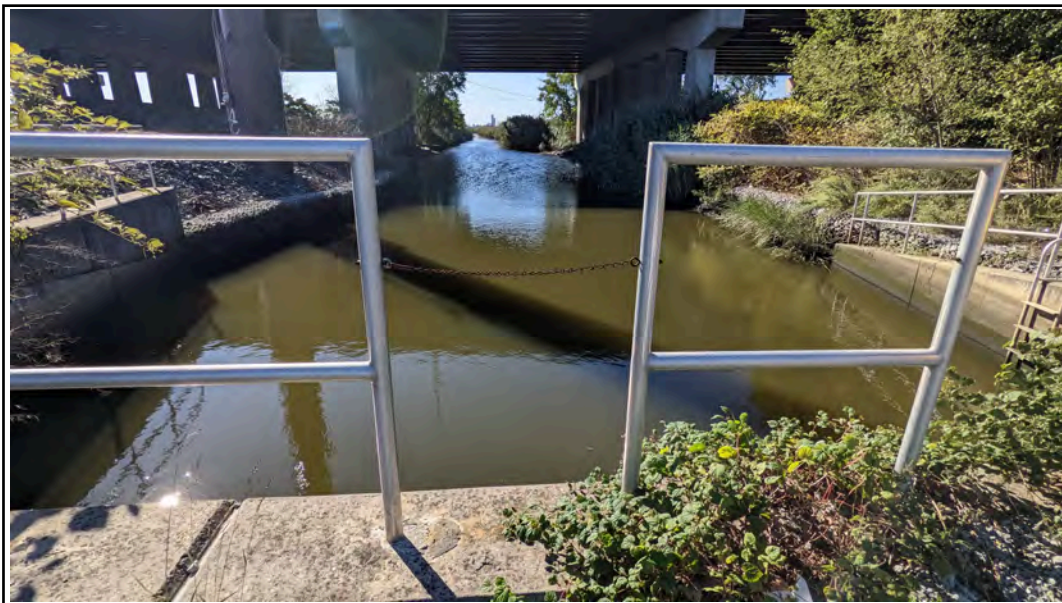
Figure 2: Downstream view at tide gate

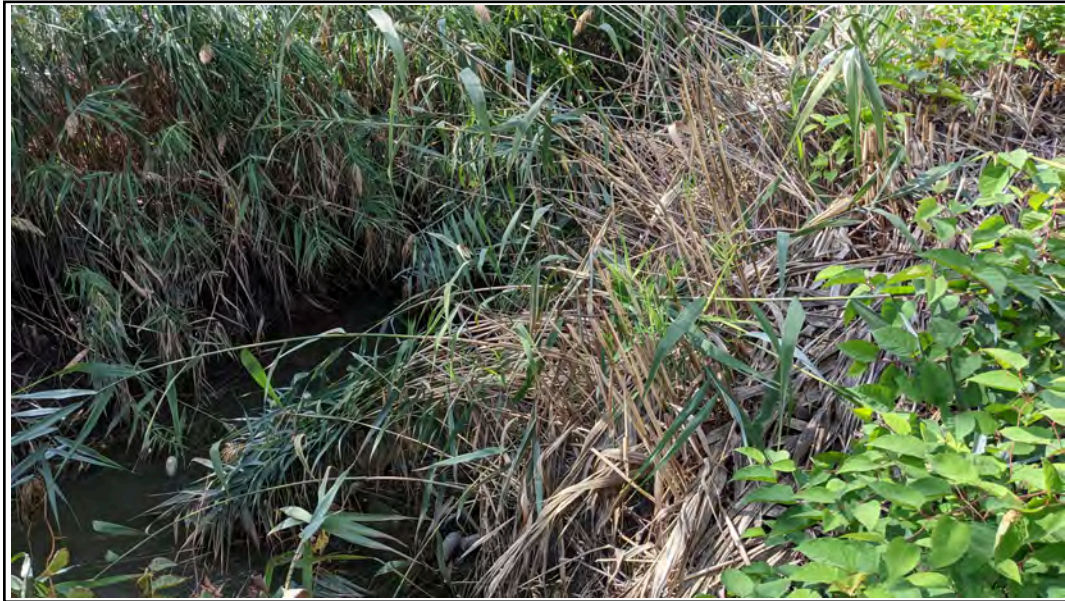
Type of Inspection: <input checked="" type="checkbox"/> Yearly <input type="checkbox"/> Post-Storm <input type="checkbox"/> Complaint <input checked="" type="checkbox"/> Ditch <input checked="" type="checkbox"/> Tide Gate <input type="checkbox"/> Pump System	Notes on Condition / Problems: Ditch is clear. Banks are overgrown. Tide gate channel is clear. Tide gate is functioning.
System Designation: <input type="checkbox"/> Natural Stream <input checked="" type="checkbox"/> Manmade Channel <input type="checkbox"/> Catch Basin <input type="checkbox"/> Culvert <input type="checkbox"/> Outfall <input type="checkbox"/> Other:	Notes on Maintenance:
Overall Functionality: <input checked="" type="checkbox"/> Fully Functional <input type="checkbox"/> Functional with Restrictions <input type="checkbox"/> Non-Functional	Other Notes: Upstream trash rack at culvert is detached from headwall. Continue to monitor.

Figure 1: Upstream view of ditch at culvert

Maintenance Required: <input type="checkbox"/> Immediate <input checked="" type="checkbox"/> Repair <input checked="" type="checkbox"/> Continued Upkeep <input type="checkbox"/> None

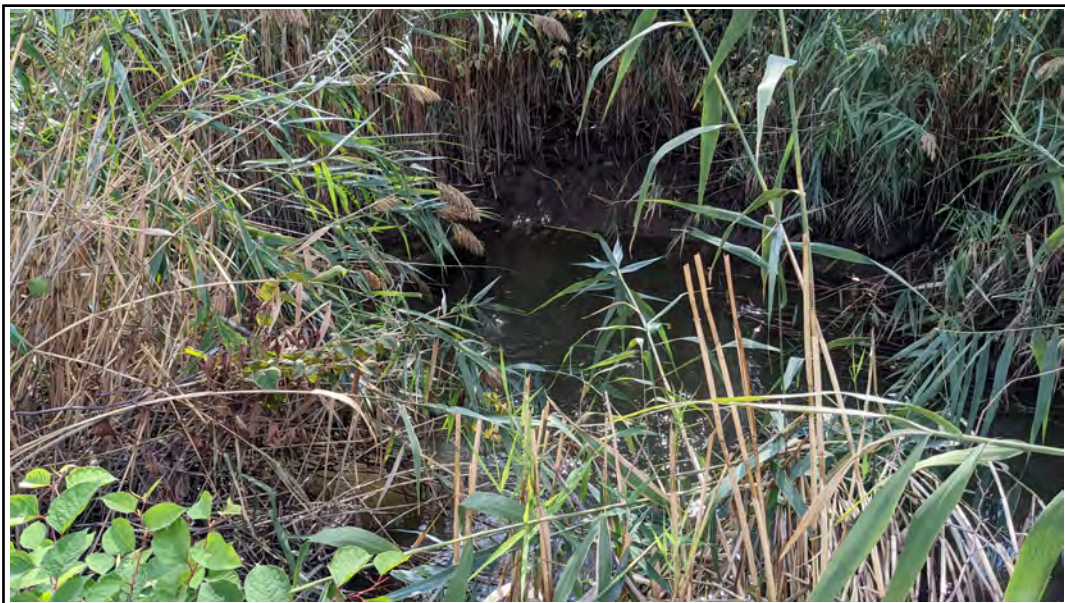
Figure 2: Downstream view at tide gate
