**CN-302 Lyndhurst Admin Building Envelope Improvements**  
Lyndhurst, New Jersey  
**Bid Submission Due Date:** January 16, 2026 @ 12:00 pm

## **ADDENDUM No. 2**

APPENDIX – A | EXTERIOR SITE PHOTOS (TAKEN FROM SCAFFOLDING)

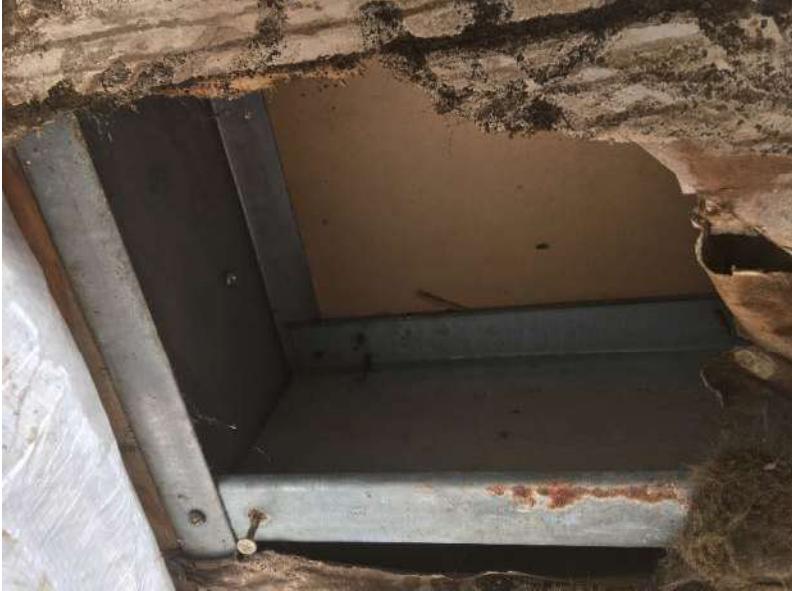
<p><b>Exterior Face of Interior Gypsum Sheathing</b>   01</p> <p><b>Exterior Face of Interior Gypsum Wall Board</b></p> <p><b>Relatively dry; but exposed to the elements.</b></p> <p><b>Corrosion visible at steel stud framing</b></p>
--	--

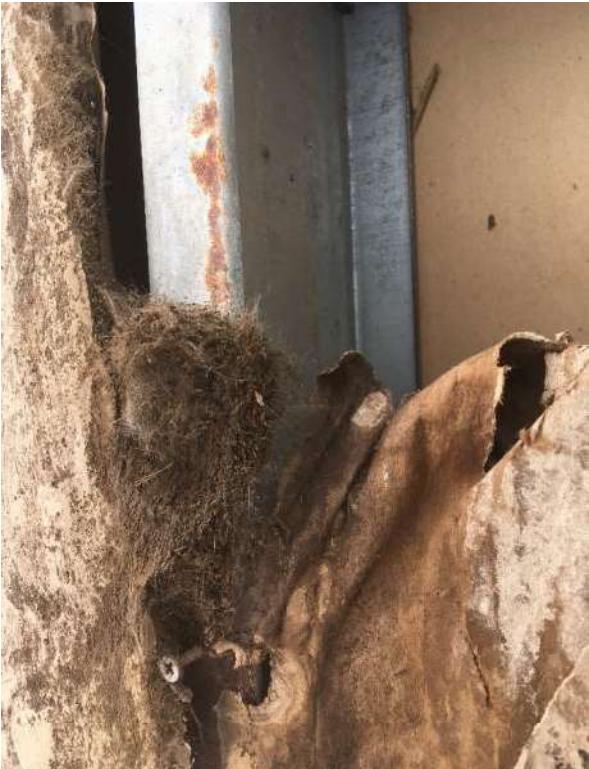
<p><b>Exterior Face of Interior Gypsum Sheathing</b>   02</p> <p><b>Steel Stud Framing varied in condition depending on location.</b></p> <p><b>Corrosion mostly on exterior-facing flange due to direct exposure to moisture.</b></p> <p><b>Integrity of stud framing no compromised by corrosion</b></p>
---	--

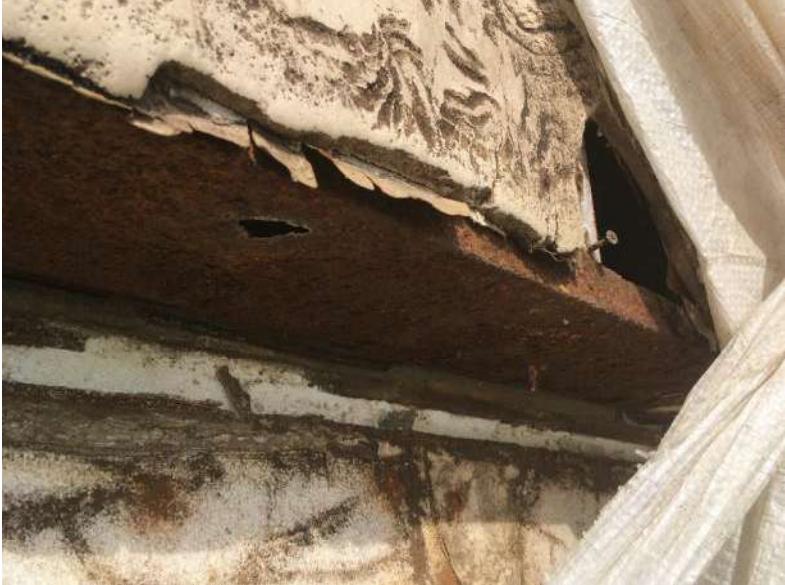
<p><b>Steel Framing (Studs &amp; Soffit Framing)</b></p>	<p><b>03</b></p>
	<p><b>Soffit-forming steel framing completely rusted through flanges and web.</b></p> <p><b>Integrity of member completely compromised</b></p>

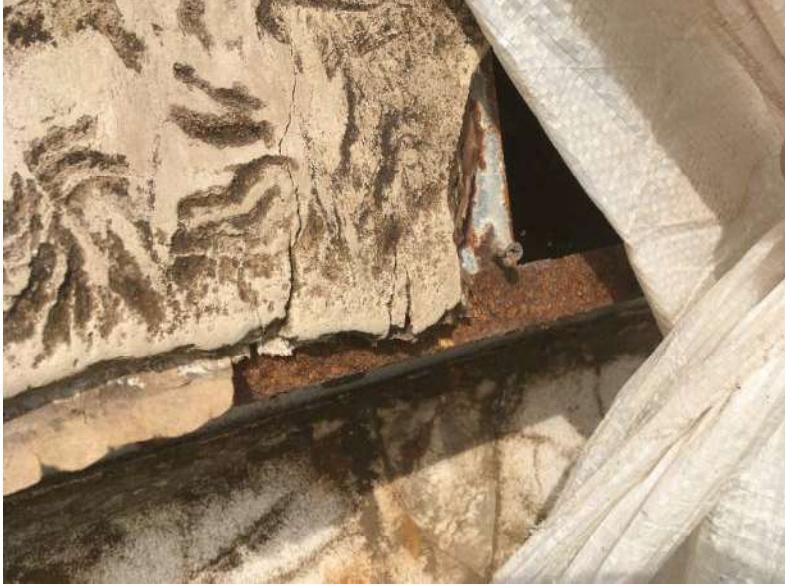
<p><b>Steel Framing (Studs &amp; Soffit Framing)</b></p>	<p><b>04</b></p>
	<p><b>Steel Stud Framing – bottom track form for exterior soffit</b></p> <p><b>Rusted through and compromised</b></p>

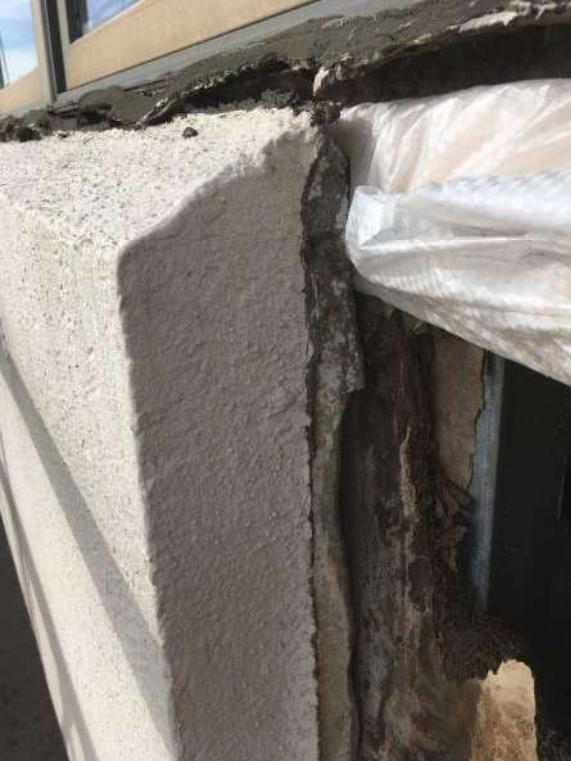
EIFS Wall Panels	05
<p><b>EIFS Panel (adjacent to missing panel) pulling away from structure and sheathing</b></p>

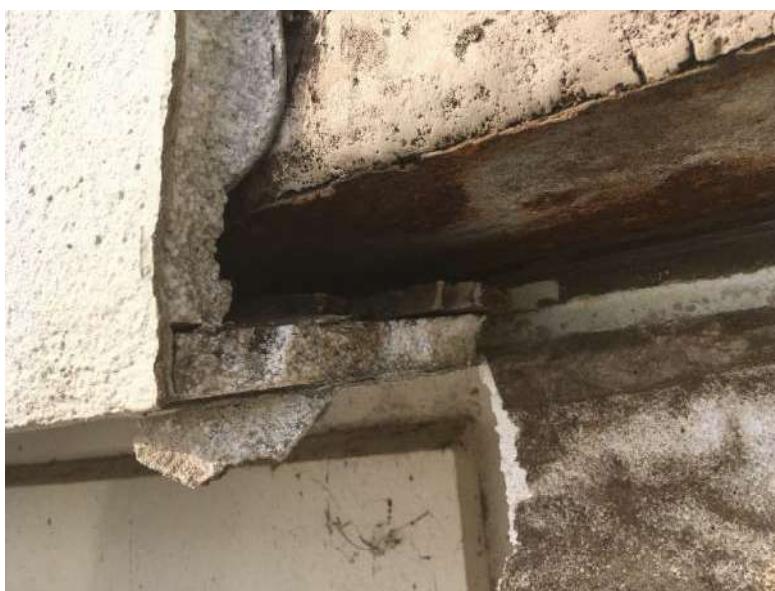
EIFS Soffit Panels	06
<p><b>View towards soffit edge of EIFS panel pulling away from building structure and sheathing</b></p>

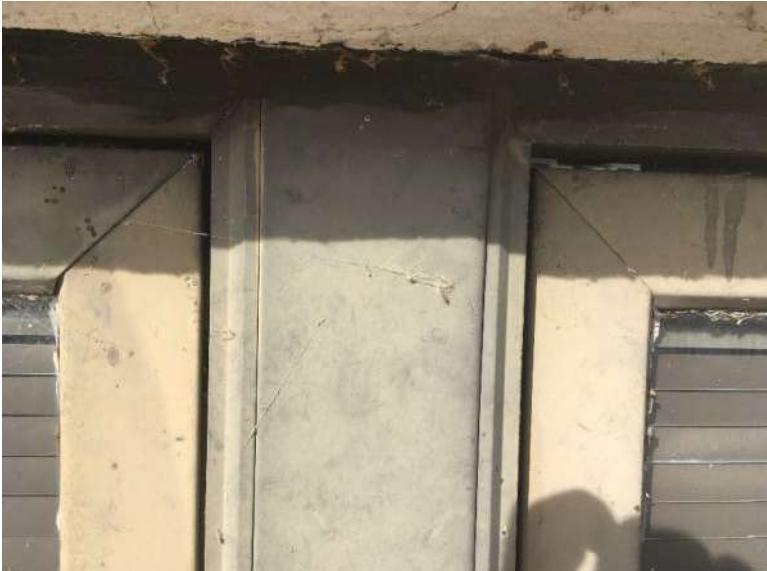
Aluminum-clad Window Systems	07

<p><b>View of aluminum-clad window system. Cladding is beginning to separate at the joints. Joint sealant at joints is gone or failing.</b></p> <p><b>Glazing bead between glass and frame has been compromised and thermal integrity is minimal</b></p>

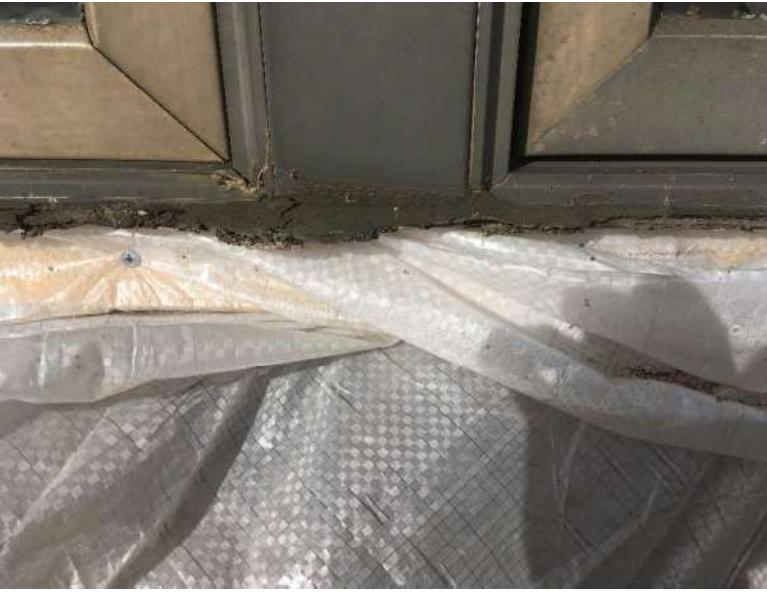
Aluminum-clad Window Systems	08

<p><b>View of aluminum-clad window system. Cladding is beginning to separate at the joints. Joint sealant at joints is gone or failing.</b></p>

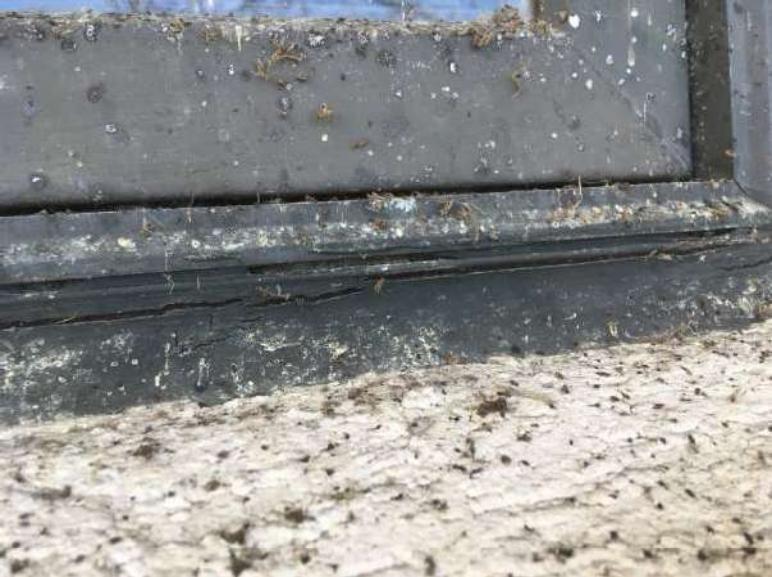
Joint Sealant	11

A close-up photograph showing a dark, textured surface, likely metal, with a horizontal seam. The seam is covered in a dry, greyish sealant that is cracked and peeling, indicating it is no longer effective. The surrounding area is dirty and shows signs of weathering.	<p><b>View of Joint Sealant. Dry, no elasticity. No longer effective as a sealant.</b></p>

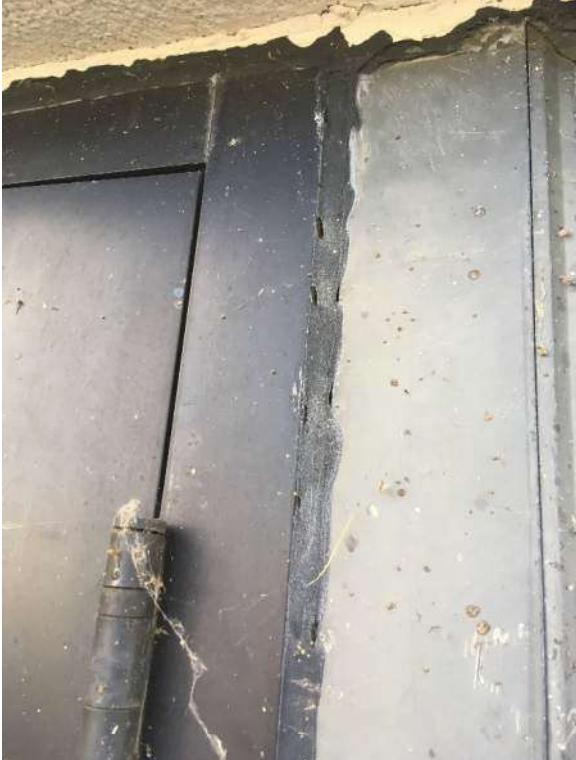
Joint Sealant	12

A close-up photograph of a vertical metal seam. The sealant is dry, cracked, and peeling, revealing the underlying metal. The surrounding area is dirty and shows signs of weathering.	<p><b>View of Joint Sealant. Dry, no elasticity. No longer effective as a sealant.</b></p>

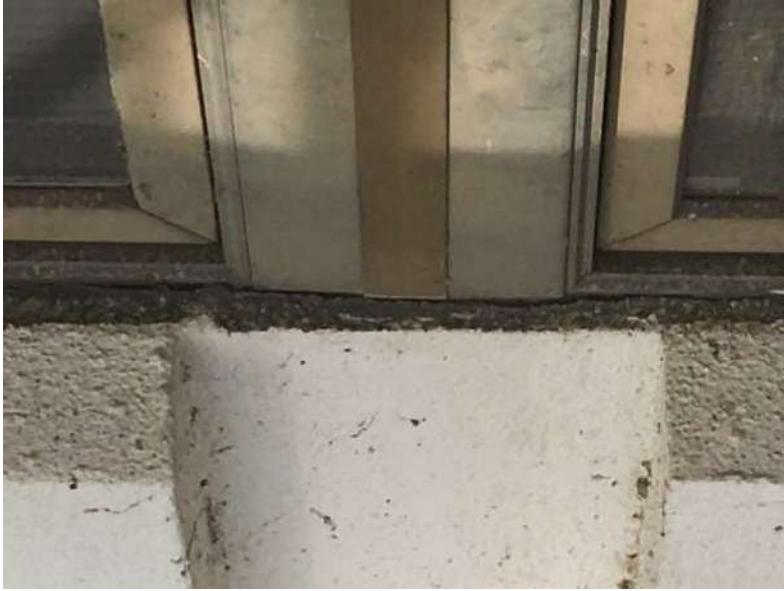
Joint Sealant	13

<p><b>Joint Sealant failures are allowing wind-driven rain behind the EIFS system and into the exterior sheathing board</b></p>

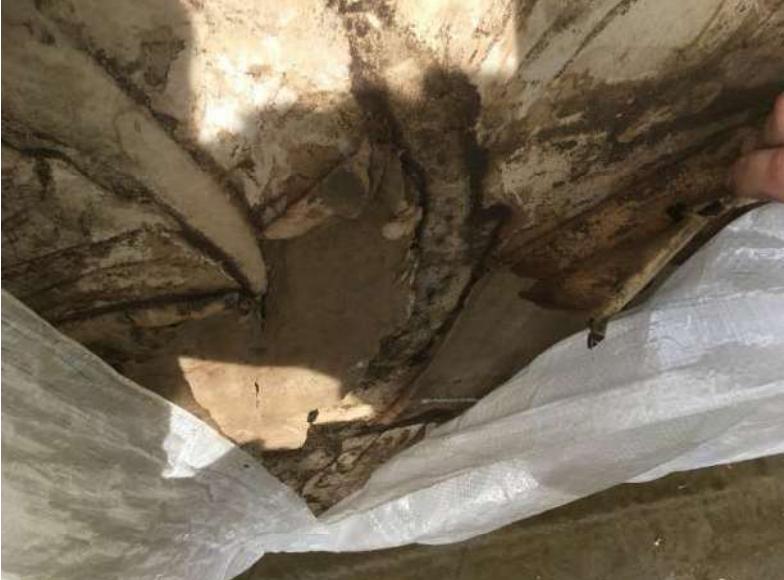
Exterior Sheathing Board	14

<p><b>View of exterior sheathing board which is completely degraded due to continuous water infiltration</b></p>

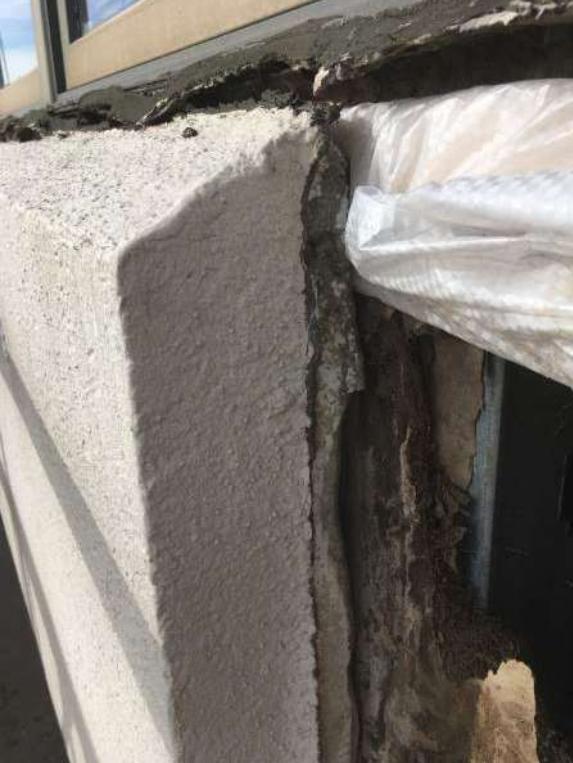
<p>Exterior Sheathing Board 15</p> <p>Section view of EIFS wall panel pulling exterior sheathing board apart at the facer</p>
---	---

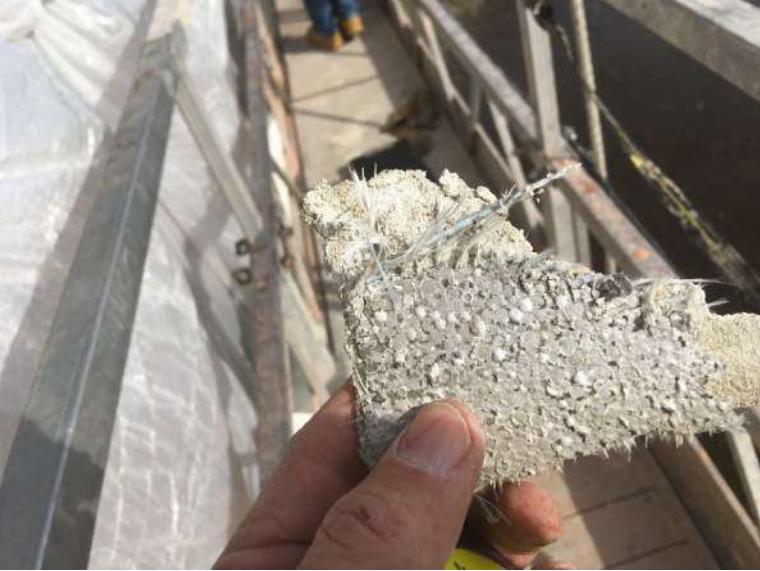
EIFS Wall Panels	19

A close-up photograph showing a hand holding a piece of broken EIFS (Exterior Insulated Finish System) panel. The panel is heavily damaged, revealing a metal reinforcing mesh underneath. The mesh is visible through the fractured concrete-like surface. The background shows a construction site with scaffolding and other panels.	<b>View of reinforcing mesh at face of broken EIFS panel</b>

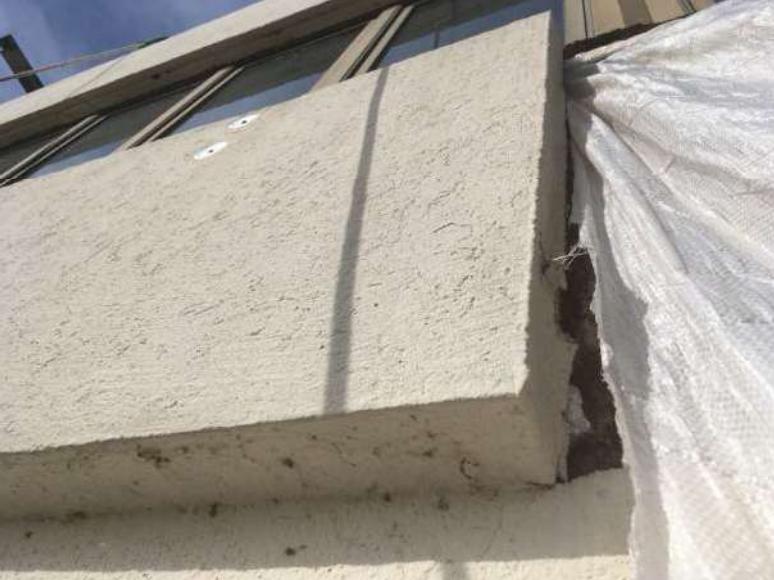
EIFS Wall Panels	20

A photograph showing a vertical EIFS panel that has pulled away from the building's structure. The panel is detached at the bottom, revealing the underlying wall and the metal reinforcement mesh. The top part of the panel is still attached to the structure. The background shows a construction site with scaffolding.	<b>View of EIFS panel (adjacent to missing panel) pulling away from building structure</b>

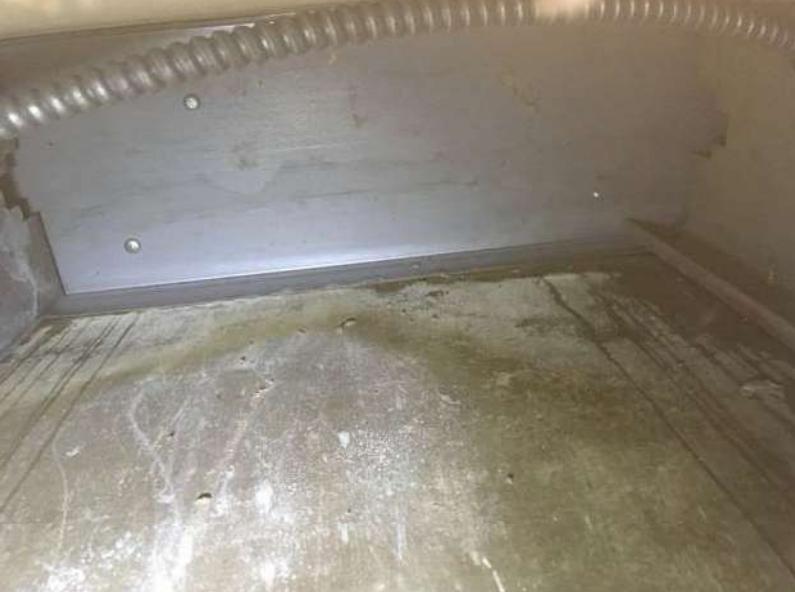
<p><b>PROBE LOCATION 01 – GROUND FLOOR / EAST</b></p> <p><b>2</b></p> <p><b>View up – towards Sill Framing Evidence of Moisture / Staining</b></p>
--	--

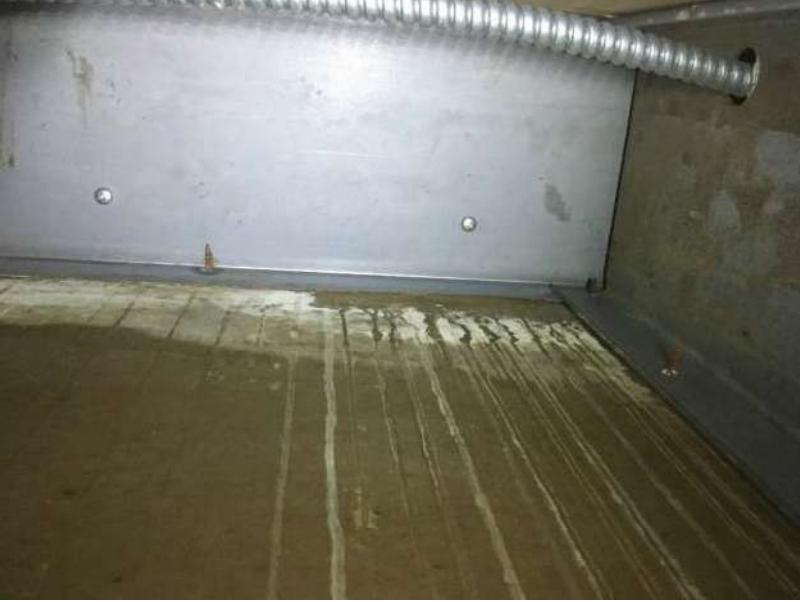
<p><b>PROBE LOCATION 02 – GROUND FLOOR / EAST</b></p> <p><b>View up – towards Sill Framing Evidence of Moisture / Staining</b></p>
--	--

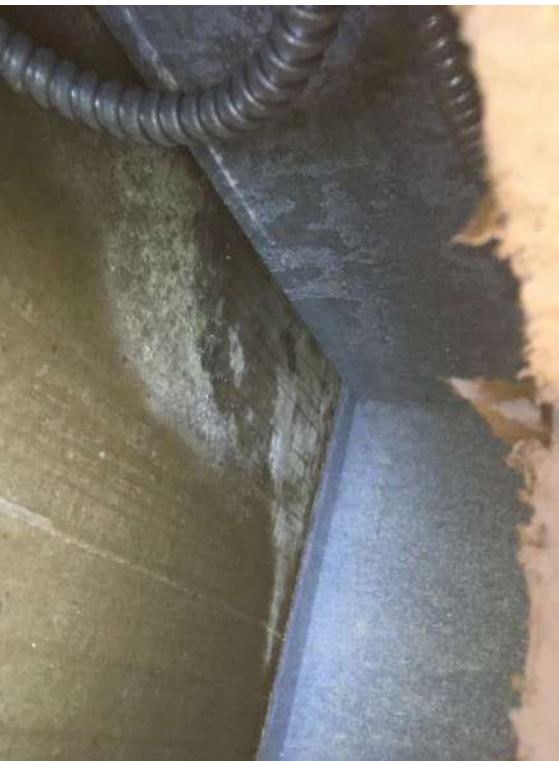
<p><b>PROBE LOCATION 03 – GROUND FLOOR / EAST</b></p> <p><b>View up – towards Sill Framing Evidence of Moisture / Staining</b></p>
---	--

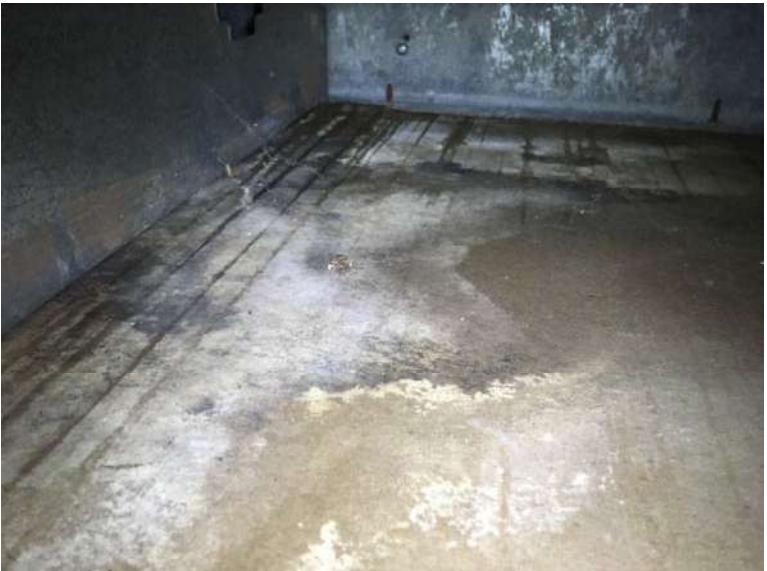
<p><b>PROBE LOCATION 04 – GROUND FLOOR / NORTH</b></p> <p><b>8</b></p> <p><b>View up – towards Sill Framing Evidence of Moisture / Staining</b></p>
---	---

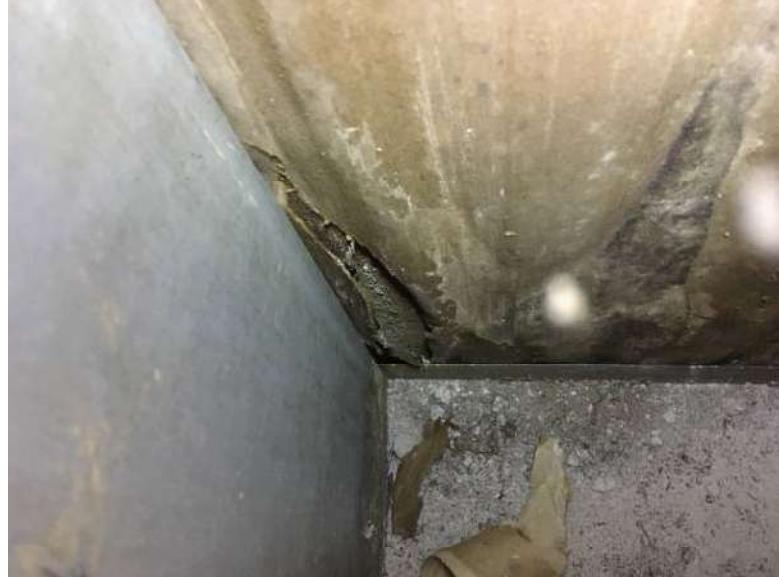
<p><b>PROBE LOCATION 05 – SECOND FLOOR / EAST</b></p> <p><b>View down – Towards Bottom Framing Track in Wall Cavity Evidence of Moisture / Staining</b></p>	10
---	---	----

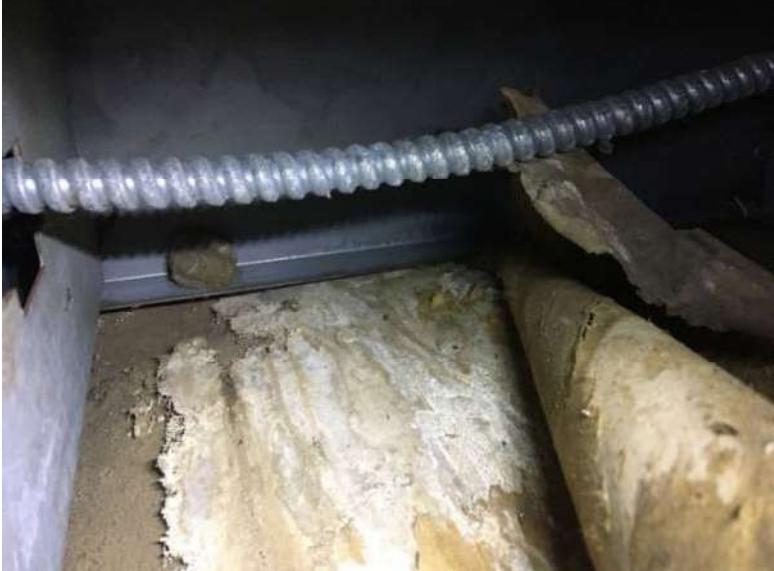
<p><b>PROBE LOCATION 05 – SECOND FLOOR / EAST</b></p>	<p><b>11</b></p>
<p><b>View up – towards Sill Framing Evidence of Moisture / Staining and facer delamination</b></p>

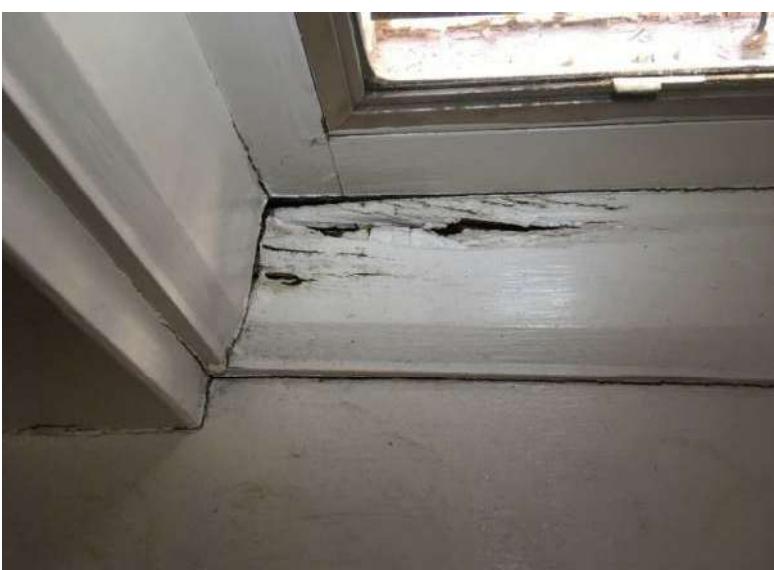
<p><b>PROBE LOCATION 05 – SECOND FLOOR / EAST</b></p>	<p><b>12</b></p>
<p><b>View of Interior Sill – Evidence of Water Damage</b></p>

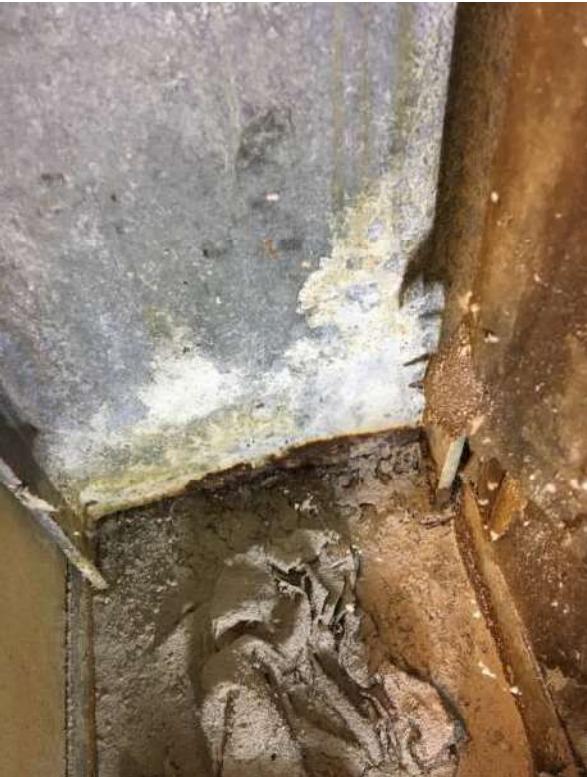
<p><b>PROBE LOCATION 06 – SECOND FLOOR / EAST</b></p> <p><b>14</b></p>
<p><b>View down – Towards Bottom Framing Track in Wall Cavity Evidence of Moisture / Staining</b></p>

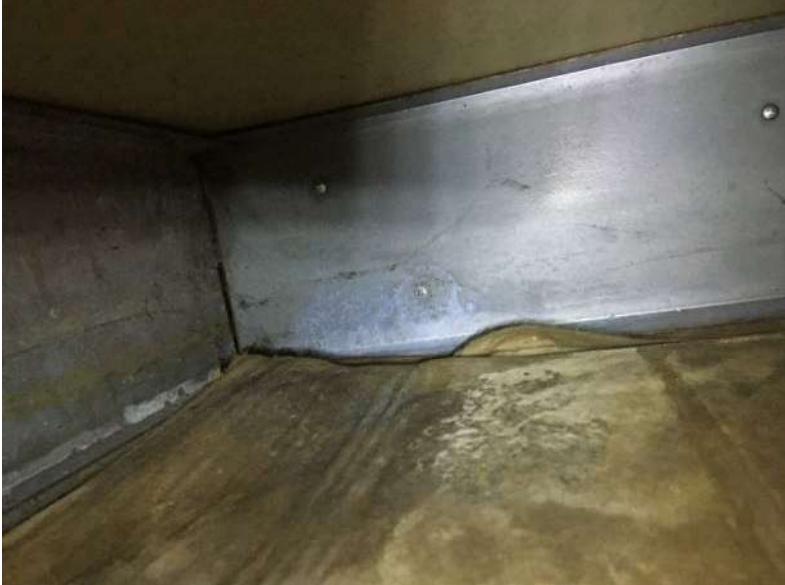
<p><b>PROBE LOCATION 06 – SECOND FLOOR / EAST</b></p> <p><b>View up – towards Sill Framing Evidence of Moisture / Staining and facer delamination</b></p>
---	---

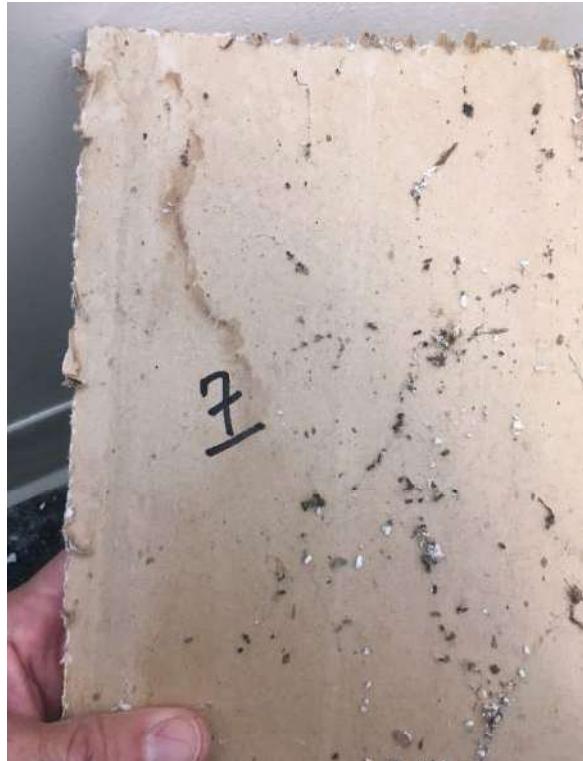
<p><b>PROBE LOCATION 07 – SECOND FLOOR / EAST</b></p> <p><b>View of Inside face of Interior Gypsum Wall Board (Evidence of Moisture / Staining)</b></p>
---	---

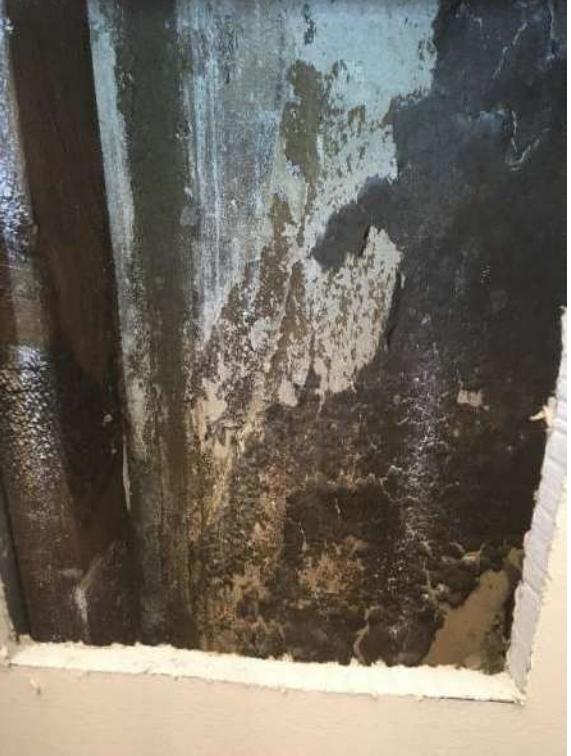
<p><b>PROBE LOCATION 07 – SECOND FLOOR / EAST</b></p>	<p><b>17</b></p>
<p><b>View of Inside face of Exterior Sheathing – Evidence of Moisture &amp; Foreign Matter (possibly mold)</b></p>

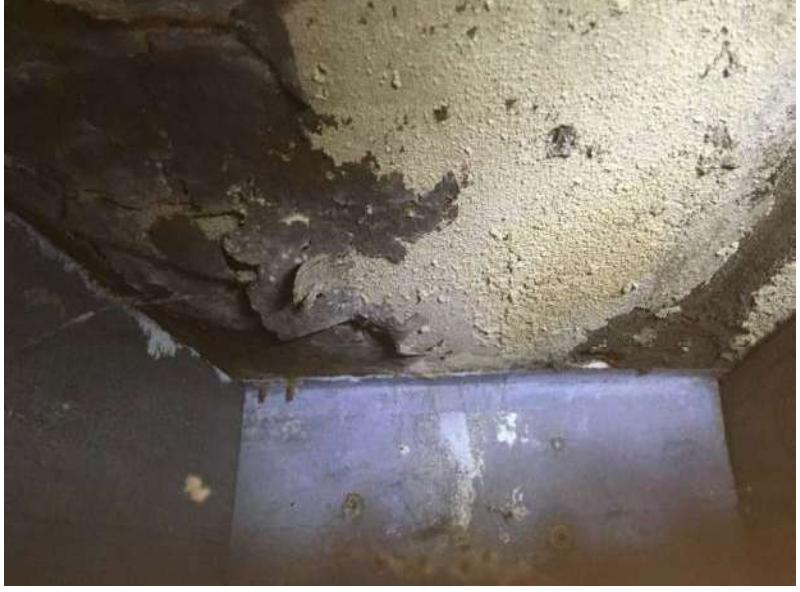
<p><b>PROBE LOCATION 07 – SECOND FLOOR / EAST</b></p>	<p><b>18</b></p>
<p><b>View down – Towards Bottom Framing Track in Wall Cavity Evidence of Moisture / Staining, Facer Delamination &amp; Foreign Matter</b></p>

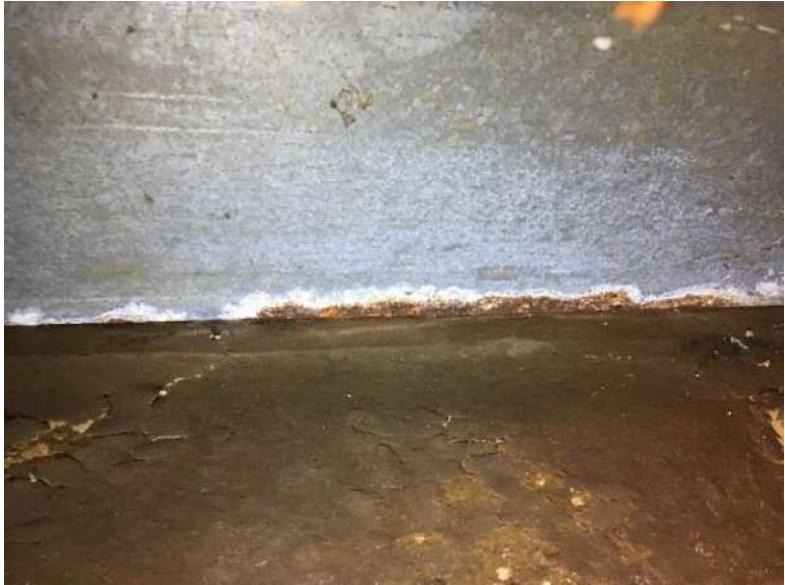
<p><b>PROBE LOCATION 07 – SECOND FLOOR / EAST</b></p> <p><b>View up – towards Sill Framing Evidence of Moisture / Staining and Corrosion on Top Track</b></p>
---	---

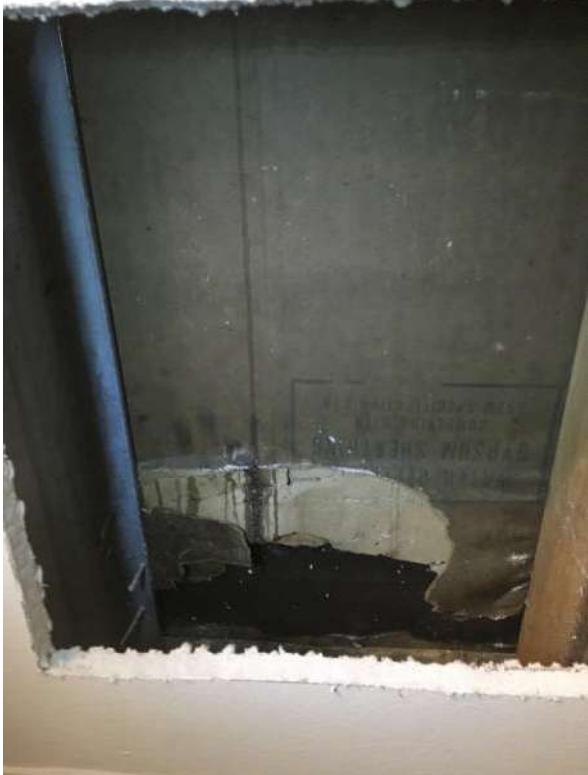
<p><b>PROBE LOCATION 08 – SECOND FLOOR / NORTH</b></p> <p><b>View of Inside Face of Exterior Sheathing – Evidence of Water Damage at Base of Panel (Sheathing labeled as “Water Resistant Gypsum Sheathing ASTM C79”)</b></p>
---	---

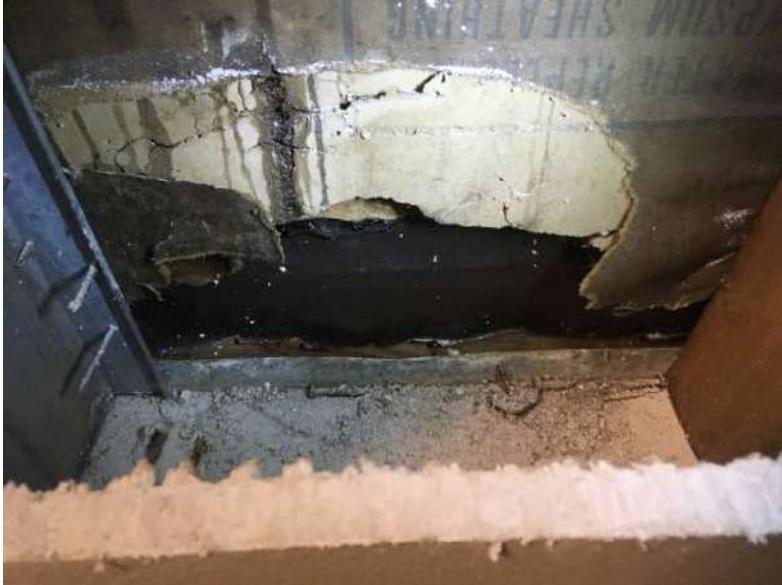
<p><b>PROBE LOCATION 08 – SECOND FLOOR / NORTH</b></p> <p><b>21</b></p> <p><b>View of Water Damage at Inside Face of Exterior Sheathing</b></p>
---	---

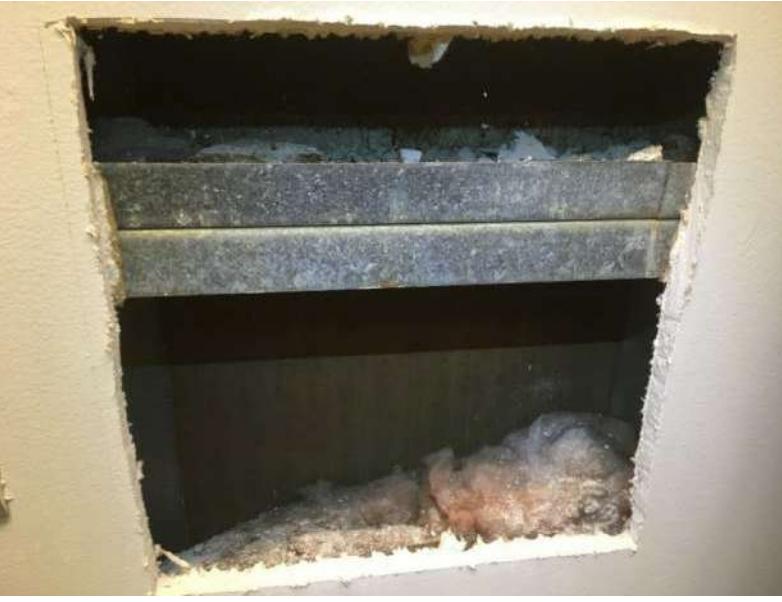
<p><b>PROBE LOCATION 09 – SECOND FLOOR / NORTH</b></p> <p><b>22</b></p> <p><b>View of Inside Face of Exterior Sheathing – Some Insulation Visible</b></p> <p><b>Sheathing and Insulation dry at this location</b></p>
---	---

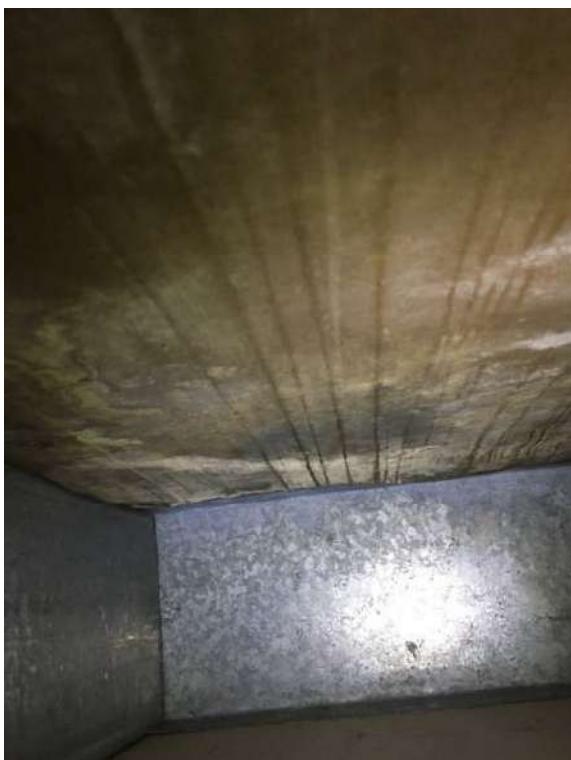
<p><b>PROBE LOCATION 10 – SECOND FLOOR / WEST</b></p> <p><b>View down – Towards Bottom Framing Track in Wall Cavity Evidence of Moisture / Staining some Facer Delamination</b></p>	24
---	---	----

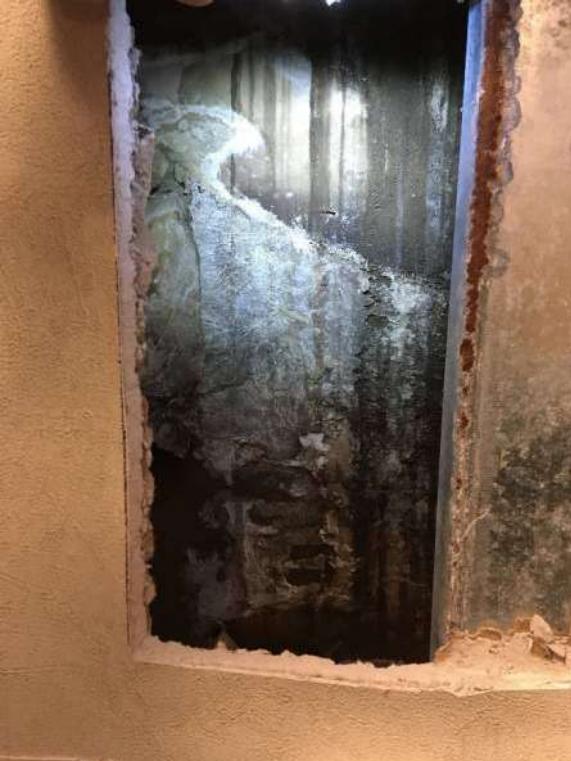
<p><b>PROBE LOCATION 12 – SECOND FLOOR / SOUTH</b></p> <p><b>View of Inside face of Exterior Sheathing – Evidence of Moisture &amp; Foreign Matter (possibly mold)</b></p>
---	--

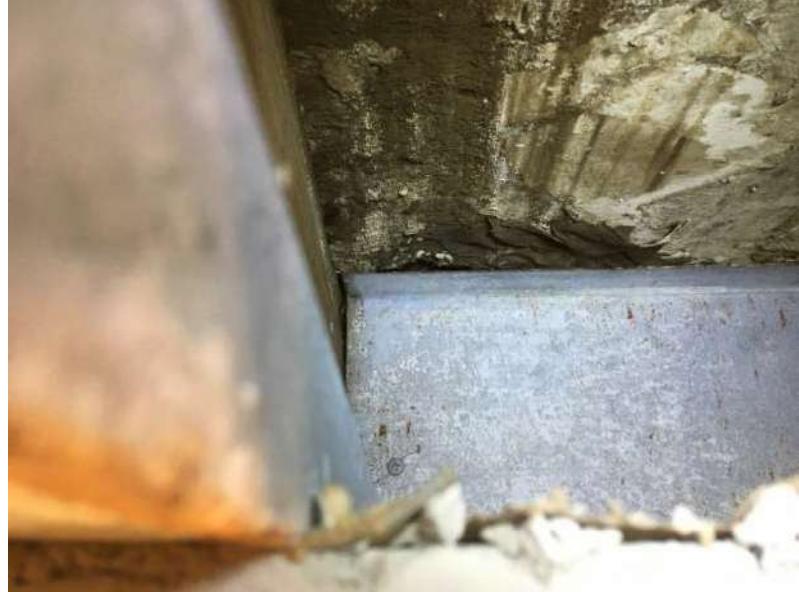
<p><b>PROBE LOCATION 12 – SECOND FLOOR / SOUTH</b></p> <p><b>View down – Towards Bottom Framing Track in Wall Cavity Evidence of Moisture / Staining, Facer Delamination &amp; Foreign Matter</b></p>
--	---

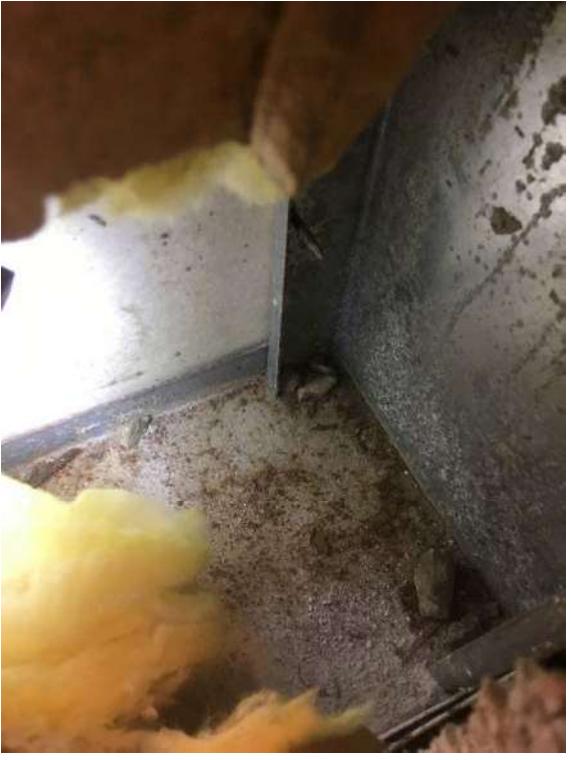
<p><b>PROBE LOCATION 15 – THRID FLOOR / EAST</b></p> <p><b>View of Inside face of Exterior Sheathing – DensGlass (Fiberglass Mat Sheathing) at 3<sup>rd</sup> Floor; some evidence of moisture &amp; corrosion of metal framing</b></p>
---	---

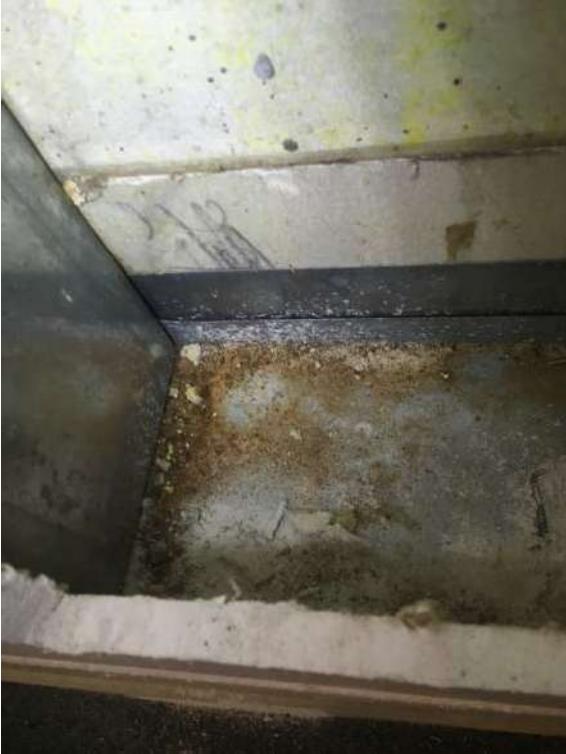
<p>PROBE LOCATION 16 – THRID FLOOR / NORTH</p>	<p>35</p>
<p>View of Inside face of Exterior Sheathing – DensGlass (Fiberglass Mat Sheathing) at 3<sup>rd</sup> Floor; some evidence of moisture &amp; corrosion of metal framing</p>

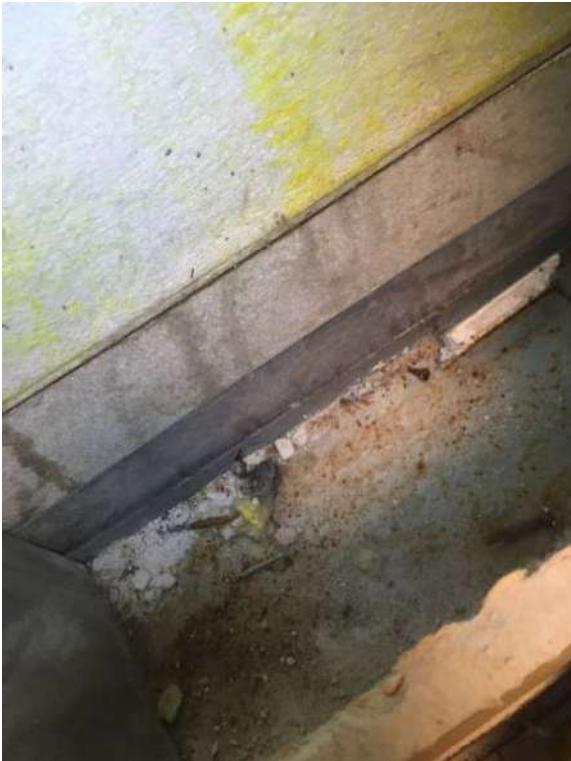
<p><b>PROBE LOCATION 17 – THRID FLOOR / NORTH</b></p> <p><b>View of Inside face of Exterior Sheathing – DensGlass (Fiberglass Mat Sheathing) at 3<sup>rd</sup> Floor; some evidence of moisture &amp; corrosion of metal framing</b></p>
---	--

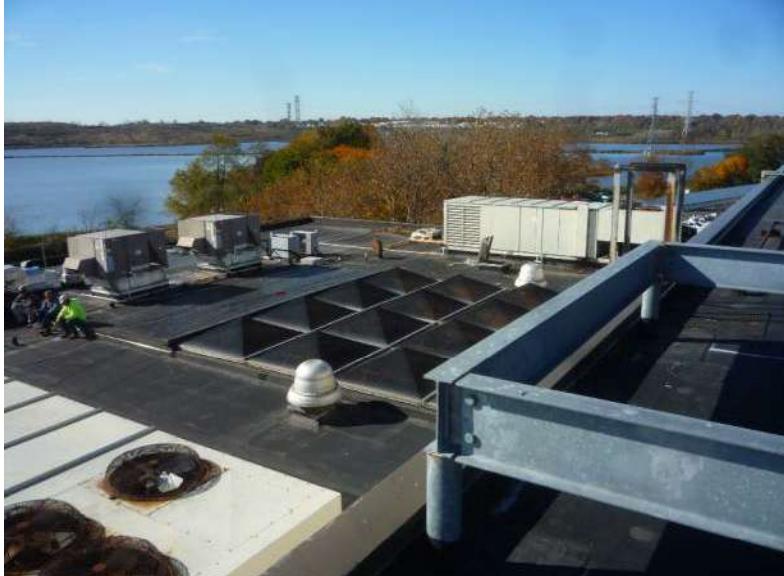
<p>Overall view 2<sup>nd</sup> Floor Roof taken from above</p> <p>Area adjacent to skylights was replaced in 2016. Age of other 2<sup>nd</sup> floor roof areas unknown.</p> <p>One row of original skylights have been removed and capped over</p>

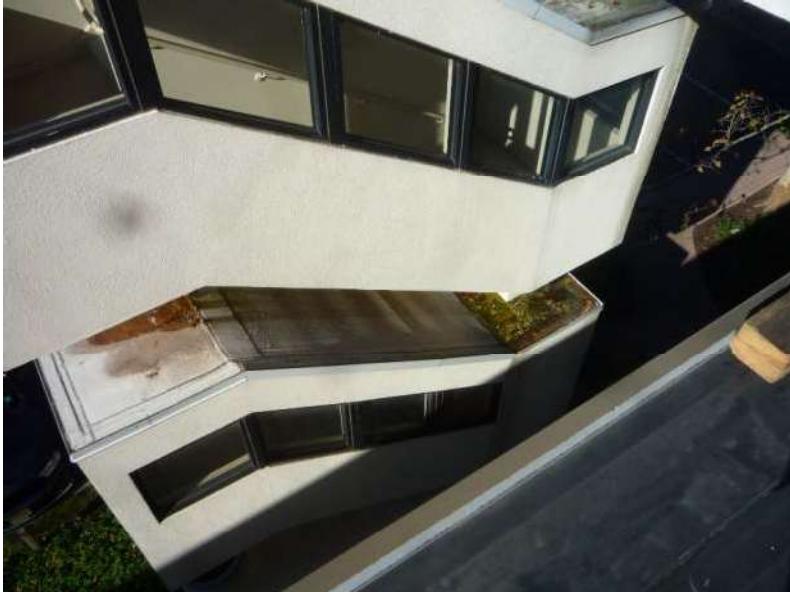
<p>No roof drains visible above landings. Water allowed to “pond”</p>

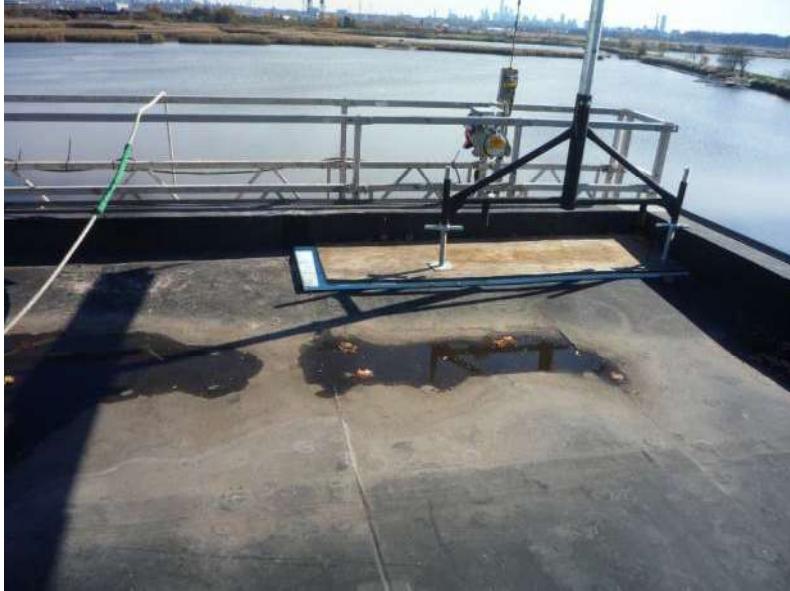
<p><b>Evidence of continuous ponding – poor drainage</b></p>

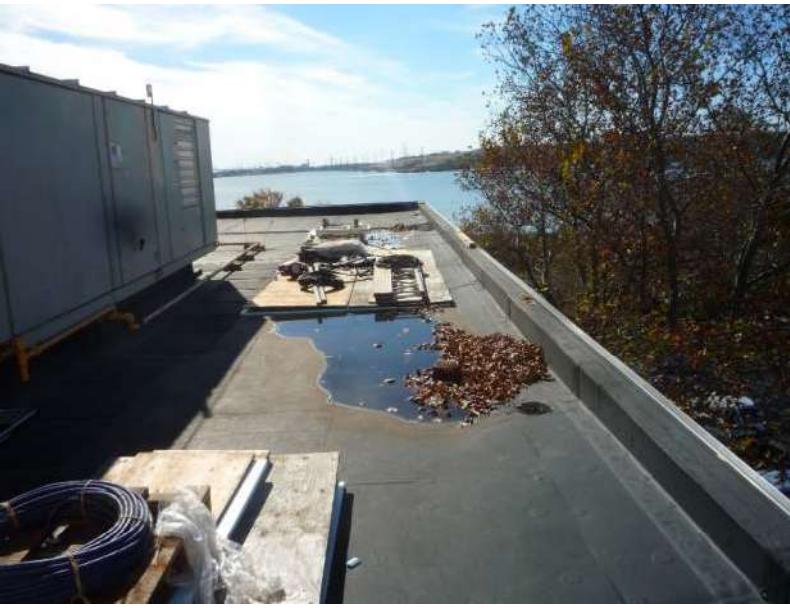
<p><b>Ponding short of roof drain</b></p>

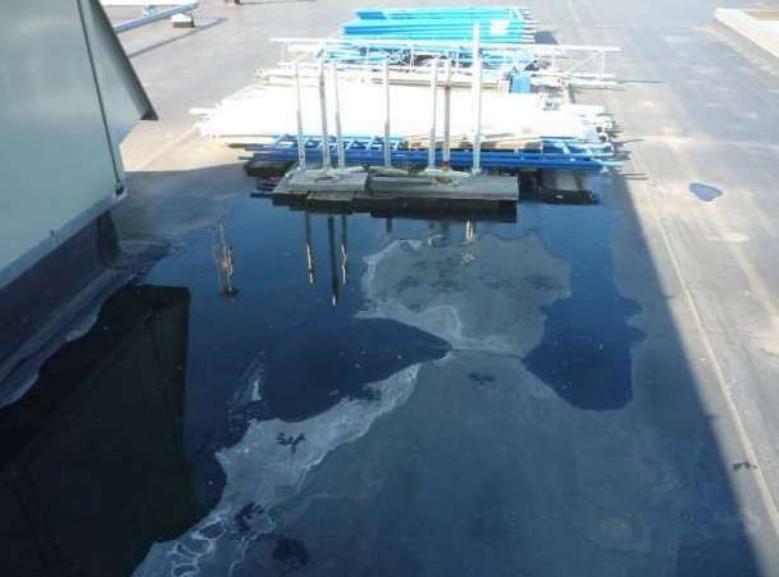
3 <sup>rd</sup> Floor – NW Edge	09
<p>Ponding – inadequate slope to drain</p>

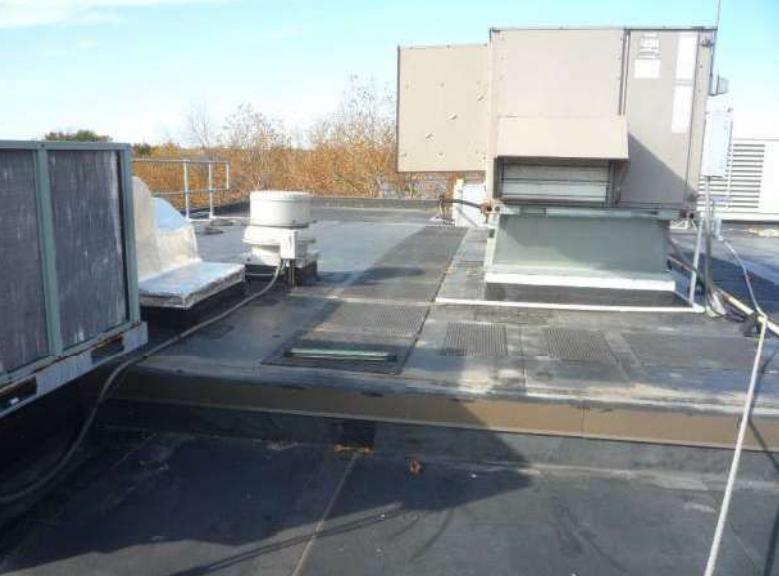
2 <sup>nd</sup> Floor – Edge of 2016 Roof	10
<p>Evidence of ponding / poor drainage at edge conditions</p>

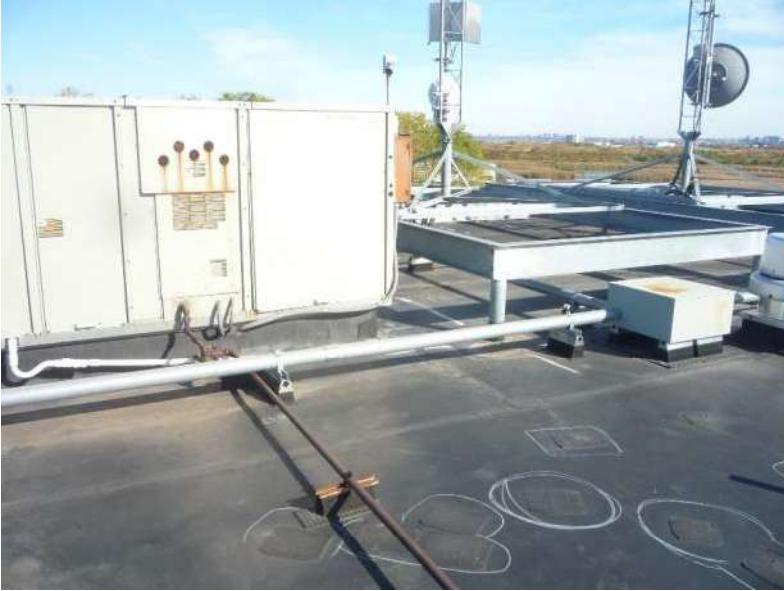
A photograph of a roof surface. There are several circular and irregular patches of different colors (white, grey, and brown) scattered across the dark, textured roof. In the background, there are white shipping containers, a metal support structure, and a tall antenna tower. The sky is clear and blue.	<p><b>3<sup>rd</sup> Floor</b></p> <p><b>11</b></p> <p><b>Evidence of multiple patches</b></p>
---	--

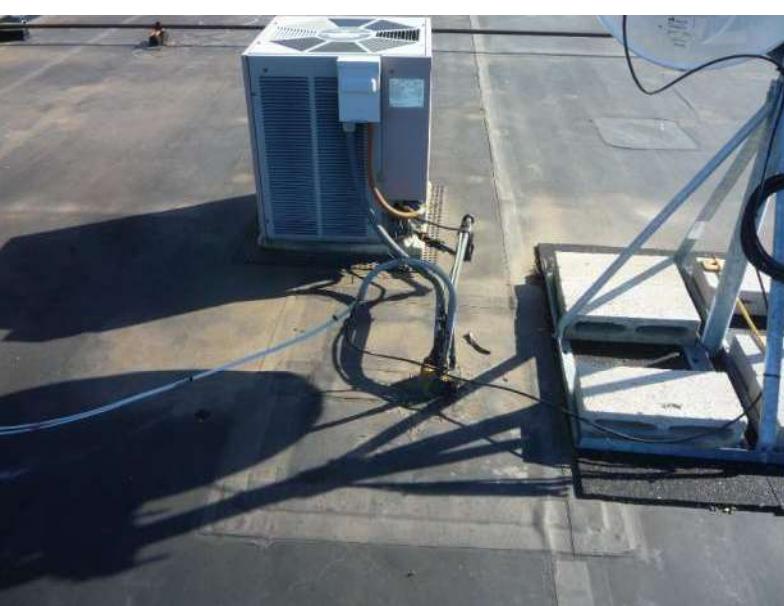
A photograph of a roof with a large white air conditioning unit and a blue support structure. The roof surface is dark and shows signs of wear and discoloration. The equipment is connected by various pipes and hoses.	<p><b>3<sup>rd</sup> Floor Equipment</b></p> <p><b>12</b></p> <p><b>Pitch-pocket for penetration in bad conditions</b></p>
--	--
