**CN-302 Lyndhurst Admin Building Envelope Improvements**  
Lyndhurst, New Jersey  
**Bid Submission Due Date:** January 16, 2026 @ 12:00 pm

## **ADDENDUM No. 2**

APPENDIX – A | EXTERIOR SITE PHOTOS (TAKEN FROM SCAFFOLDING)

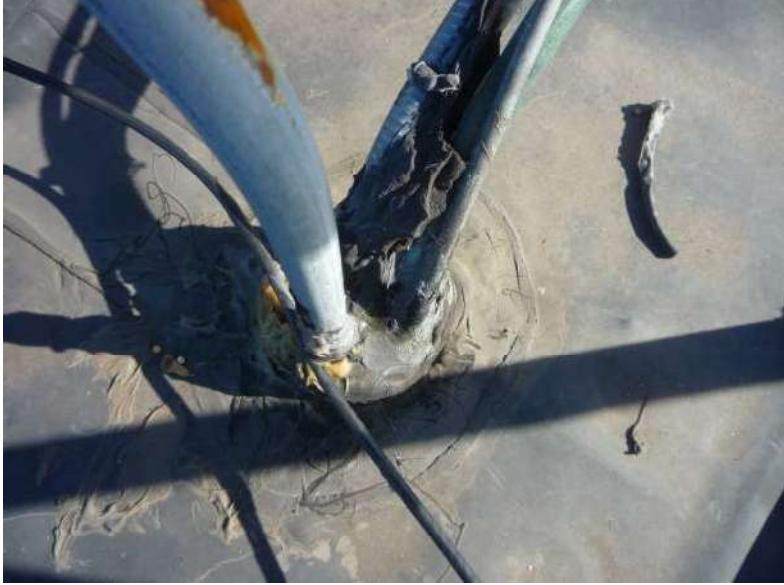
<p>Image of pitch-pocket at end of useful life – has been patched / caulked</p>

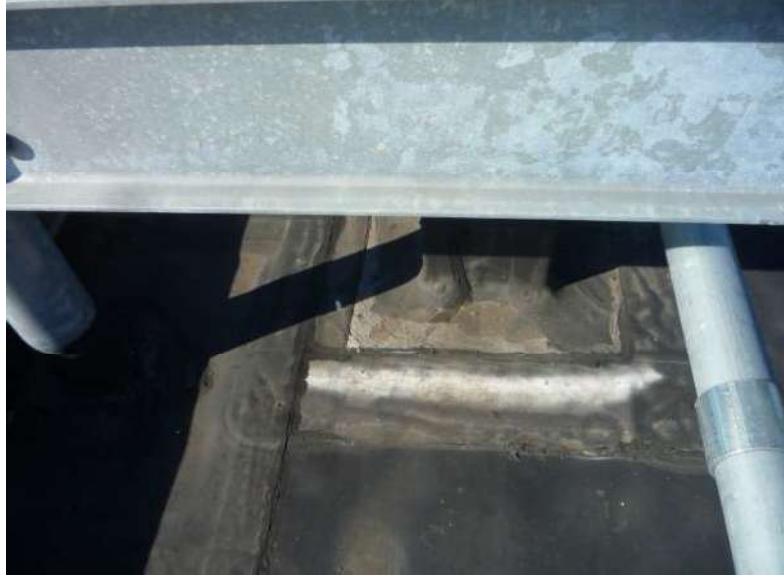
<p>Dunnage steel penetrations – flashing is worn / poor condition</p>

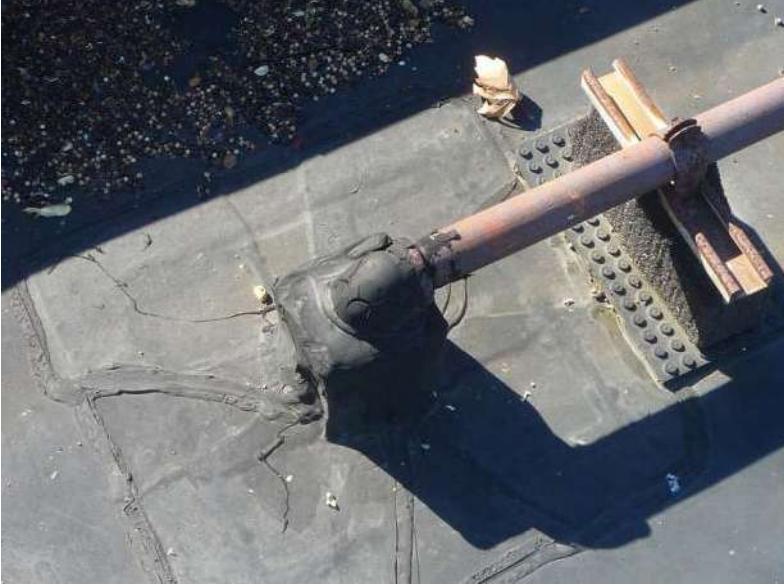
3 <sup>rd</sup> Floor	15
<p><b>Penetration for conduit – pitch pocket at end of useful life</b></p>

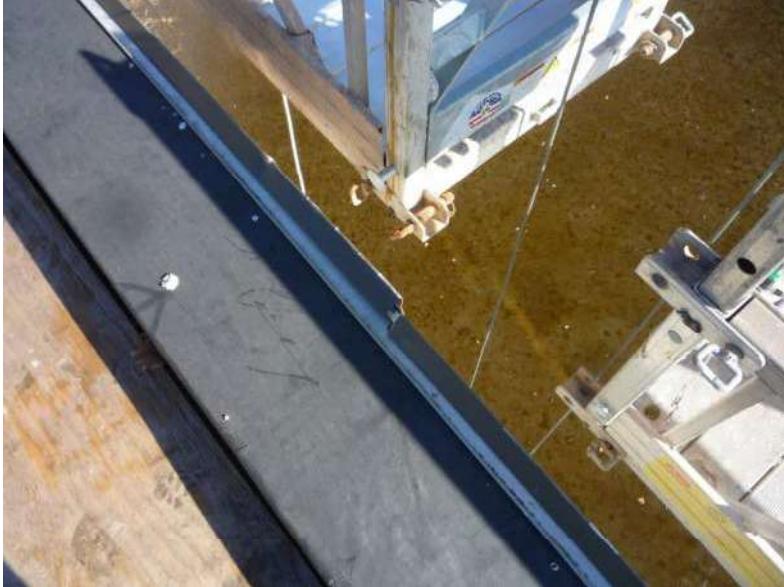
2 <sup>nd</sup> Floor	16
<p><b>Coping splice in poorly finished; no splice plate – joint completely opened</b></p>

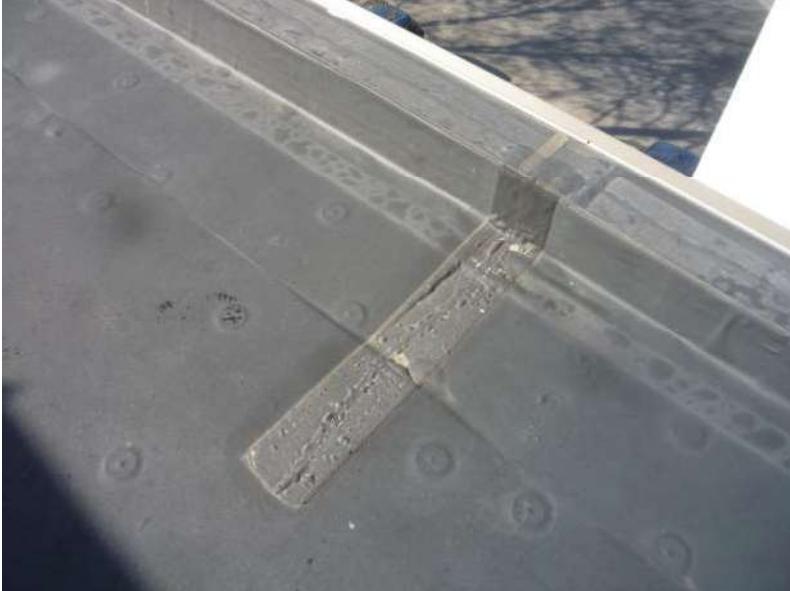
Typical Patch	17

<p><b>Patch is blistering and compromised</b></p>

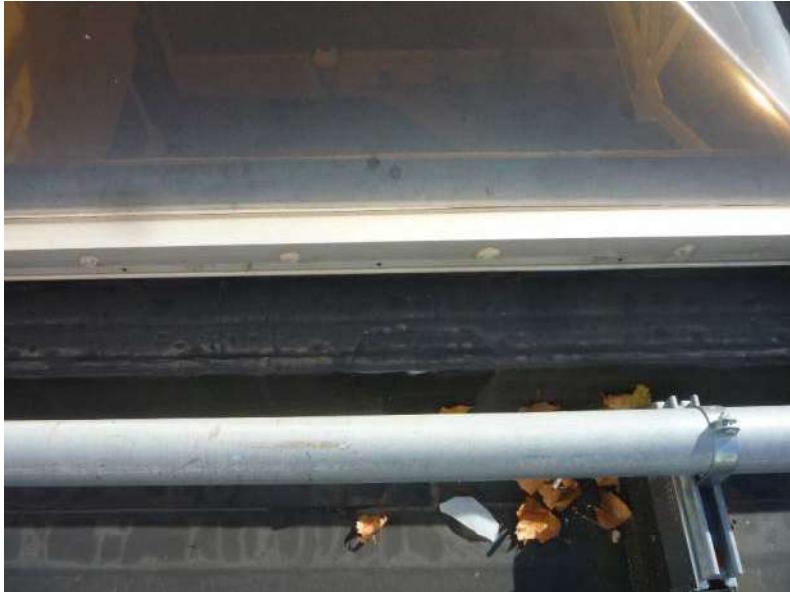
<p><b>Curb at skylight – part of 2016 partial reroof. Edge in poor condition (beginning to degrade)</b></p>

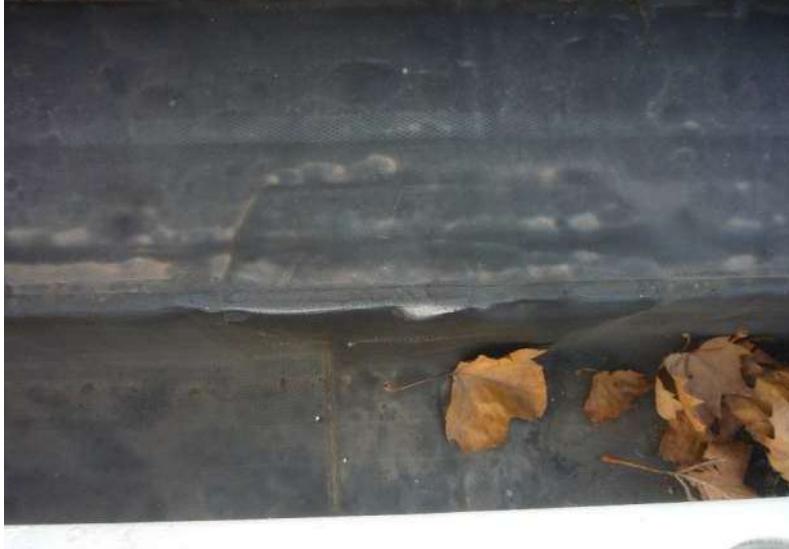
<p><b>2<sup>nd</sup> Floor curb</b></p> <p><b>19</b></p> <p>Close view of image no. 18. Joint and seam are vulnerable - 90° corner with seam edge unprotected</p>
---	---

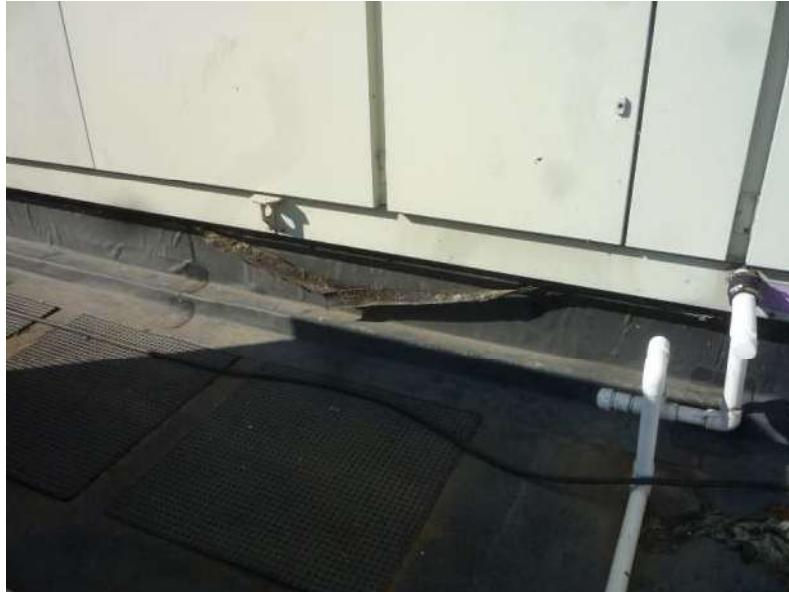
<p><b>2<sup>nd</sup> Floor</b></p> <p><b>20</b></p> <p>Curb flashing at RTU – flashing tape not adhered</p>
---	---

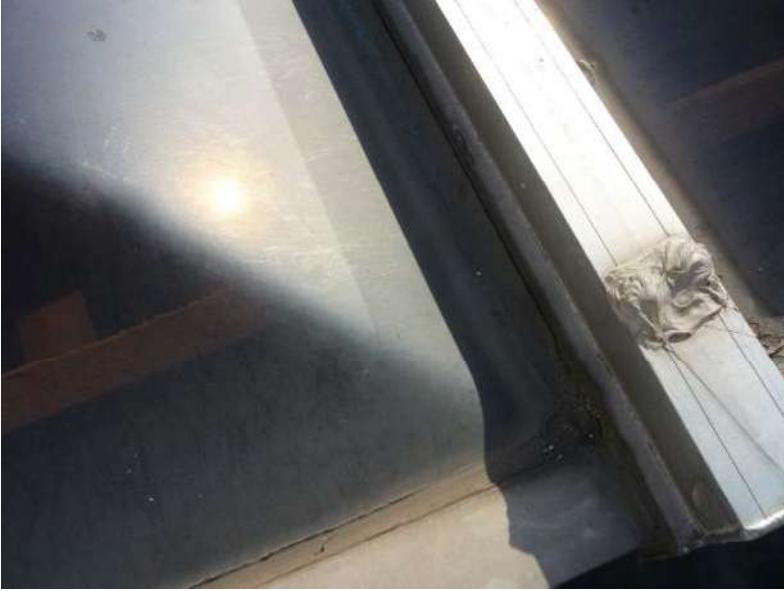
<p>Joint sealant at skylight beginning to fail and open up. (See joint adjacent to aluminum extrusion)</p>
