NJSEA Arena Stair and Ramp Repairs
Contract No.CN-303

Book 4 of 4
DESIGN DOCUMENTS
January 13, 2026

**Project CN-303 NJSEA Arena Stair and Ramp Repairs
DESIGN DOCUMENTS**

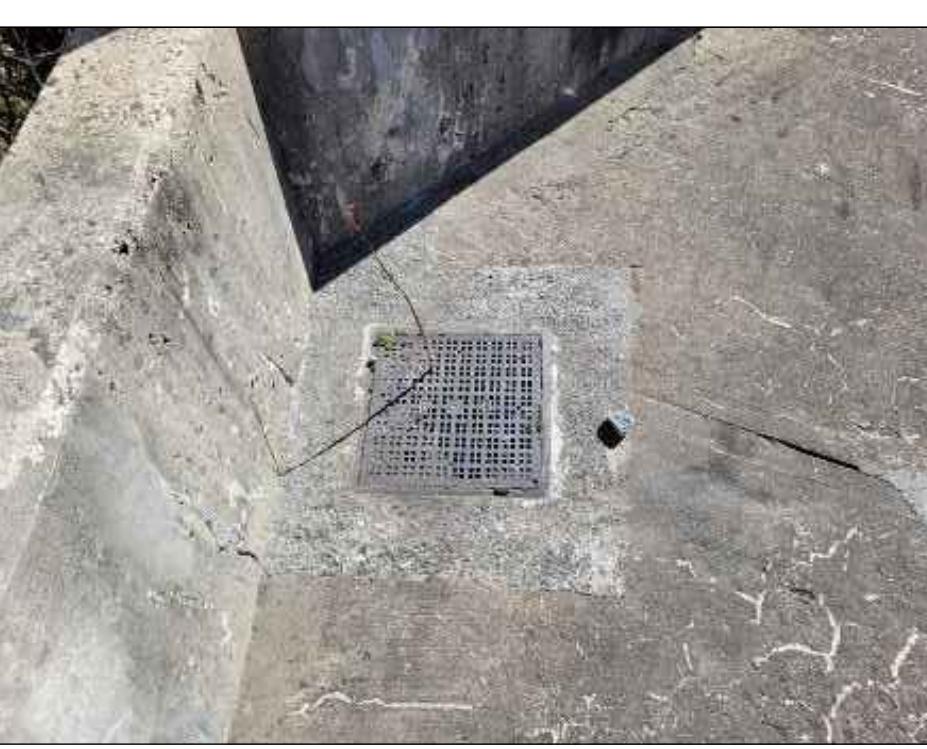
100% CLOGGED RAIN (RAMP)

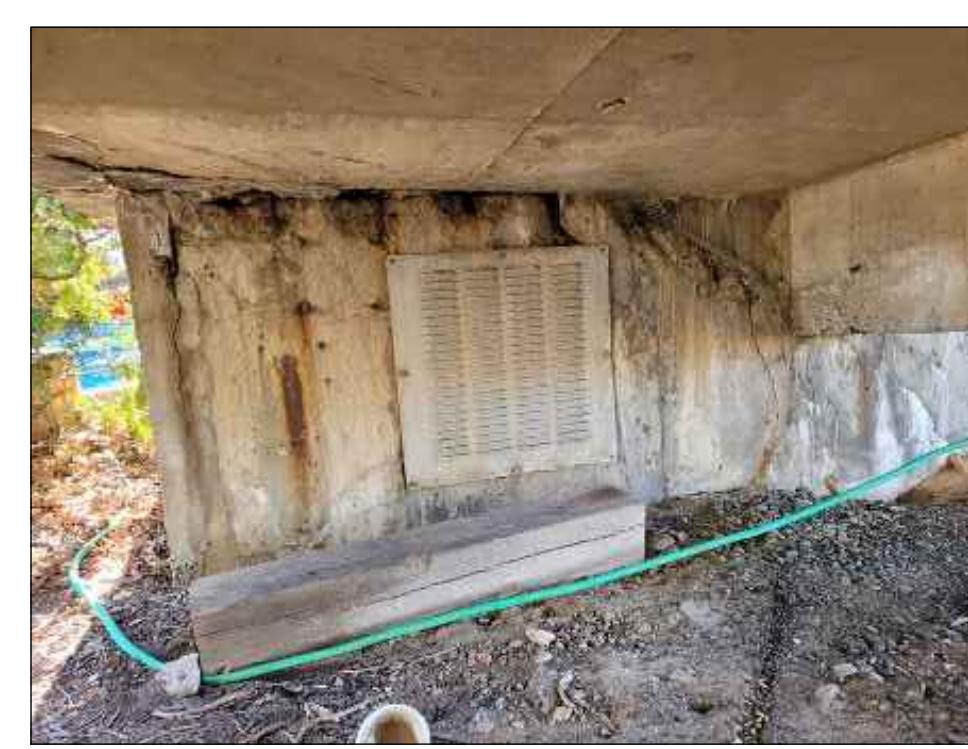
SPALL WITH EXPOSED CORRODED REBAR AND STAINING ON WALL

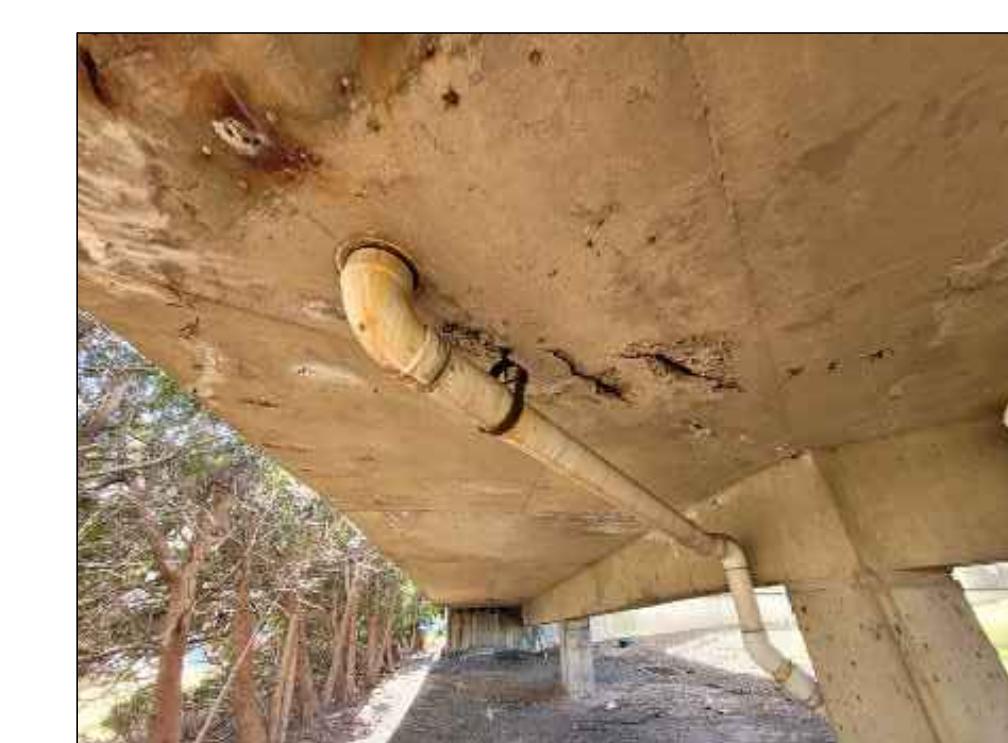
SPALL WITH EXPOSED CORRODED REBAR AND LEAKS WITH EFFLORESCENCE(UNDERSIDE RAMP)

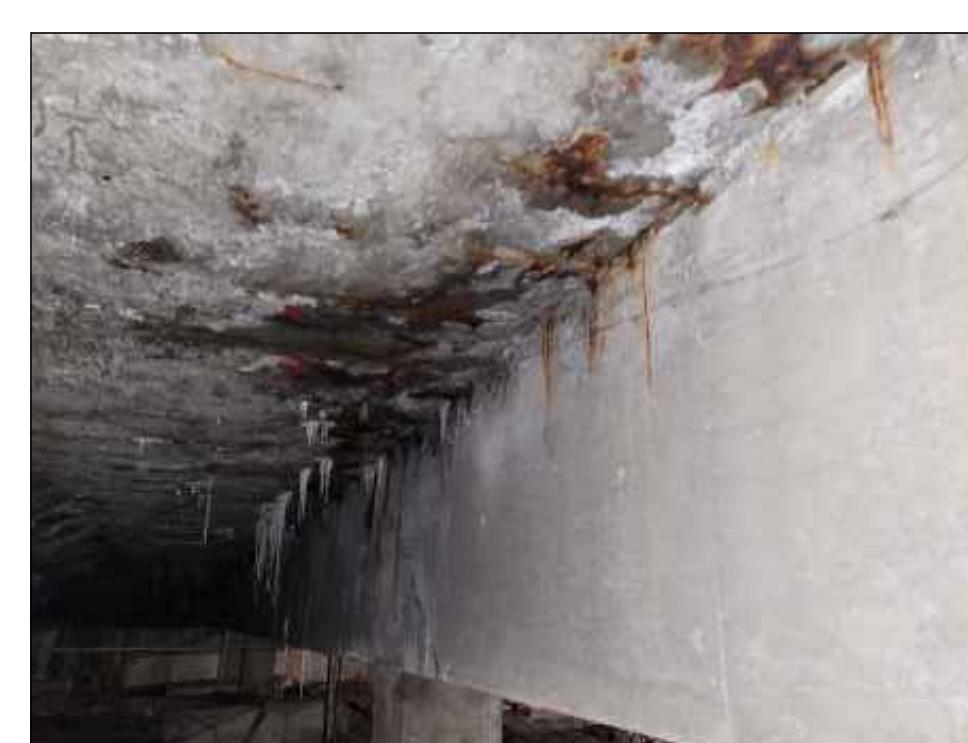
CRACKS WITH LEAK/ EFFLORESCENCE/ STAINING (UNDERSIDE STAIR)

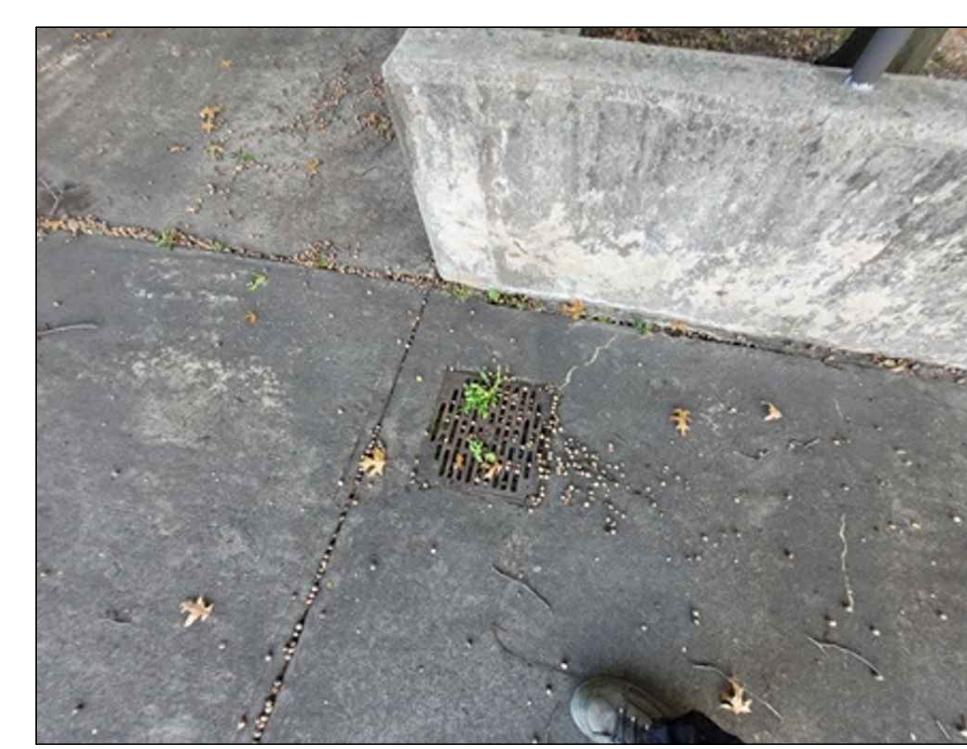
100% CLOGGED RAIN (RAMP)

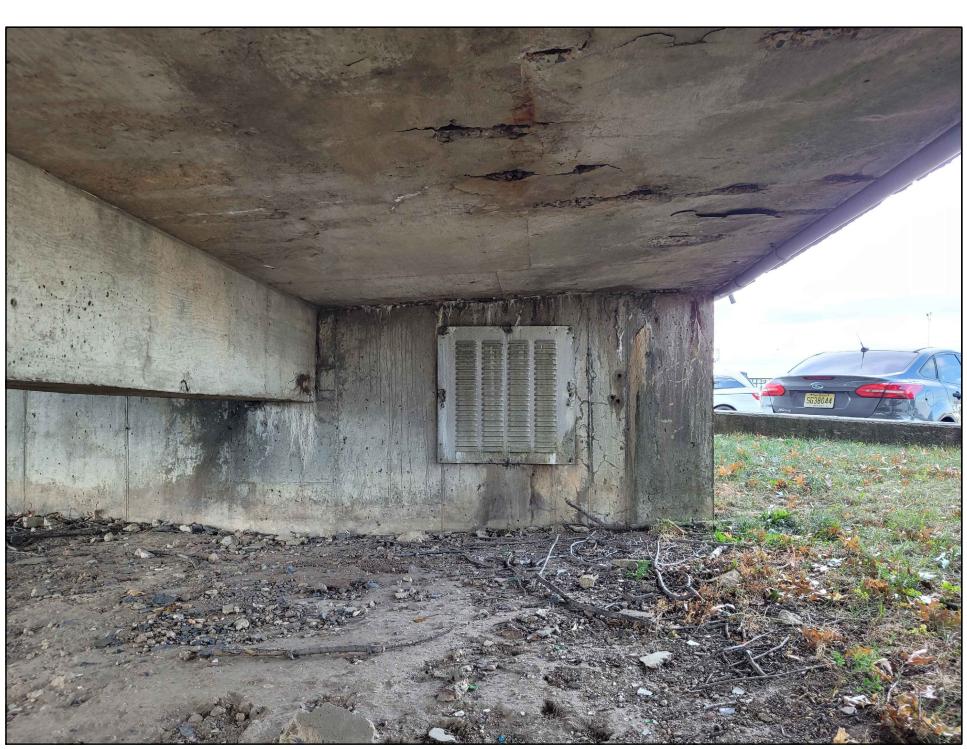
EXISTING WALL EXHIBITS CRACK/ EFFLORESCENCE/STAINING

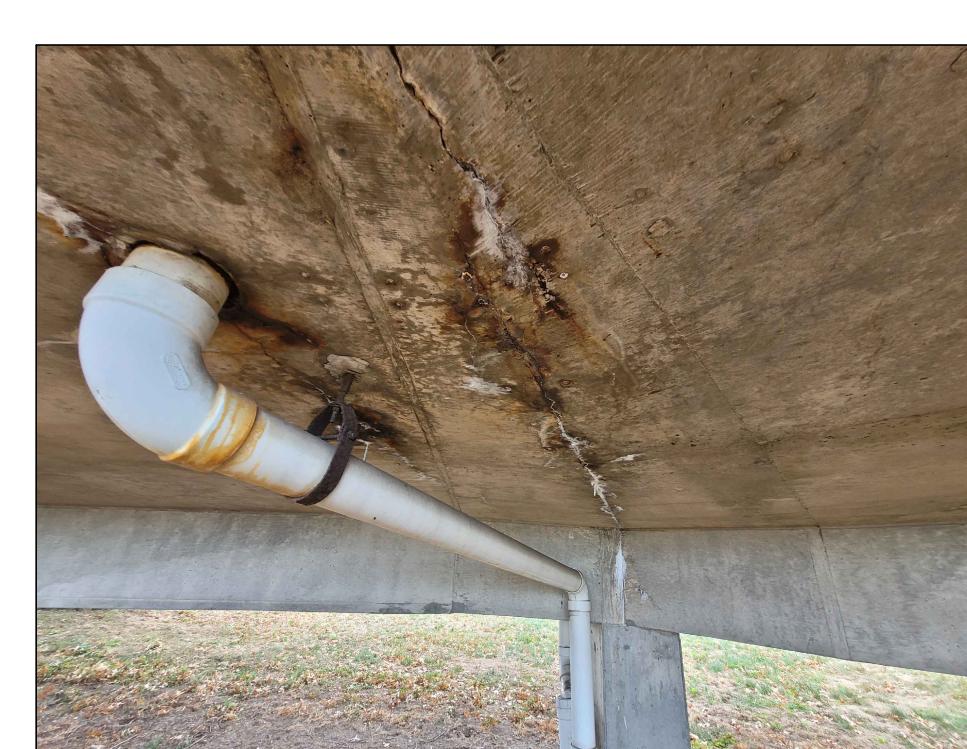
RAMP EXHIBITS CRACKS/LEAKS
WITH EFFLORESCENCE (UNDERSIDE RAMP)

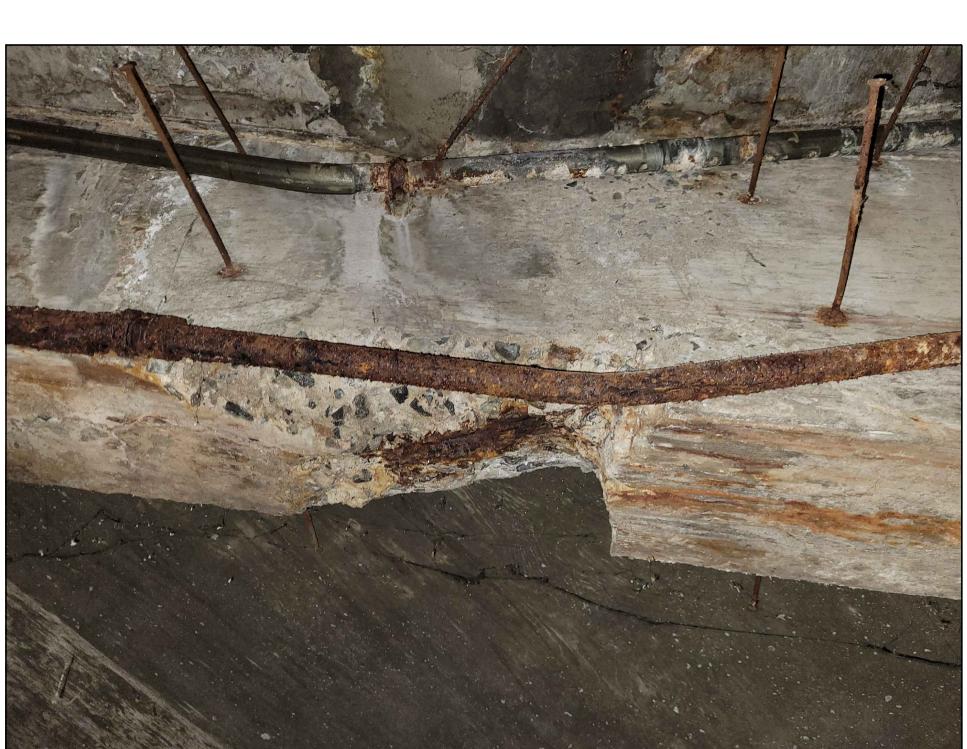
BEAM EXHIBITS SPALL WITH EXPOSED CORRODED REBAR (UNDERSIDE STAIR)

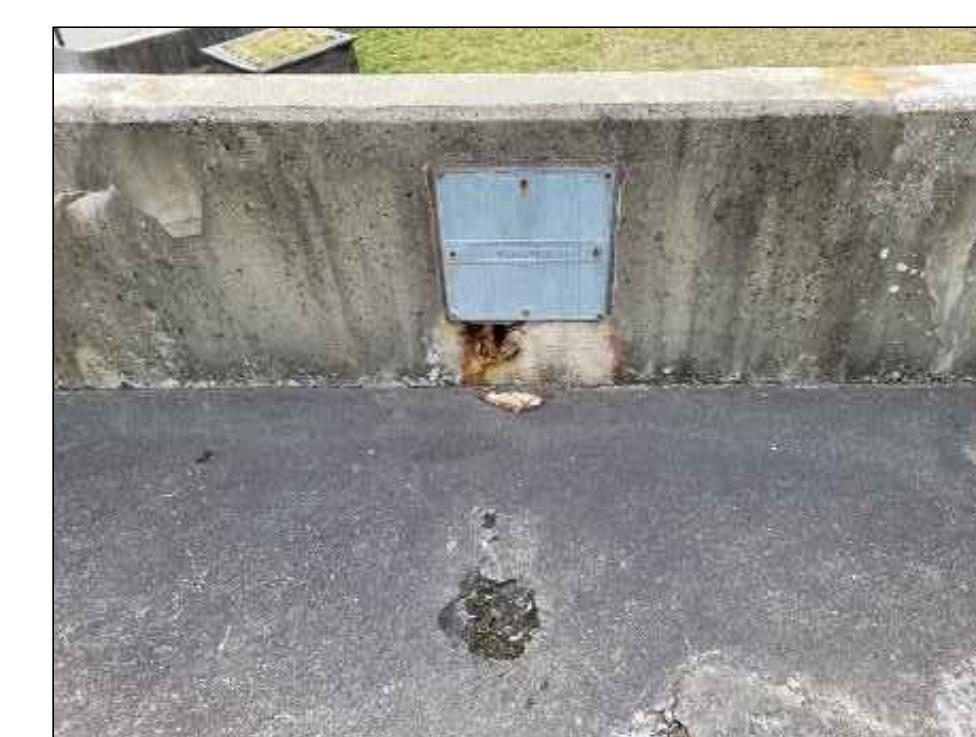
SPALL WITH EXPOSED REBAR AT UTILITY PANEL

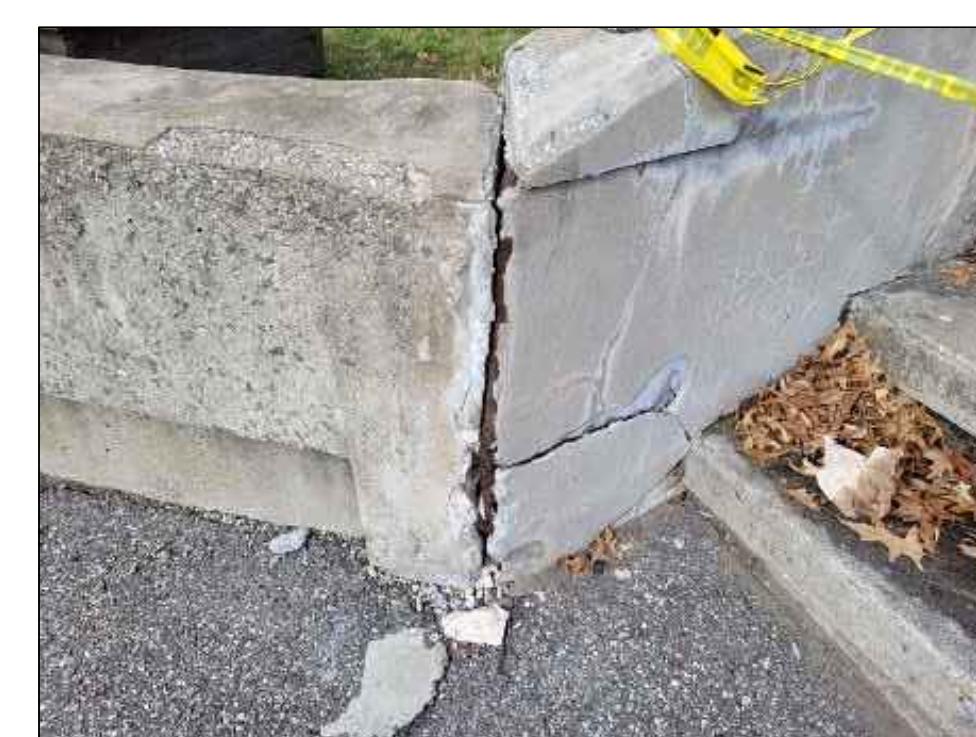
DELAMINATION AND JOINT MATERIAL FAILURE

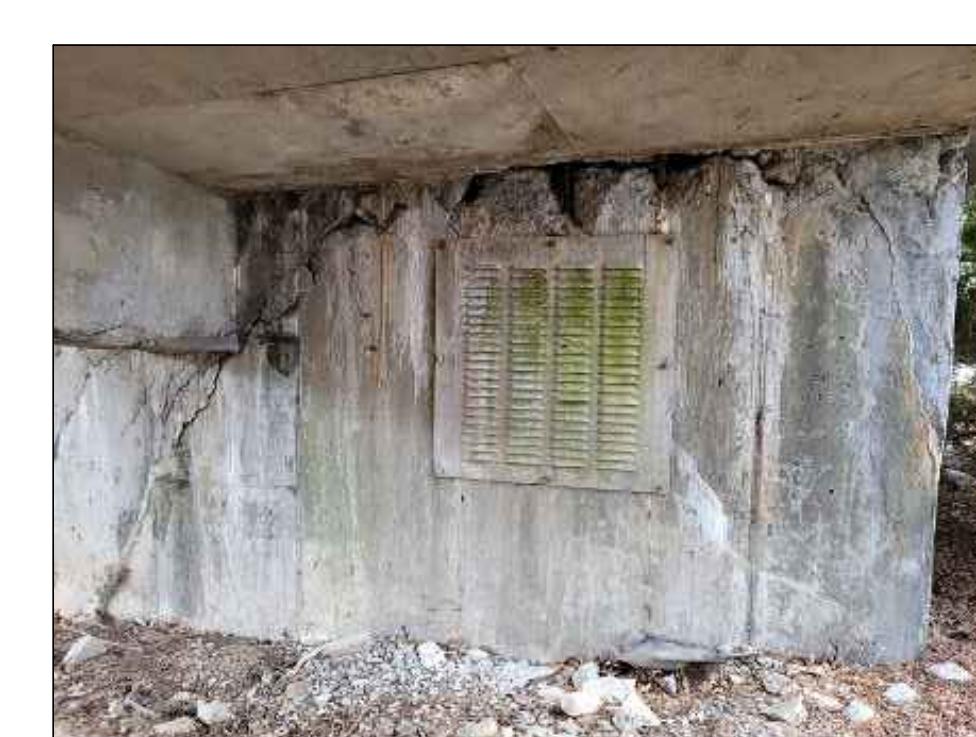
CRACKS AND DELAMINATION AT WALL FACE

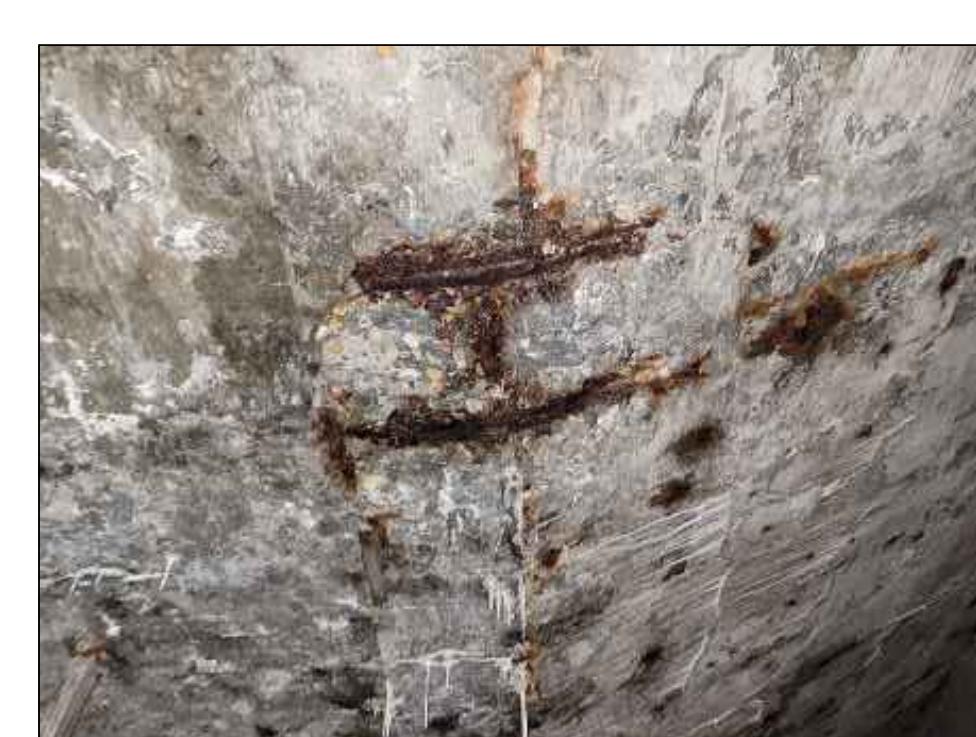
SPALL WITH EXPOSED REBAR AT UNDERSIDE OF STAIRS

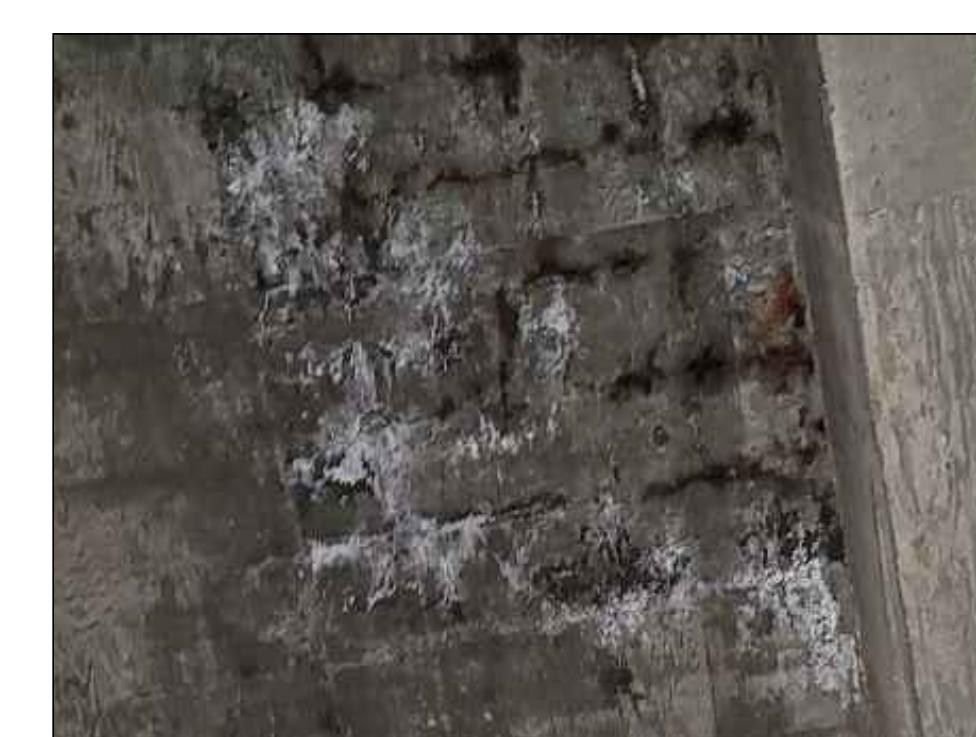
SPALL WITH EXPOSED REBAR AT UNDERSIDE OF PLAZA
