# IN NEED OF REDEVELOPMENT INVESTIGATION REPORT

## CARLSTADT BLOCK 84

Lots 2, 3, 4, 7, 8.01, 10, and 13

**June 2022**

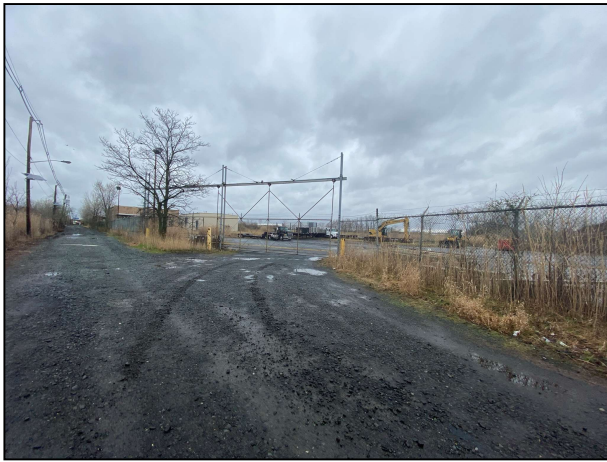
**Photo 1**

*View from Twelfth Street toward site entrance to east*

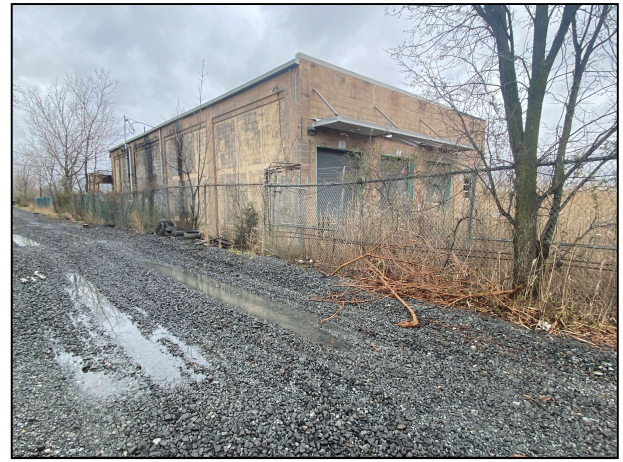
**Photo 2**

*View of existing dilapidated structure on subject property, from Twelfth Street*

The property at Block 84, Lot 2 contains two existing structures. One structure is a dilapidated and obsolescent former industrial building, characterized by broken and boarded-up windows and graffiti, which makes it unconducive to providing working conditions consistent with today's health and safety standards. One other existing building remains on the site to support remedial activities, housing water treatment equipment. The two remaining buildings exhibit small building footprints and low ceiling heights, which make them obsolete in their ability to accommodate contemporary industrial operations, or to be adapted to other uses. Therefore, this criterion is applicable to the Study Area.

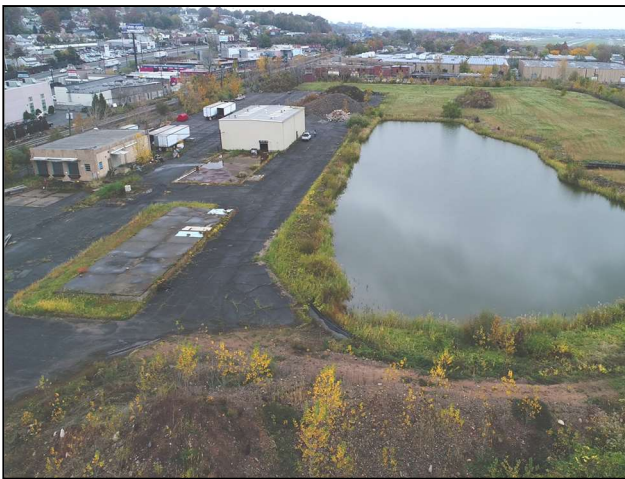
**Photo 3**

*NJSEA drone image of subject property, with view toward the north. (November 2017)*

The subject property is a 16.4-acre site owned by Russo Meadowlands Park, LLC. The site contains the remains of a former chemical plant and is in the process of being remediated. The site contains frontage on Twelfth Street to the west.

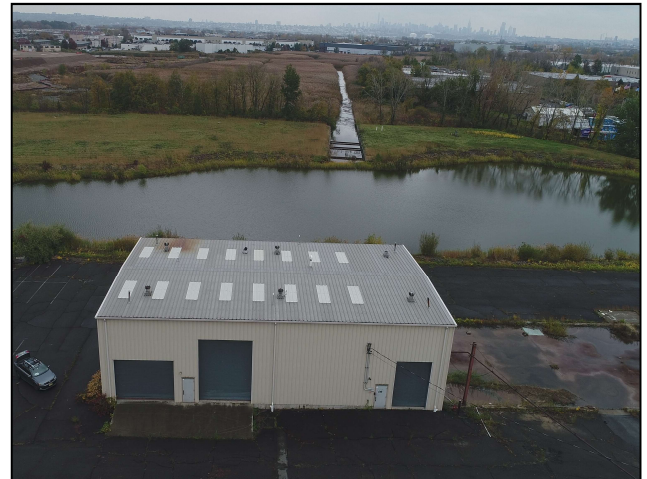
**Photo 4**

*NJSEA drone image of existing water treatment structure in foreground and man-made pond with channel flowing toward Berry's Creek in background*

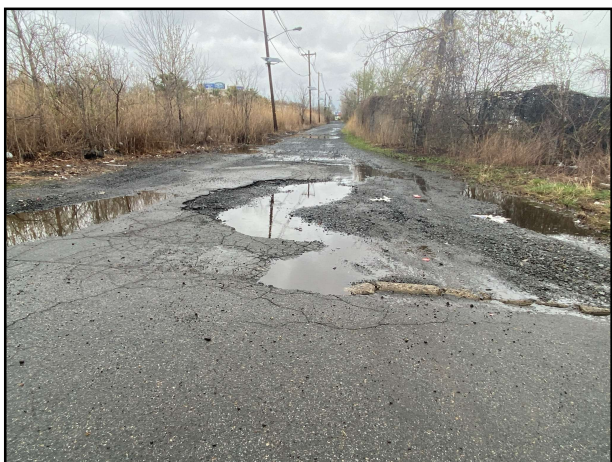
**Photo 1**  
*View of roadway facing north*

The subject property is a 0.69-acre right-of-way owned by the Borough of Carlstadt.  
The ROW is primarily composed of gravel and degraded asphalt, and contains deep ruts and potholes.  
There is no through access to the northerly part of the Twelfth Street ROW beyond the property at Block 84, Lot 2.
