**CN-302 Lyndhurst Admin Building Envelope Improvements**  
Lyndhurst, New Jersey  
**Bid Submission Due Date:** January 16, 2026 @ 12:00 pm

## **ADDENDUM No. 2**

APPENDIX – A | EXTERIOR SITE PHOTOS (TAKEN FROM SCAFFOLDING)

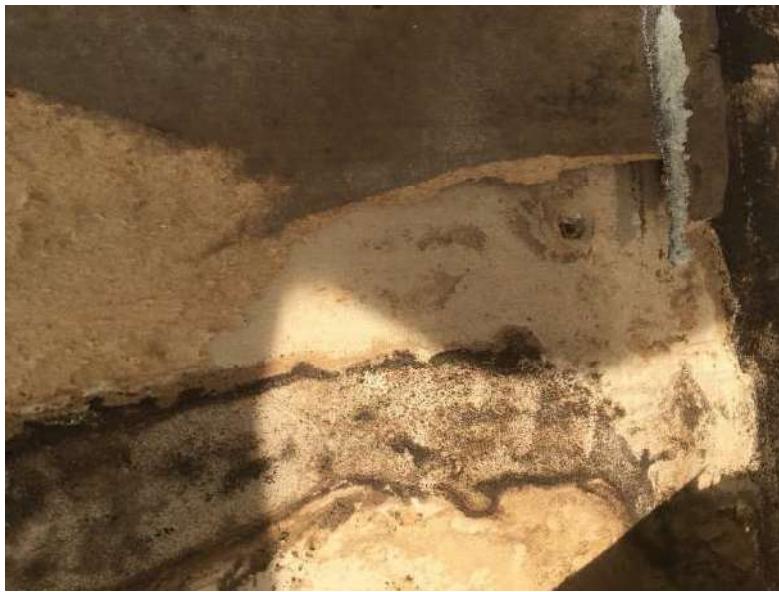
<p>Exterior Sheathing Board 16</p> <p>View of exterior sheathing board. Facer has pulled away from board material</p>
---	---

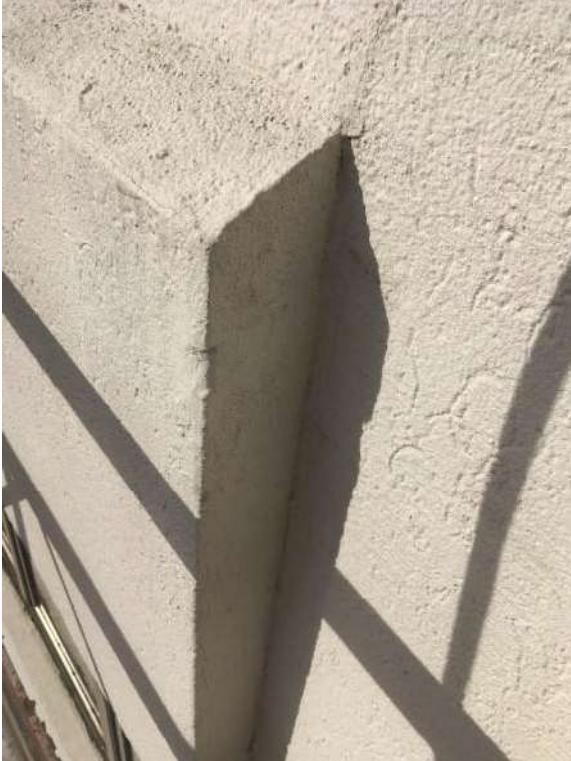
<p>EIFS Wall Panels</p>	17
<p>View of EIFS System - exterior</p>

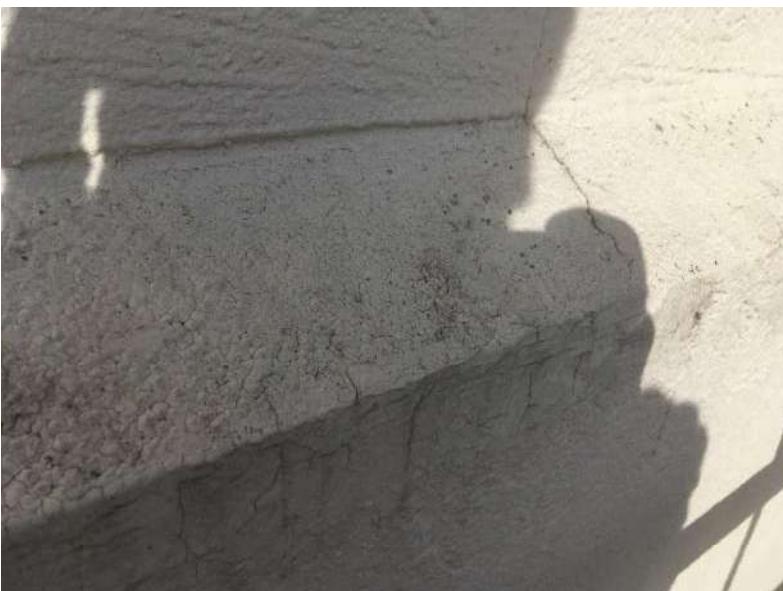
<p>EIFS Wall Panels</p>	18
<p>EIFS – sloped profile at top of 4-inch deep panel</p>

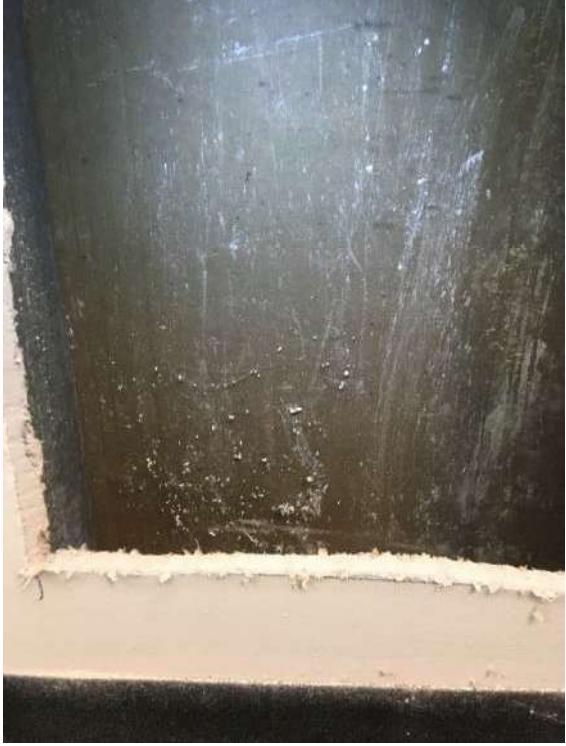
<p><b>PROBE LOCATION 01 – GROUND FLOOR / EAST</b></p> <p><b>1</b></p> <p><b>View of Inside Face of Exterior Sheathing</b></p>
---	---

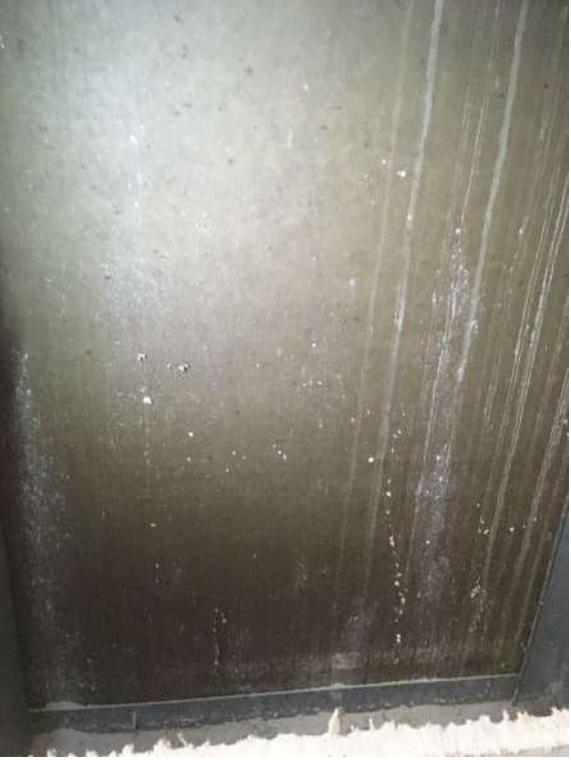
<p><b>PROBE LOCATION 02 – GROUND FLOOR / EAST</b></p> <p><b>View of Inside Face of Exterior Sheathing</b></p>
---	---

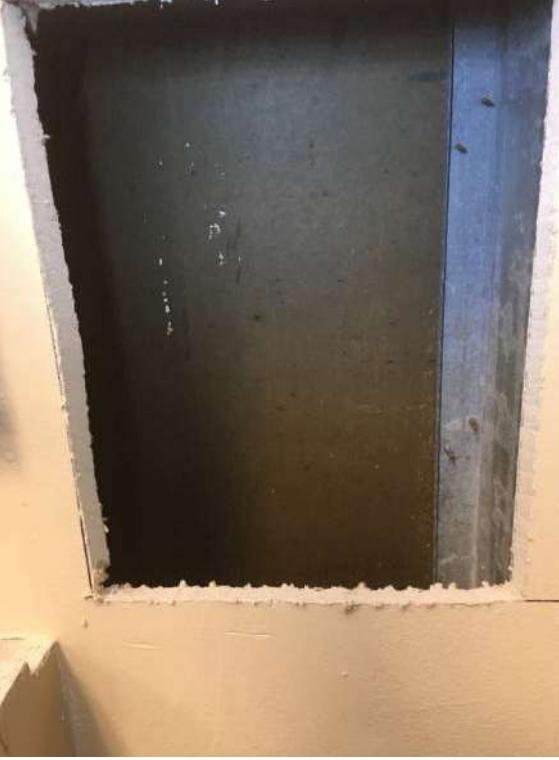
<p><b>PROBE LOCATION 03 – GROUND FLOOR / EAST</b></p> <p><b>View of Inside Face of Exterior Sheathing</b></p>
---	---

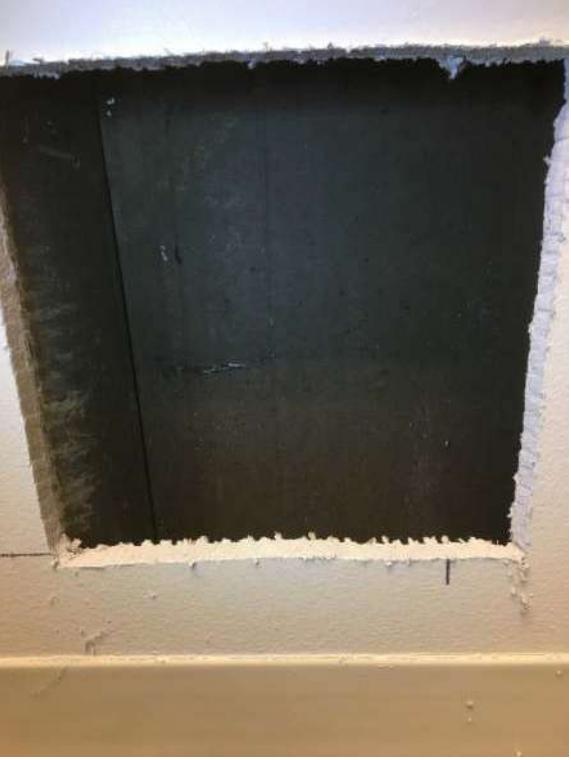
<p><b>PROBE LOCATION 04 – GROUND FLOOR / NORTH</b></p> <p><b>7</b></p> <p><b>View of Inside Face of Exterior Sheathing</b></p>
---	--

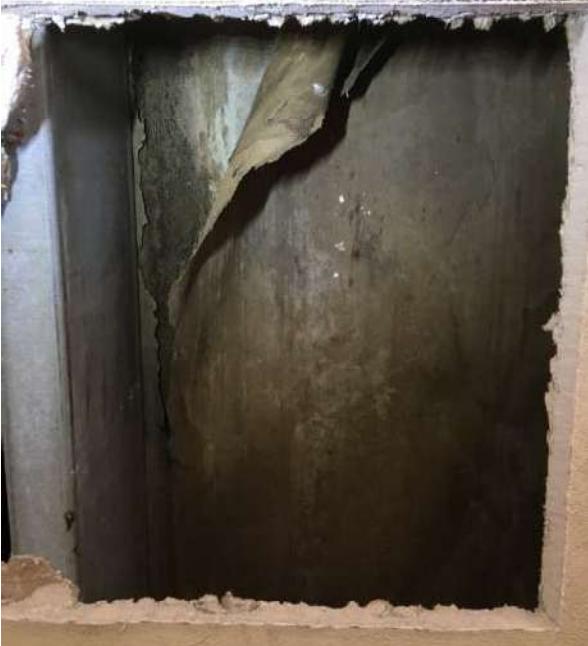
<p><b>PROBE LOCATION 05 – SECOND FLOOR / EAST</b></p> <p><b>View of Inside Face of Exterior Sheathing</b></p>	9
---	---	---

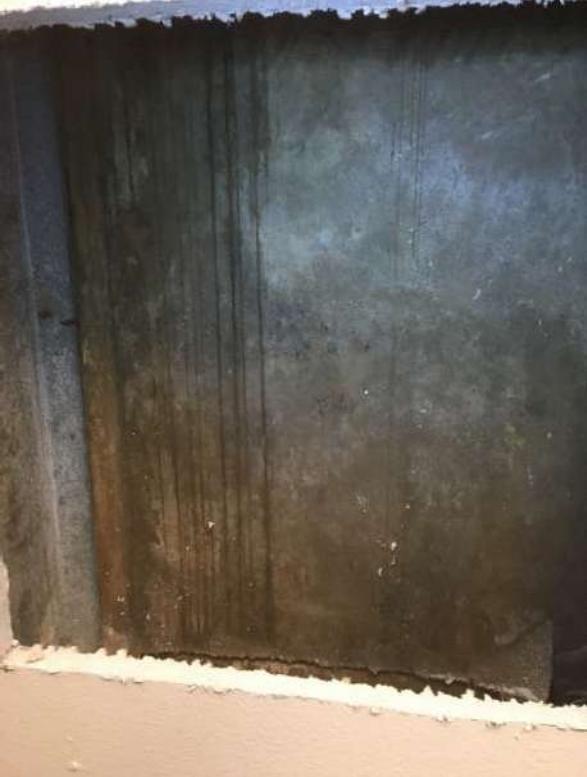
<p><b>PROBE LOCATION 06 – SECOND FLOOR / EAST</b></p> <p><b>13</b></p>
<p><b>View of Inside Face of Exterior Sheathing</b></p>

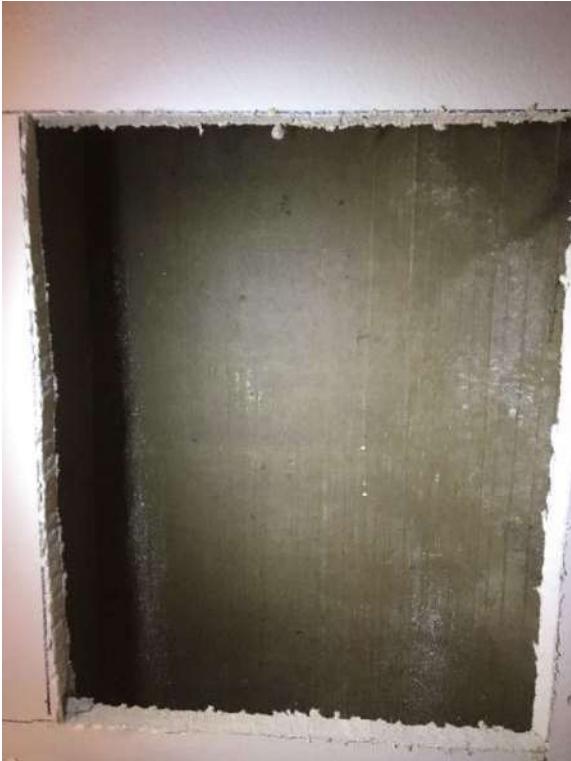
<p><b>PROBE LOCATION 10 – SECOND FLOOR / WEST</b></p> <p><b>View of Inside Face of Exterior Sheathing</b></p>	23
---	---	----

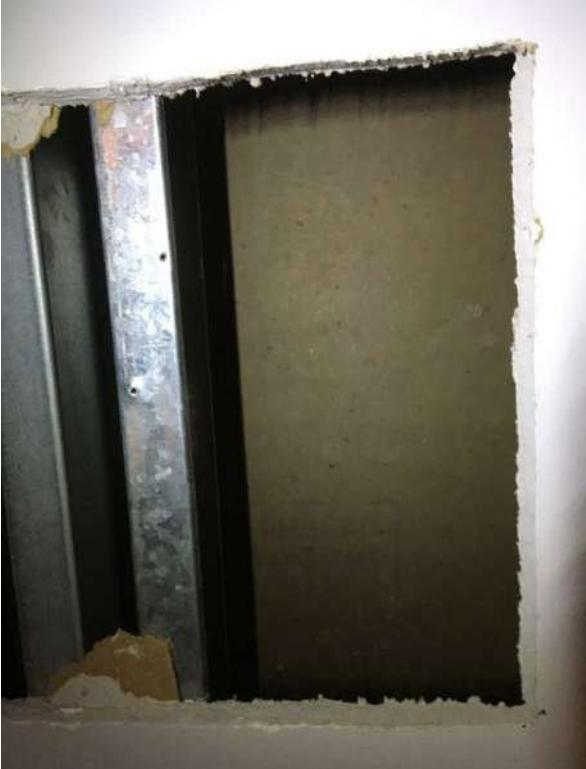
<p><b>PROBE LOCATION 11 – SECOND FLOOR / WEST</b></p> <p><b>View of Inside Face of Exterior Sheathing</b></p>
---	---

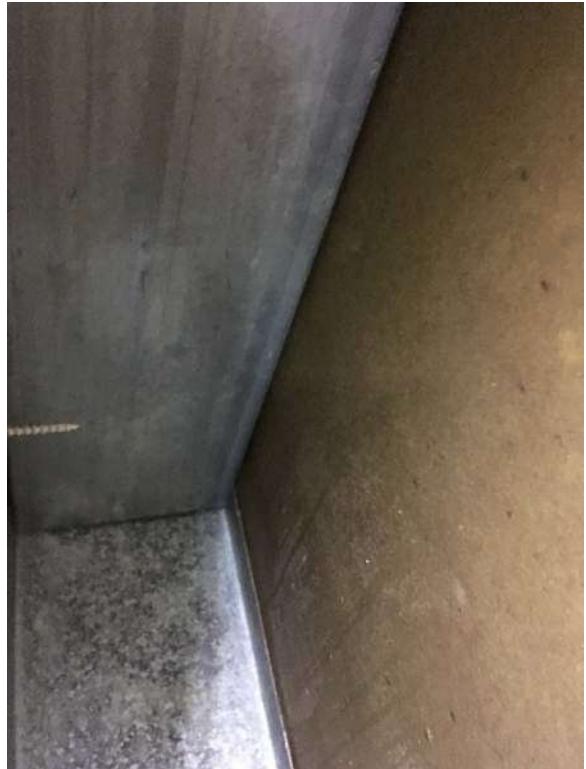
<p><b>PROBE LOCATION 11 – SECOND FLOOR / WEST</b></p> <p><b>View down – Towards Bottom Framing Track in Wall Cavity</b></p>
---	---

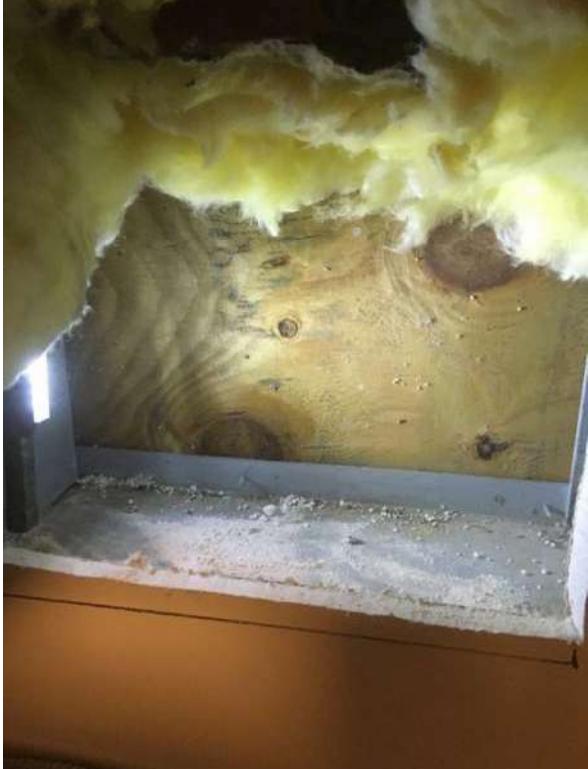
A photograph showing the inside face of exterior sheathing. The material appears to be plywood, with visible grain and some dark spots or holes. The surface is relatively dry and clean. A metal frame or track is visible at the bottom, and a bright light source is visible on the left side.	<p><b>PROBE LOCATION 13 – THRID FLOOR / SOUTH</b></p>	<p><b>29</b></p>
<p><b>View of Inside face of Exterior Sheathing – (Plywood Sheathing used in this area – possibly backer for roof ladder or other exterior wall-mounted equipment); condition dry</b></p>

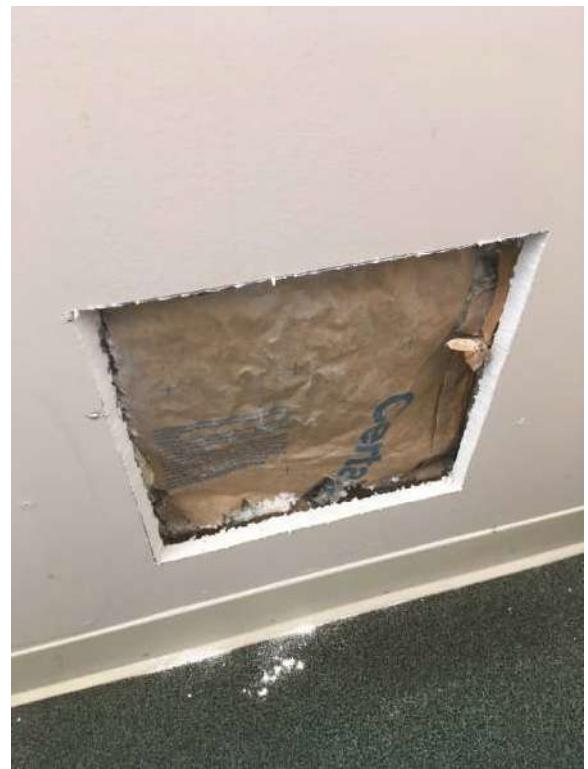
A photograph showing a portal view of insulation. A rectangular opening has been cut into a light-colored wall, revealing a dark, textured material, likely insulation, inside. The opening is framed by a white material, possibly drywall or insulation board. The floor in the foreground is dark and textured.	<p><b>PROBE LOCATION 14 – THIRD FLOOR / EAST</b></p>	<p><b>30</b></p>
<p><b>Portal View – Insulation present at Third Floor</b></p>

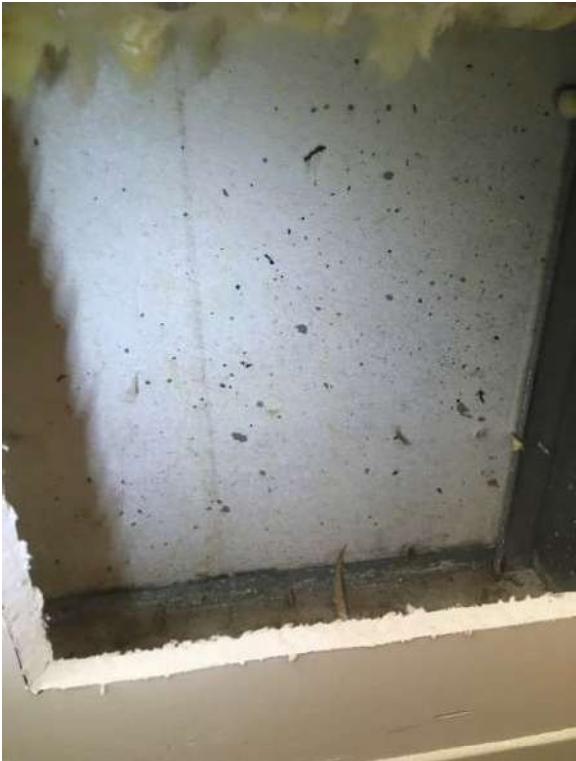
<p><b>PROBE LOCATION 14 – THRID FLOOR / EAST</b></p> <p><b>View of Inside face of Exterior Sheathing – DensGlass (Fiberglass Mat Sheathing) at 3<sup>rd</sup> Floor</b></p>
---	---

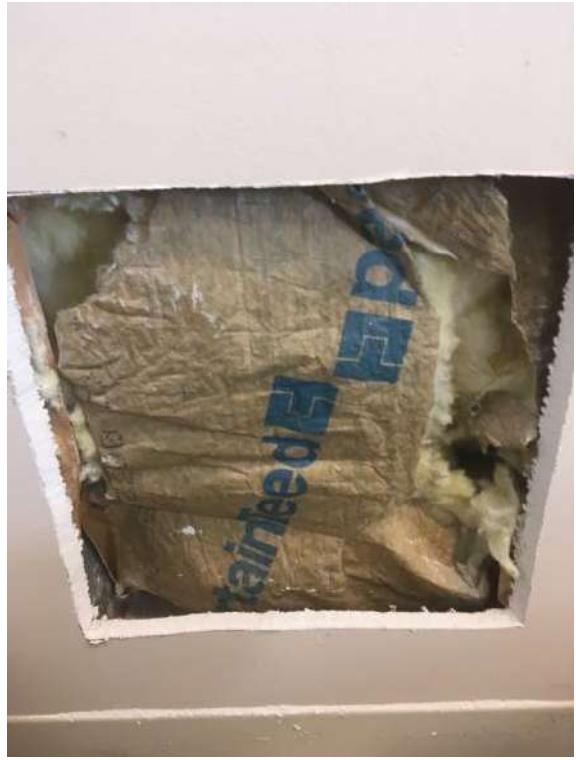
<p><b>PROBE LOCATION 15 – THIRD FLOOR / EAST</b></p> <p><b>Portal View – Insulation present at Third Floor</b></p>
---	--

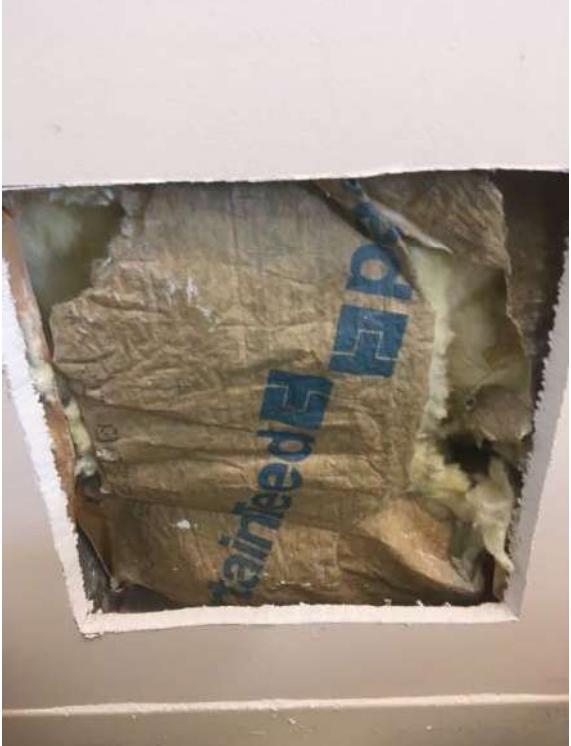
<p><b>PROBE LOCATION 16 – THIRD FLOOR / NORTH</b></p> <p><b>Portal View – Insulation present at Third Floor</b></p>
---	---

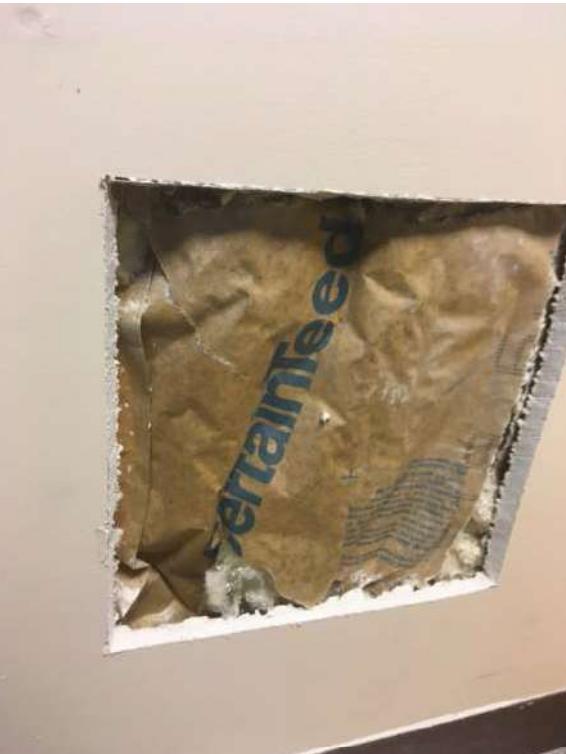
<p>PROBE LOCATION 17 – THIRD FLOOR / NORTH</p>	<p>36</p>
<p>Portal View – Insulation present at Third Floor</p>

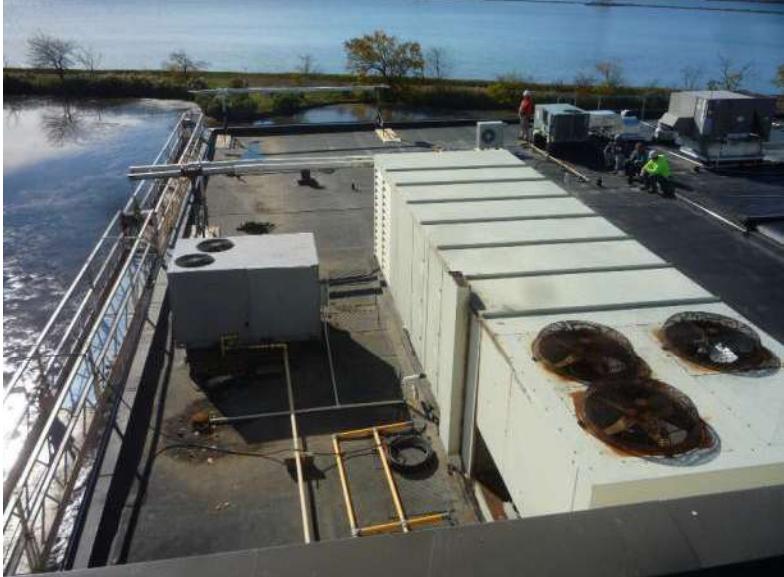
2 <sup>nd</sup> Floor Roof (East)	01

<p>Overall view 2<sup>nd</sup> Floor Roof taken from above</p> <p>Single-Ply EPDM Membrane roofing system.</p> <p>Age of roof system unknown</p>

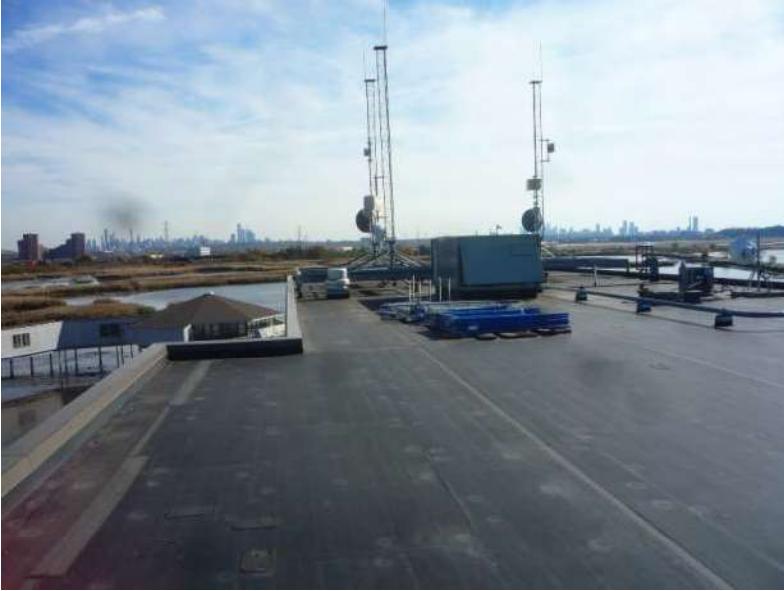
3 <sup>rd</sup> Floor Roof	03

<p>Overall view of 3<sup>rd</sup> Floor Roof (Original roof system from 2000 addition)</p>

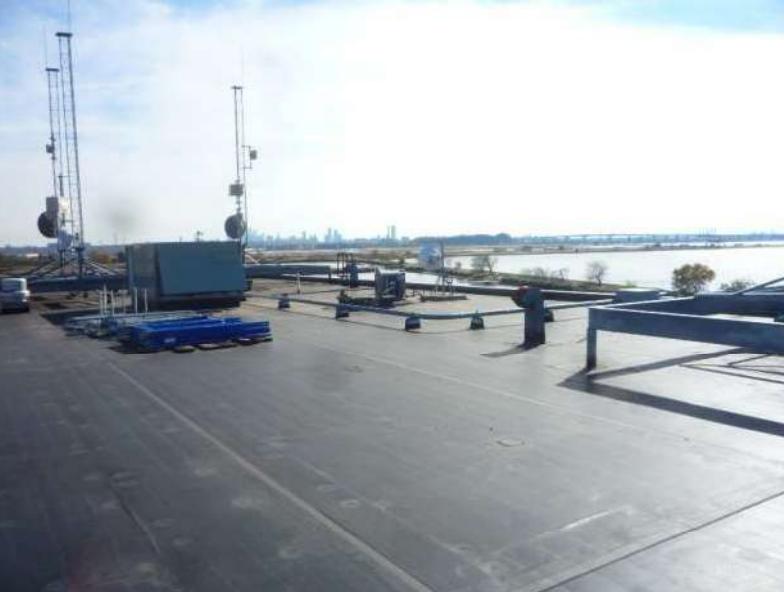
3 <sup>rd</sup> Floor Roof	04

<p>Overall view of 3<sup>rd</sup> Floor Roof (Original roof system from 2000 addition)</p>

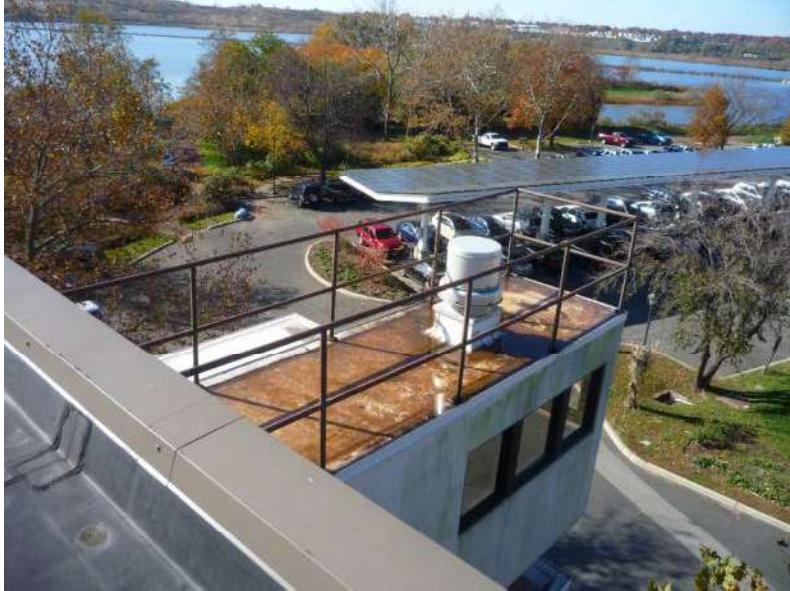
3 <sup>rd</sup> Floor Addition Stair	05

<p><b>Roof at Stair of 3<sup>rd</sup> Floor</b></p> <p>Noted as “White EPDM” in original construction documents for this project addition</p>
