NJSEA Arena Stair and Ramp Repairs
Contract No.CN-303

Book 4 of 4
DESIGN DOCUMENTS
January 13, 2026

**Project CN-303 NJSEA Arena Stair and Ramp Repairs
DESIGN DOCUMENTS**

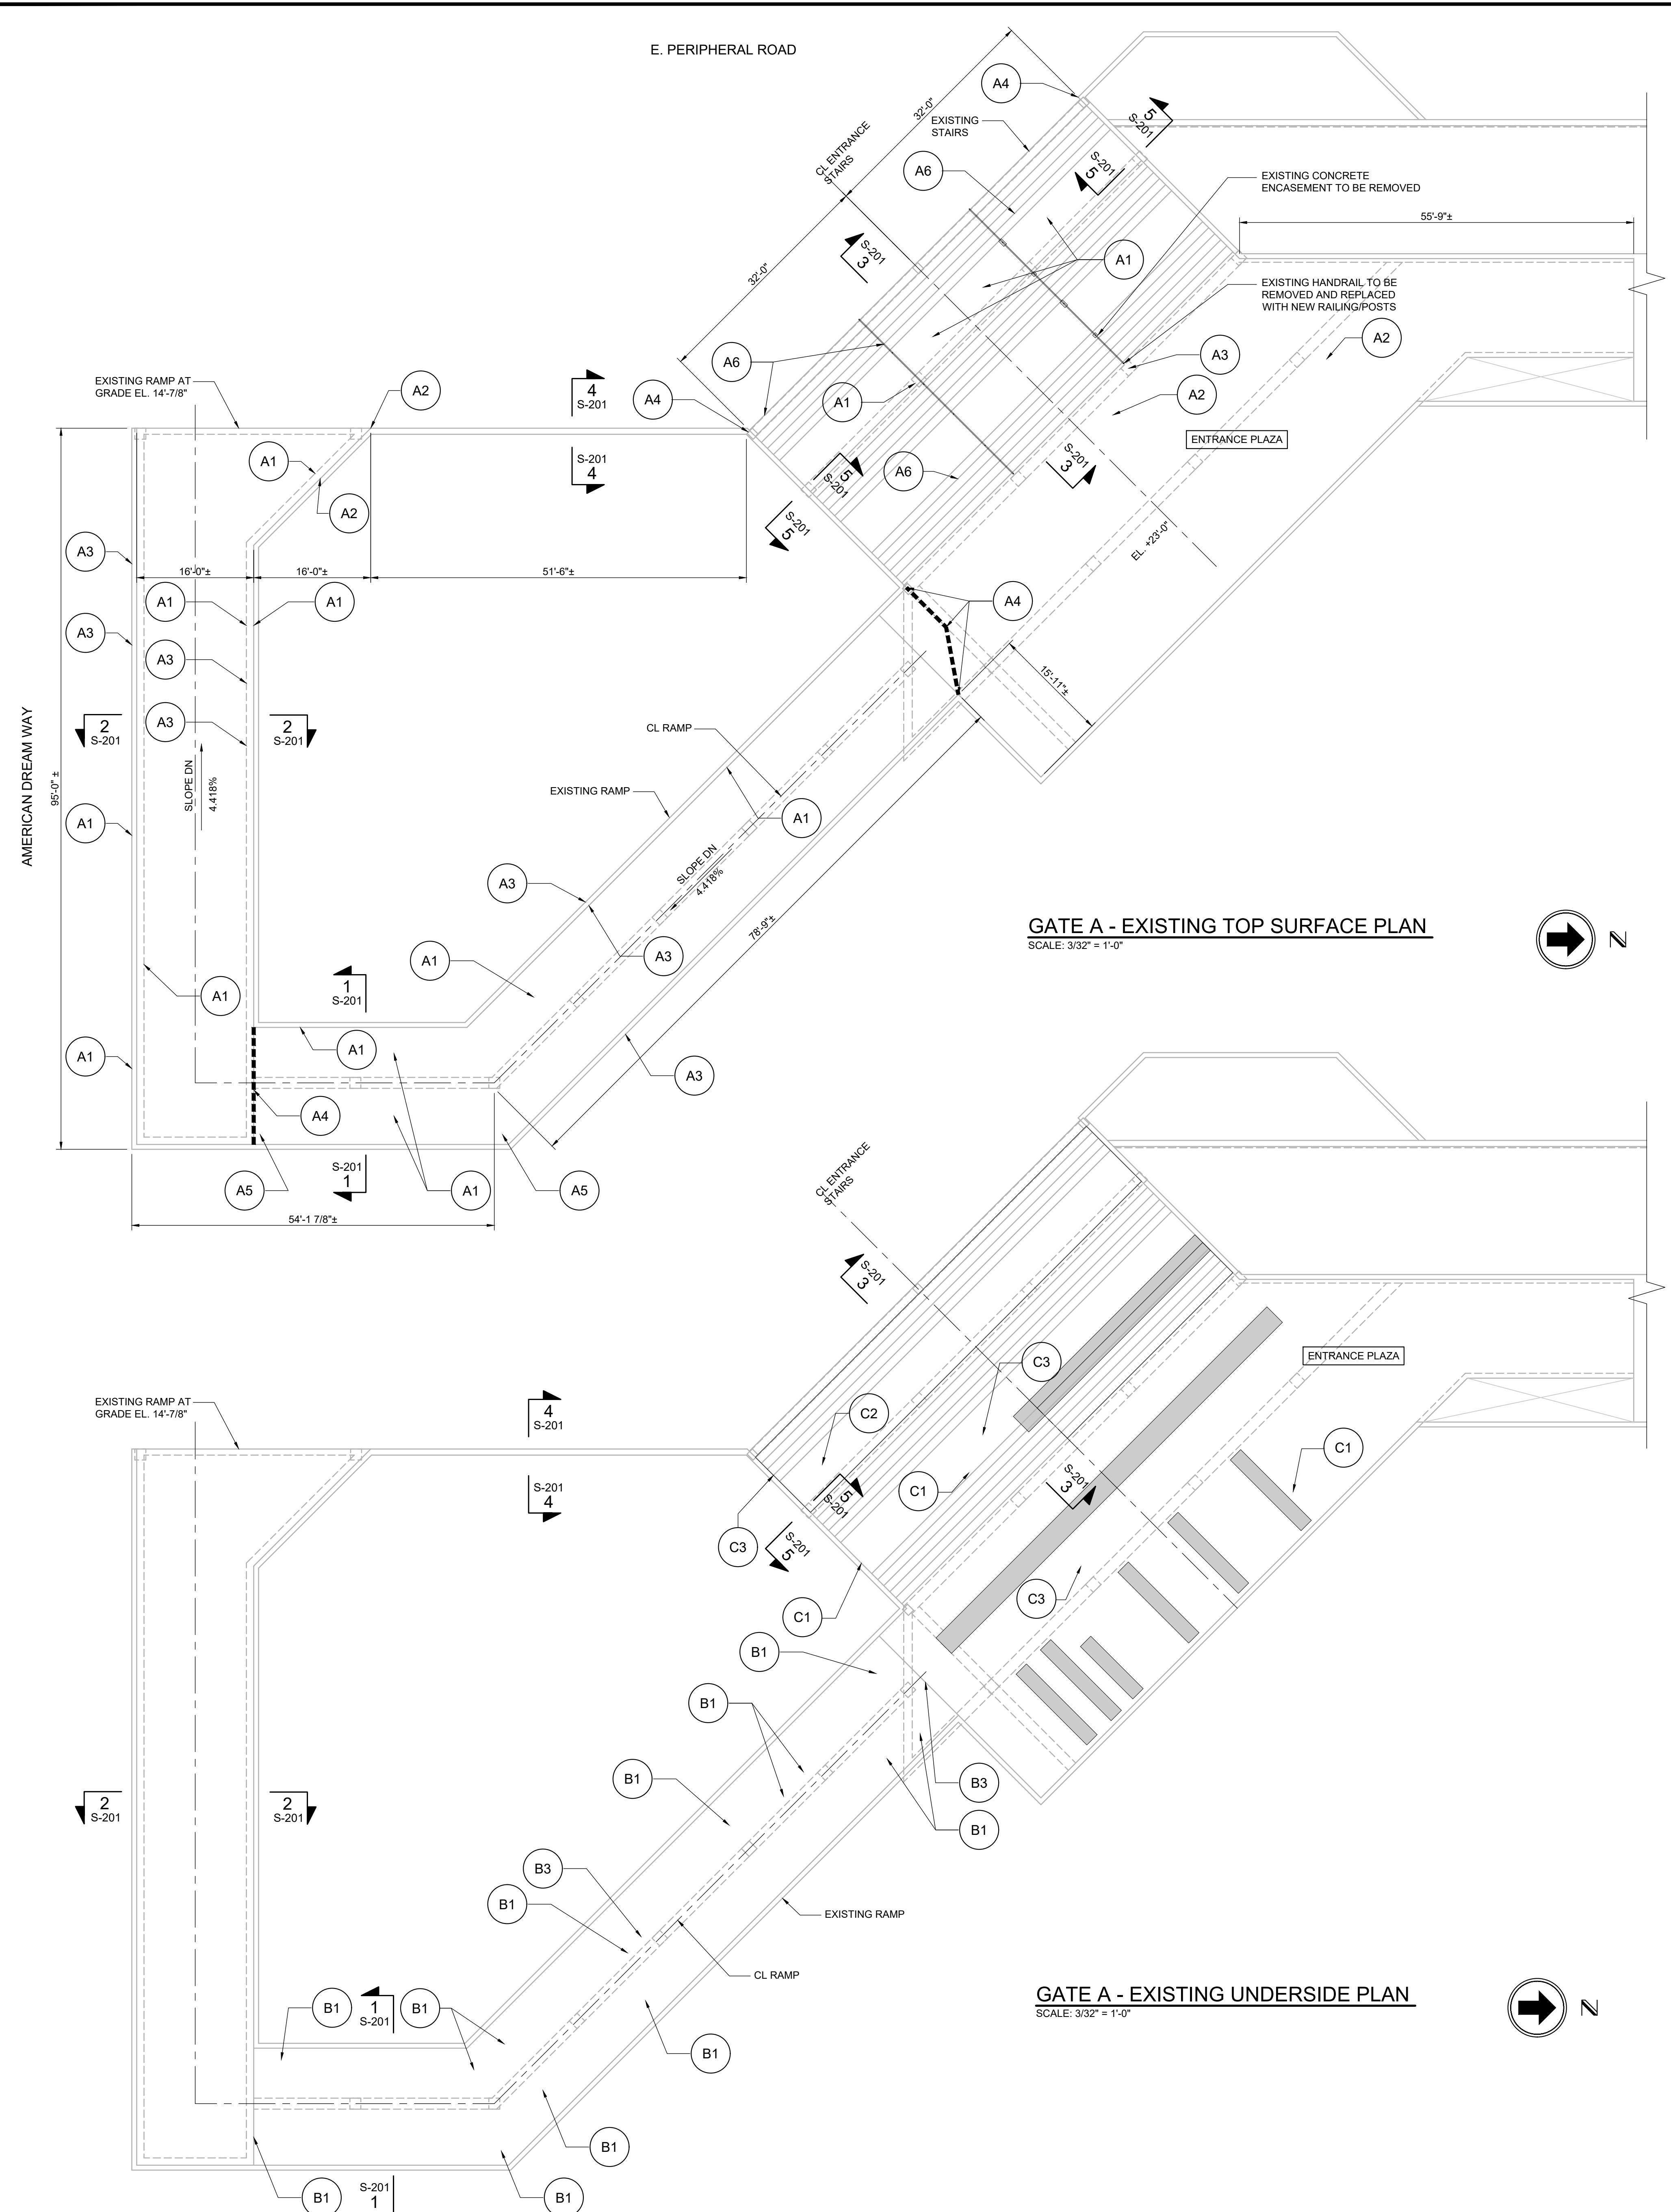
DEFECT ID	DESCRIPTION	UNIT	QUANTITY
A1	SPALLS	SF	26
A2	CRACKS	LF	19
A3	DELAMINATION	SF	16
A4	JOINT MATERIAL DAMAGE	LF	57
A5	CLOGGED DRAIN WITH VEGETATION GROWTH	EA	2
A6	STAIR NOSING REPAIR	LF	11
B1	OVERHEAD SPALLS	SF	118
B2	OVERHEAD CRACKS	LF	0
B3	OVERHEAD DELAMINATION	SF	16
C1	OVERHEAD SPALLS	SF	23
C2	OVERHEAD CRACKS	LF	30
C3	OVERHEAD DELAMINATION	SF	48

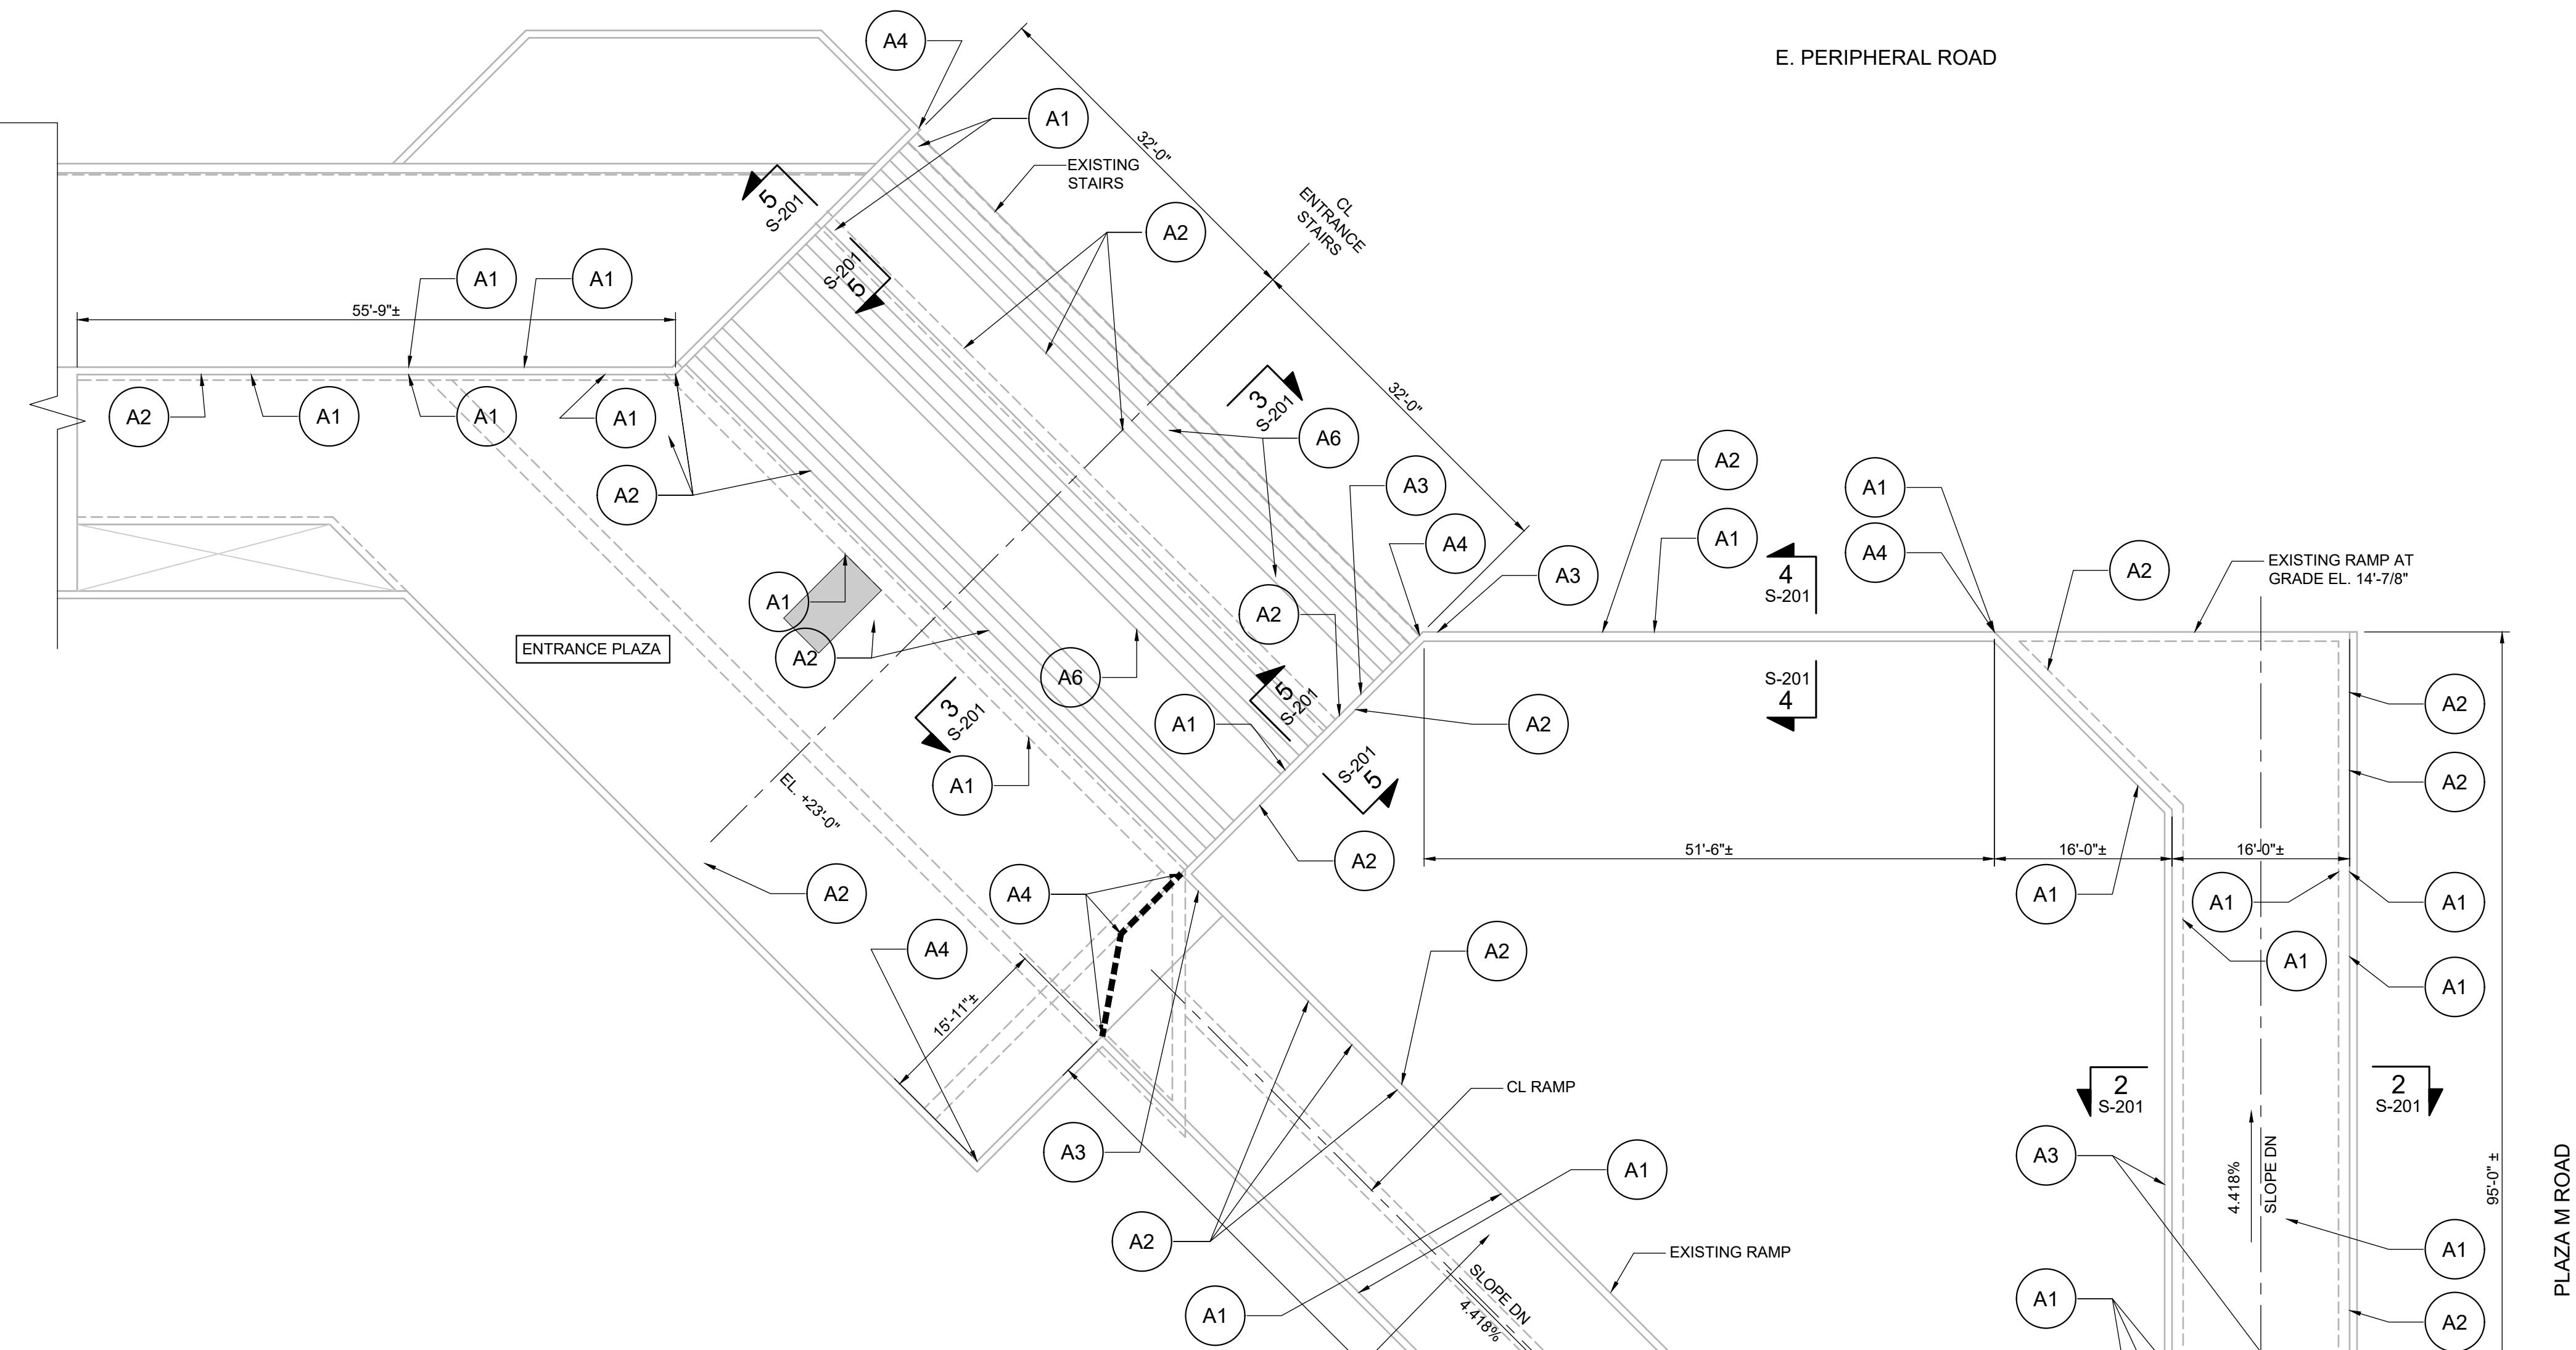
GATE B - EXISTING TOP SURFACE PLAN

DEFECT ID	DESCRIPTION	UNIT	QUANTITY
A1	SPALLS	SF	89
A2	CRACKS	LF	101
A3	DELAMINATION	SF	28
A4	JOINT MATERIAL DAMAGE	LF	66
A5	CLOGGED DRAIN WITH VEGETATION GROWTH	EA	2
A6	STAIR NOSING REPAIR	LF	22
B1	OVERHEAD SPALLS	SF	111
B2	OVERHEAD CRACKS	LF	10
B3	OVERHEAD DELAMINATION	SF	97
C1	OVERHEAD/VERTICAL SPALLS	SF	7
C2	OVERHEAD CRACKS	LF	81
C3	OVERHEAD DELAMINATION	SF	178

1. FOR REPAIR DETAILS SEE DRAWING NOS. S-201 AND S-202.
2. FOR ADDITIONAL NOTES SEE DRAWING NO. S-001.
3. QUANTITY SHOWN IN TABLE IS FOR ALL STRUCTURAL DEFECTS SHOWN IN THE PLAN.
4. EXISTING RAILINGS, POSTS, AND POSTS WITH ENCASEMENT AT STAIRS TO BE REMOVED AND REPLACED WITH NEW RAILINGS AND POSTS.

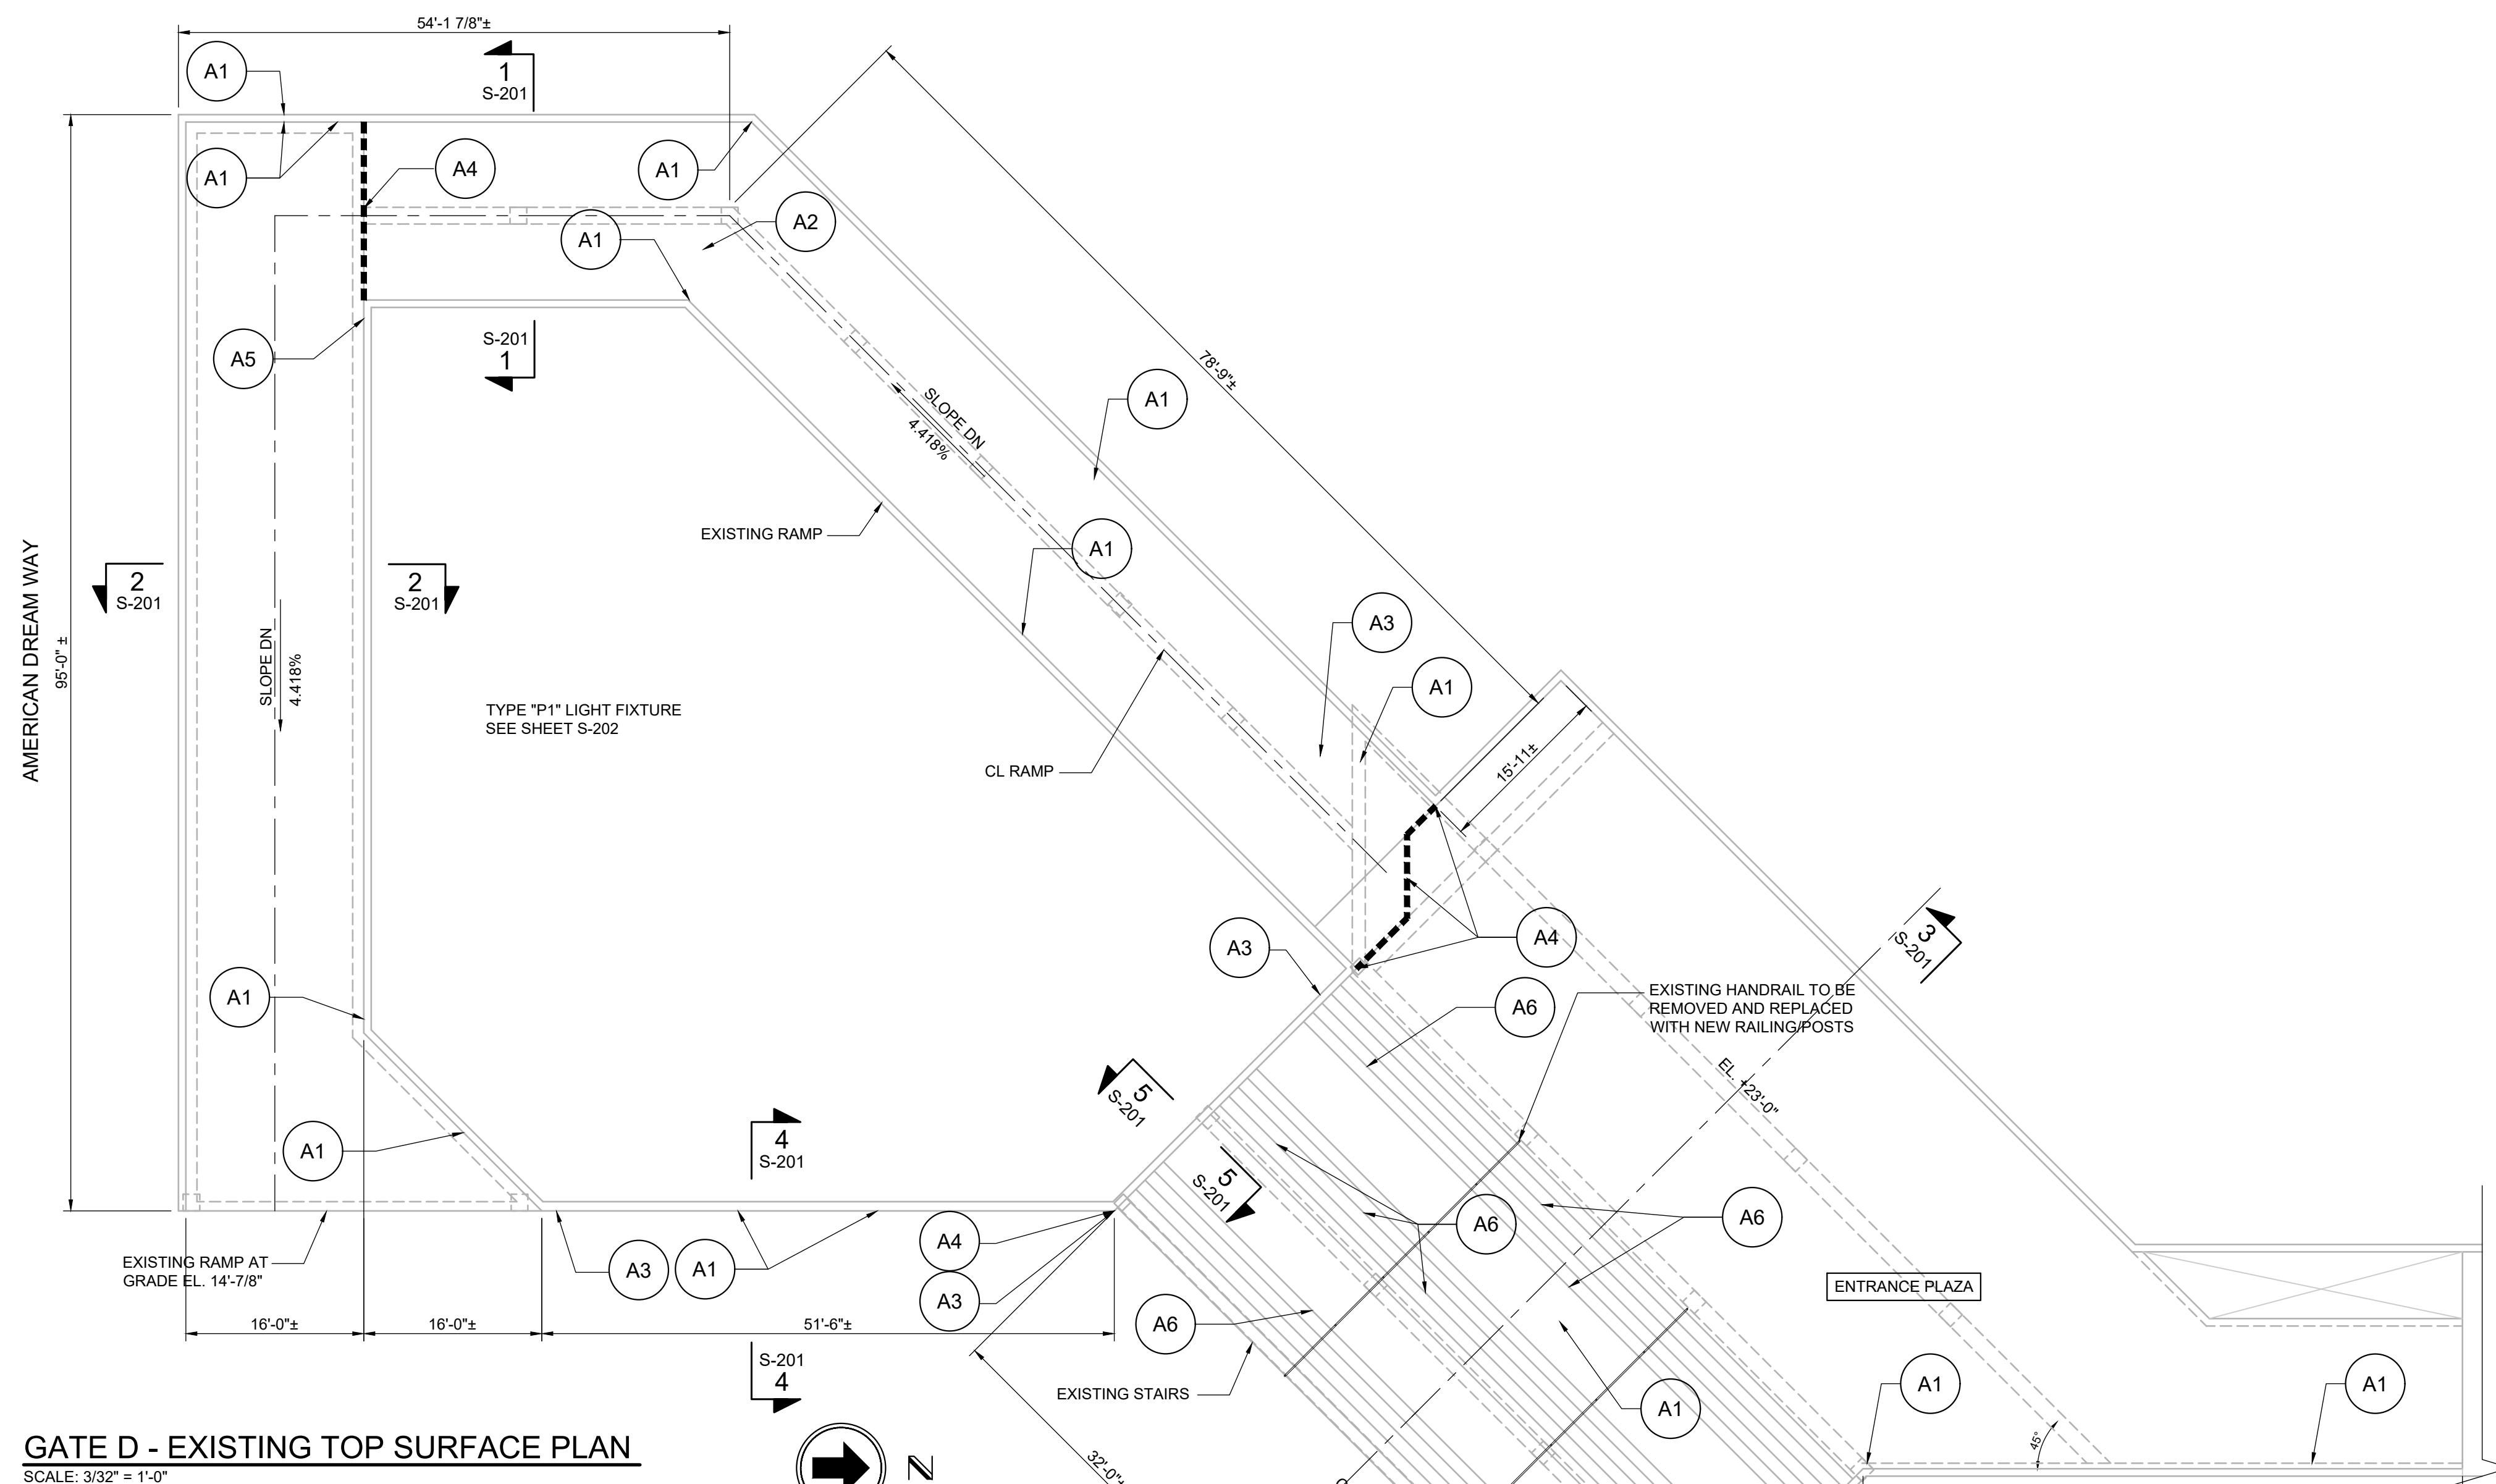
GATE D - EXISTING TOP SURFACE PLAN

DEFECT ID	DESCRIPTION	UNIT	QUANTITY
A1	SPALLS	SF	31
A2	CRACKS	LF	16
A3	DELAMINATION	SF	10
A4	JOINT MATERIAL DAMAGE	LF	57
A5	CLOGGED DRAIN WITH VEGETATION GROWTH	EA	1
A6	STAIR NOSING REPAIR	LF	122
B1	OVERHEAD SPALLS	SF	37
B2	OVERHEAD CRACKS	LF	40
B3	OVERHEAD DELAMINATION	SF	21
C1	OVERHEAD SPALLS	SF	63
C2	OVERHEAD CRACKS	LF	80
C3	OVERHEAD DELAMINATION	SF	90
