| <b>Keegan Landfill Monitoring Project</b><br> | <b>DAILY AIR MONITORING REPORT</b><br><b>NON-PROPERTY LINE</b><br><b>Keegan Landfill Monitoring Stations</b><br><b>Kearny, New Jersey</b> | | | | 11/27/22 | |

| <b>Keegan Landfill Monitoring Project</b><br><br> | <b>DAILY AIR MONITORING REPORT</b><br><b>AT OR NEAR PROPERTY LINE</b><br><b>Keegan Landfill Monitoring Stations</b><br><b>Kearny, New Jersey</b> | | | 11/27/22 | |

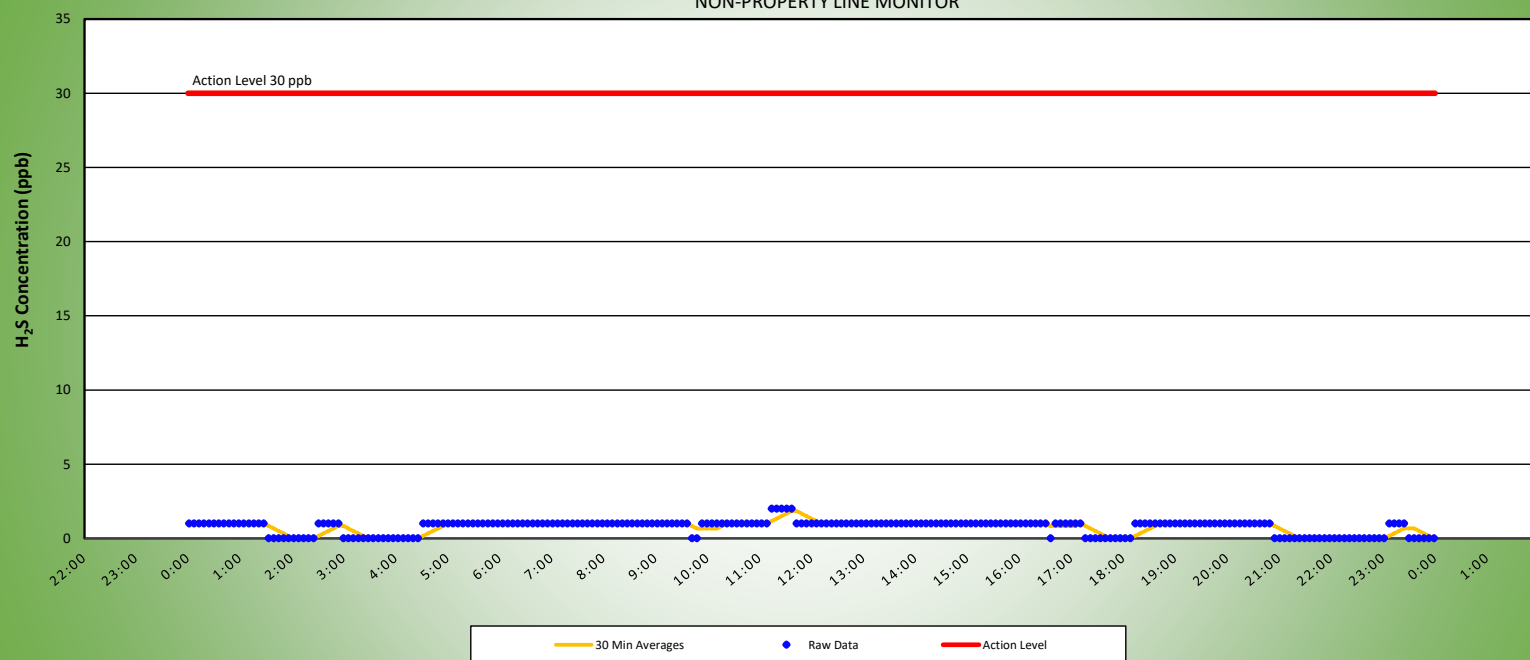
# MS1 H2S MONITORING RESULTS - 11/27/22

| Station Location Area | Work | Daily Avg. 30 Min H <sub>2</sub> S Concentration (ppb) | Max 30 Min H <sub>2</sub> S Concentration (ppb) | Time of Max 30 Min H <sub>2</sub> S Reading | Corresponding Wind Direction |
|---|---|---|---|---|---|
| MS-1 | | 0.8 | 1.8 | 11:36 | SSW |

NON-PROPERTY LINE MONITOR

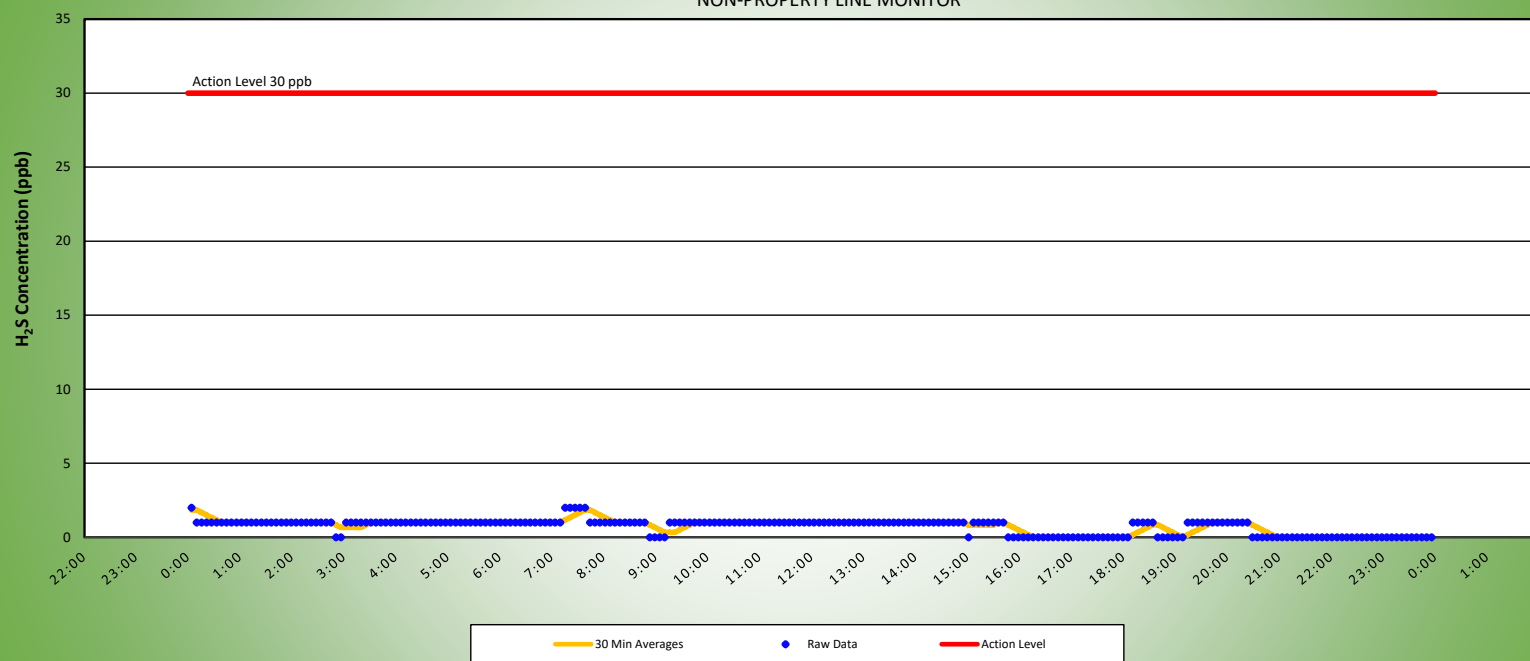
## MS2 H2S MONITORING RESULTS - 11/27/22

| Station Location Area | Work | Daily Avg. 30 Min H <sub>2</sub> S Concentration (ppb) | Max 30 Min H <sub>2</sub> S Concentration (ppb) | Time of Max 30 Min H <sub>2</sub> S Reading | Corresponding Wind Direction |
|---|---|---|---|---|---|
| MS-2 | | 0.8 | 1.8 | 0:04 | S |

NON-PROPERTY LINE MONITOR

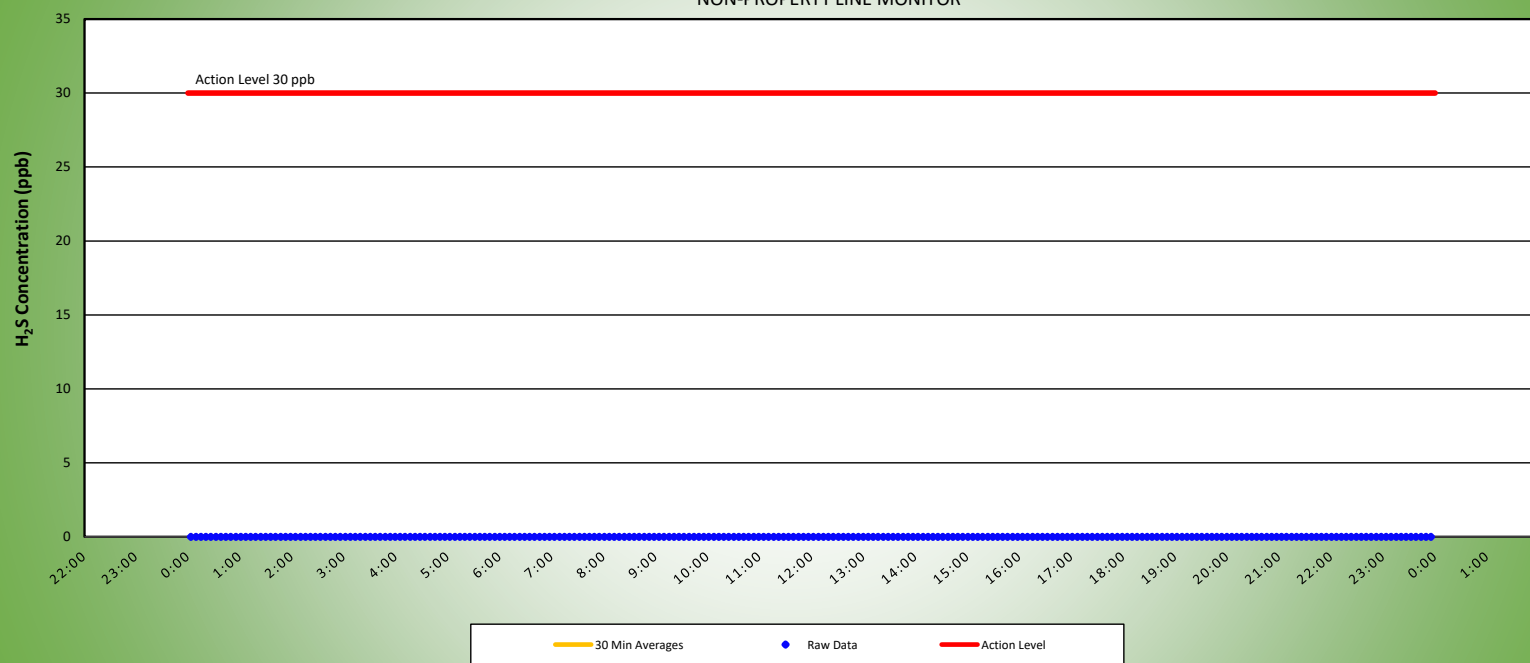
# MS3 H2S MONITORING RESULTS - 11/27/22

| Station Location Area | Work | Daily Avg. 30 Min H <sub>2</sub> S Concentration (ppb) | Max 30 Min H <sub>2</sub> S Concentration (ppb) | Time of Max 30 Min H <sub>2</sub> S Reading | Corresponding Wind Direction |
|---|---|---|---|---|---|
| MS-3 | | 0.0 | 0.0 | 0:03 | SW |

NON-PROPERTY LINE MONITOR

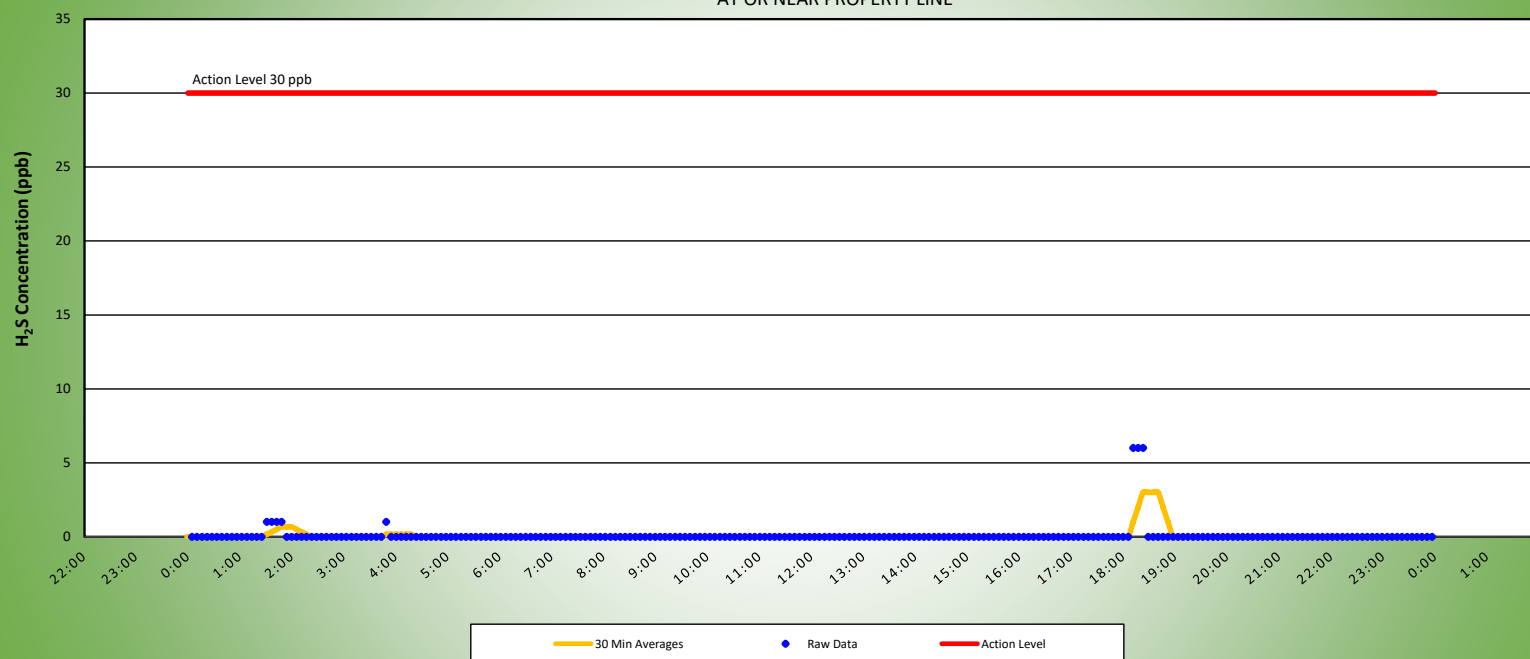
# MS4 H2S MONITORING RESULTS - 11/27/22

| Station Location Area | Work | Daily Avg. 30 Min H <sub>2</sub> S Concentration (ppb) | Max 30 Min H <sub>2</sub> S Concentration (ppb) | Time of Max 30 Min H <sub>2</sub> S Reading | Corresponding Wind Direction |
|---|---|---|---|---|---|
| MS-4 | | 0.1 | 3.0 | 18:22 | S |

AT OR NEAR PROPERTY LINE

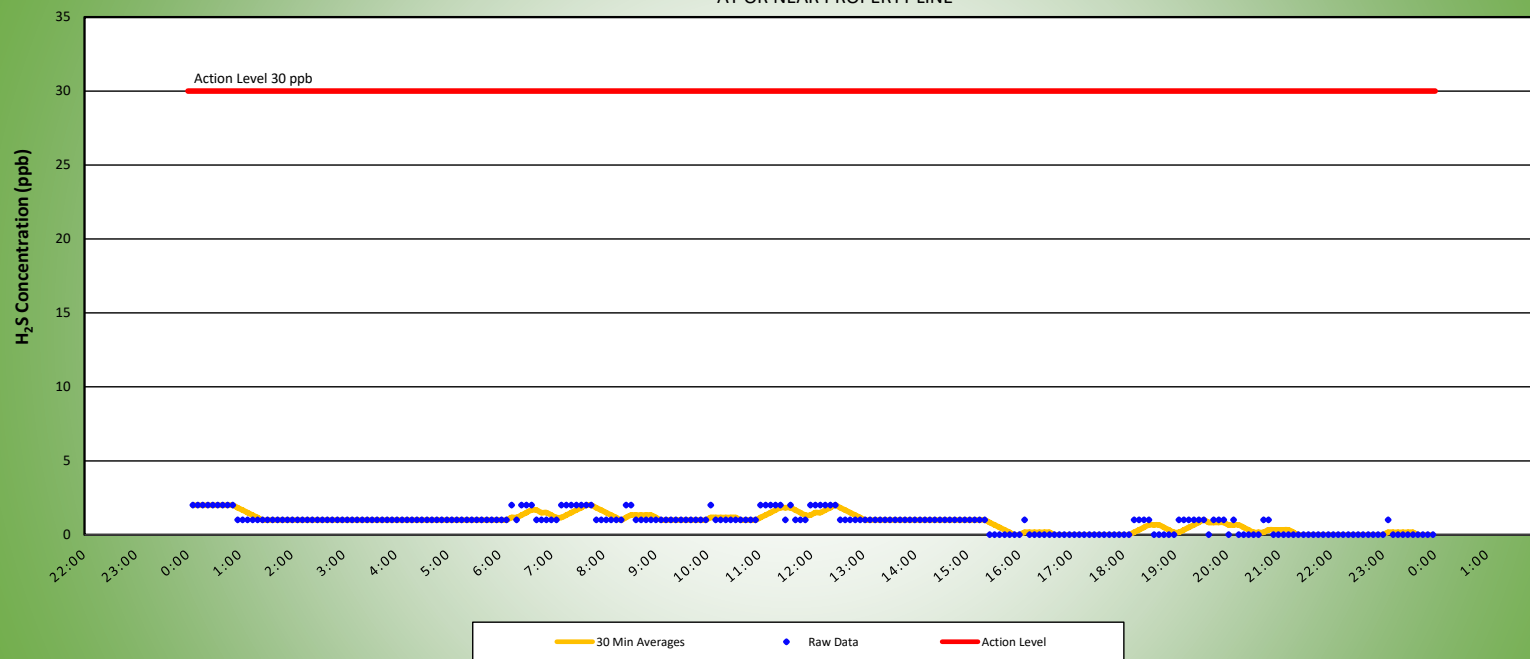
# MS5 H2S MONITORING RESULTS - 11/27/22

| Station Location Area | Work | Daily Avg. 30 Min H <sub>2</sub> S Concentration (ppb) | Max 30 Min H <sub>2</sub> S Concentration (ppb) | Time of Max 30 Min H <sub>2</sub> S Reading | Corresponding Wind Direction |
|---|---|---|---|---|---|
| MS-5 | | 0.9 | 2.0 | 0:05 | S |

AT OR NEAR PROPERTY LINE

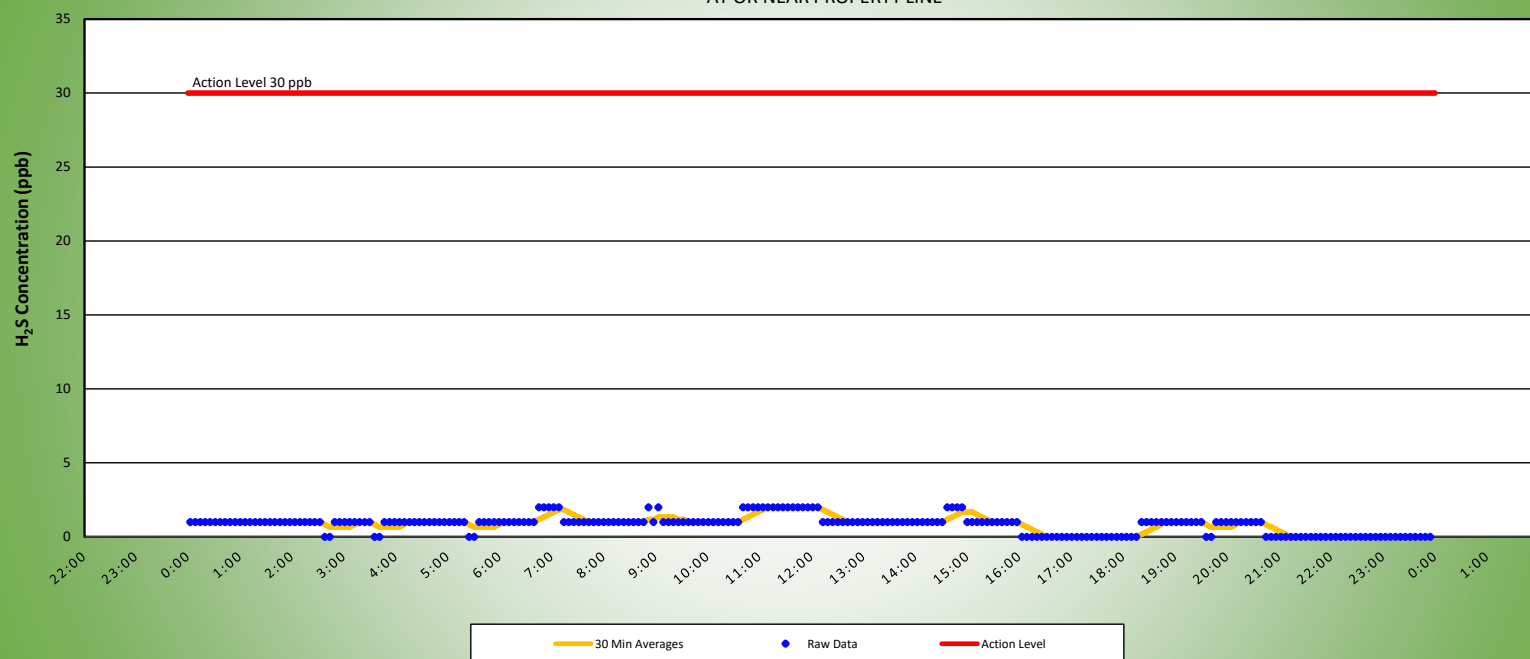
# MS6 H2S MONITORING RESULTS - 11/27/22

| Station Location Area | Work | Daily Avg. 30 Min H <sub>2</sub> S Concentration (ppb) | Max 30 Min H <sub>2</sub> S Concentration (ppb) | Time of Max 30 Min H <sub>2</sub> S Reading | Corresponding Wind Direction |
|---|---|---|---|---|---|
| MS-6 | | 0.9 | 2.0 | 11:09 | SSW |

AT OR NEAR PROPERTY LINE

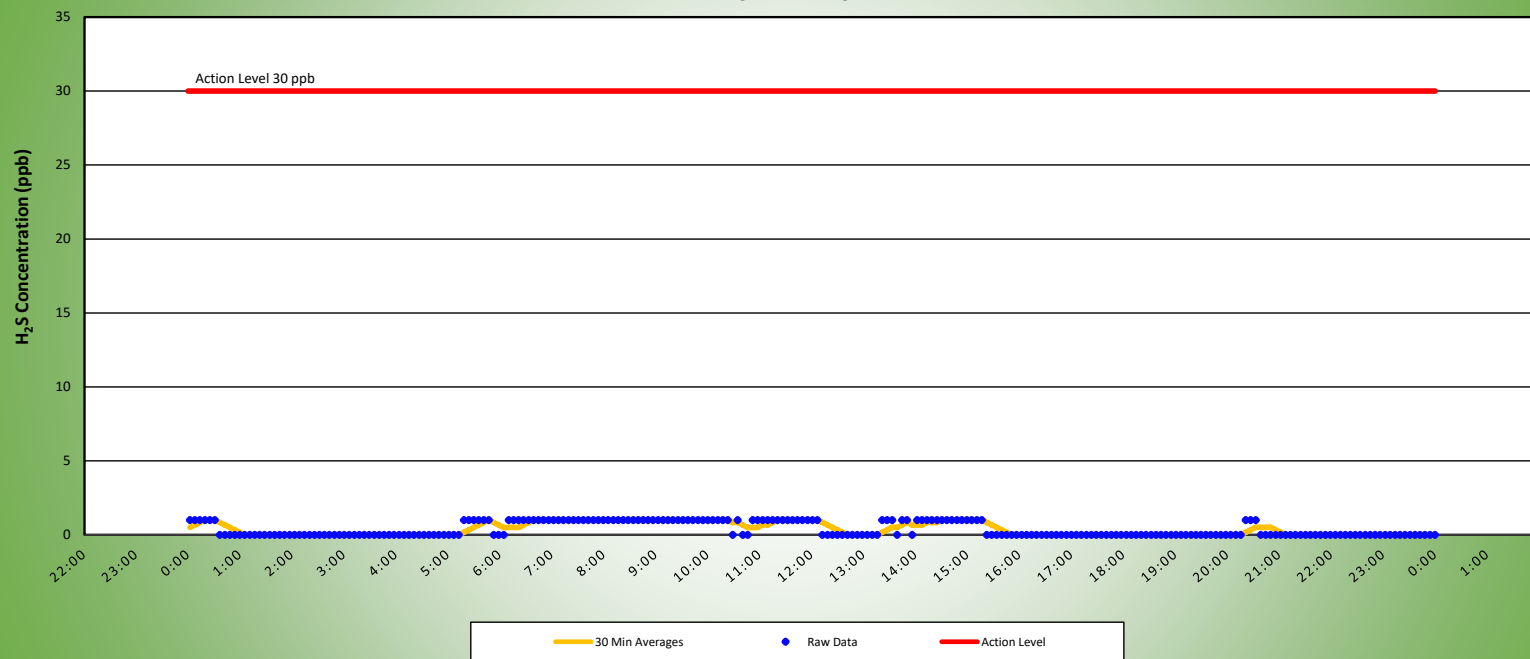
# MS7 H2S MONITORING RESULTS - 11/27/22

| Station Location Area | Work | Daily Avg. 30 Min H <sub>2</sub> S Concentration (ppb) | Max 30 Min H <sub>2</sub> S Concentration (ppb) | Time of Max 30 Min H <sub>2</sub> S Reading | Corresponding Wind Direction |
|---|---|---|---|---|---|
| MS-7 | | 0.4 | 1.0 | 0:19 | ESE |

AT OR NEAR PROPERTY LINE

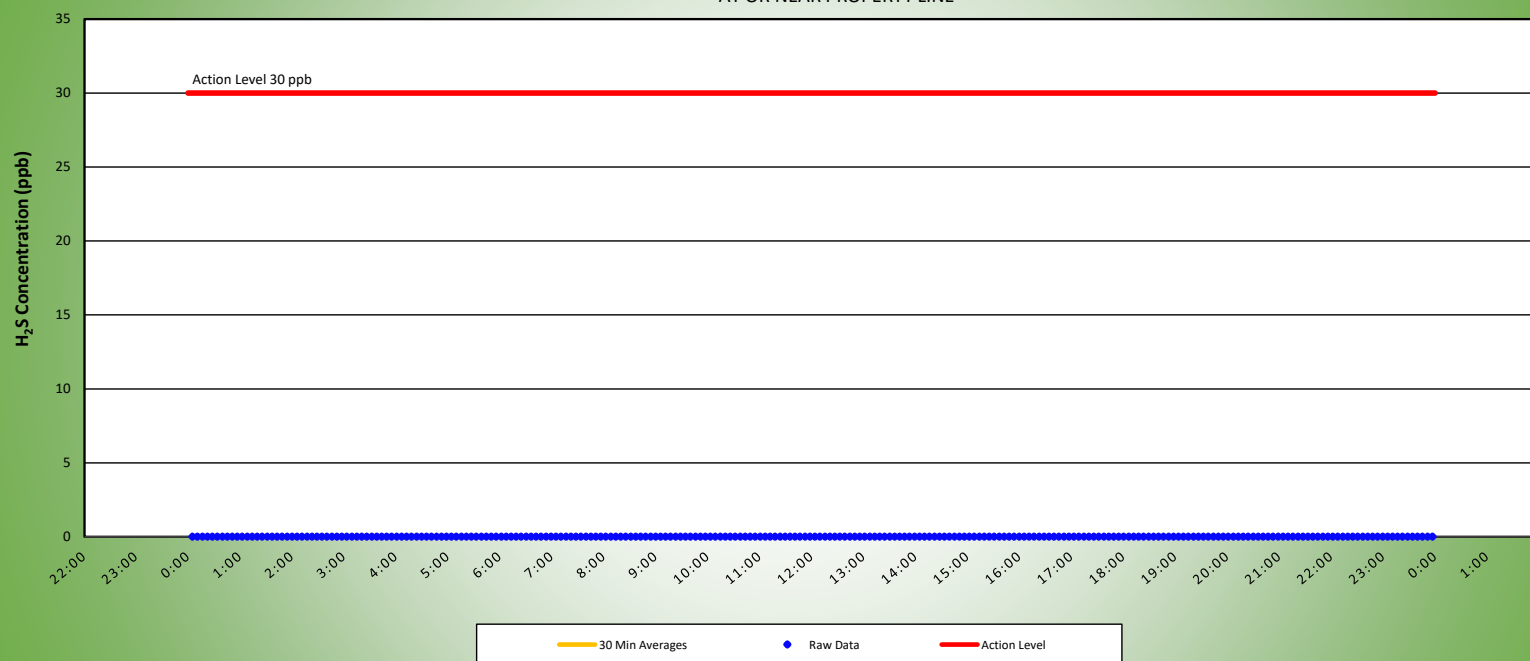
# MS8 H2S MONITORING RESULTS - 11/27/22

| Station Location Area | Work | Daily Avg. 30 Min H <sub>2</sub> S Concentration (ppb) | Max 30 Min H <sub>2</sub> S Concentration (ppb) | Time of Max 30 Min H <sub>2</sub> S Reading | Corresponding Wind Direction |
|---|---|---|---|---|---|
| MS-8 | | 0.0 | 0.0 | 0:05 | SW |

AT OR NEAR PROPERTY LINE
