November 20, 2019
File No. 02219702.00

Subject: November 19, 2019 Monitoring Station Data
Keegan Landfill
New Jersey Sports and Exposition Authority
Permit Activity Number: EIP190001
EA ID#: NEA 190001-13317

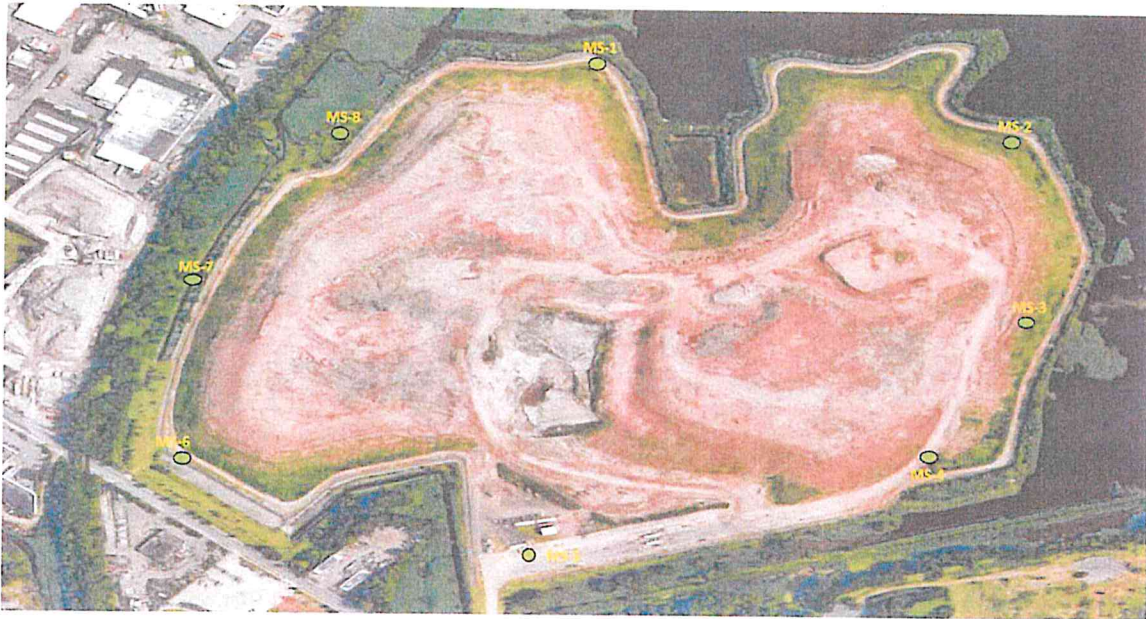
The 30-minute rolling average H₂S concentration at Monitoring Station MS-1 was in excess of 30 ppb for intermittent periods between 4:30 am and 5:09 am on November 19 (see NEXA notifications in Attachment 1 and raw data in Attachment 2). The hydrogen sulfide concentration, average wind speed and wind direction measured during the period of the exceedances are provided in Attachment 3. The average wind speed and calculated wind direction was 0.5 mph and 124 degrees (i.e., from the southeast). The wind direction and MS-1 are shown on a map of the site. The nearest potential receptor is approximately 500 feet from the monitoring station (see Attachment 4). However, we note that the wind direction measured at such low wind speeds was highly variable and therefore unreliable.

The cause of the emissions from Monitoring Station MS-1 appears to be uncontrolled emissions from the Landfill. There was no corrective action implemented in accordance with the Odor Control Plan as the exceedances occurred overnight and returned to 30 ppb within less than one hour.
