| <b>Keegan Landfill Monitoring Project</b><br> | <b>DAILY AIR MONITORING REPORT</b><br><b>NON-PROPERTY LINE</b><br><b>Keegan Landfill Monitoring Stations</b><br><b>Kearny, New Jersey</b> | | | | 01/27/21 | |

| <div>Keegan Landfill Monitoring Project</div> <div></div> | <div>DAILY AIR MONITORING REPORT</div> <div>AT OR NEAR PROPERTY LINE</div> <div>Keegan Landfill Monitoring Stations</div> <div>Kearny, New Jersey</div> | 01/27/21 | |

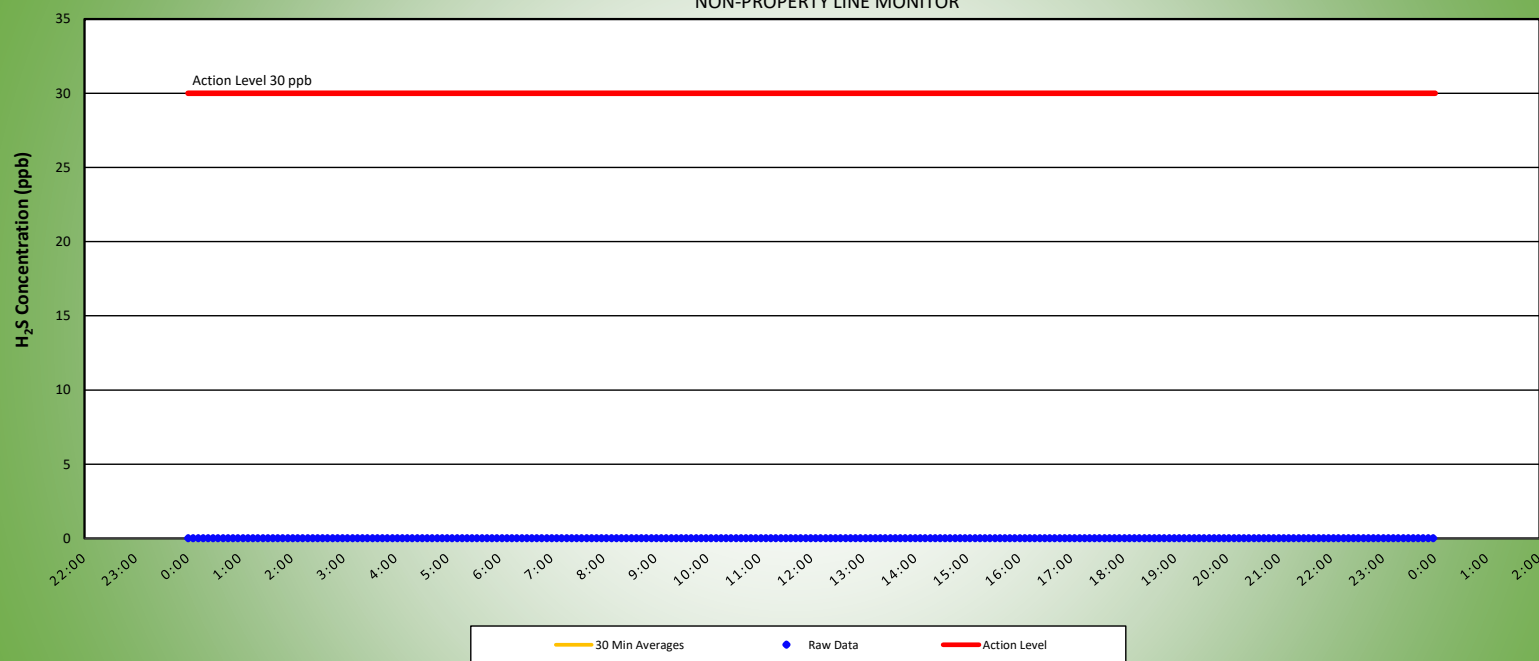
# MS1 H2S MONITORING RESULTS - 01/27/21

| Station Location Area | Work | Daily Avg. 30 Min H <sub>2</sub> S Concentration (ppb) | Max 30 Min H <sub>2</sub> S Concentration (ppb) | Time of Max 30 Min H <sub>2</sub> S Reading | Corresponding Wind Direction |
|---|---|---|---|---|---|
| MS-1 | | 0.0 | 0.0 | 0:00 | NNE |

NON-PROPERTY LINE MONITOR

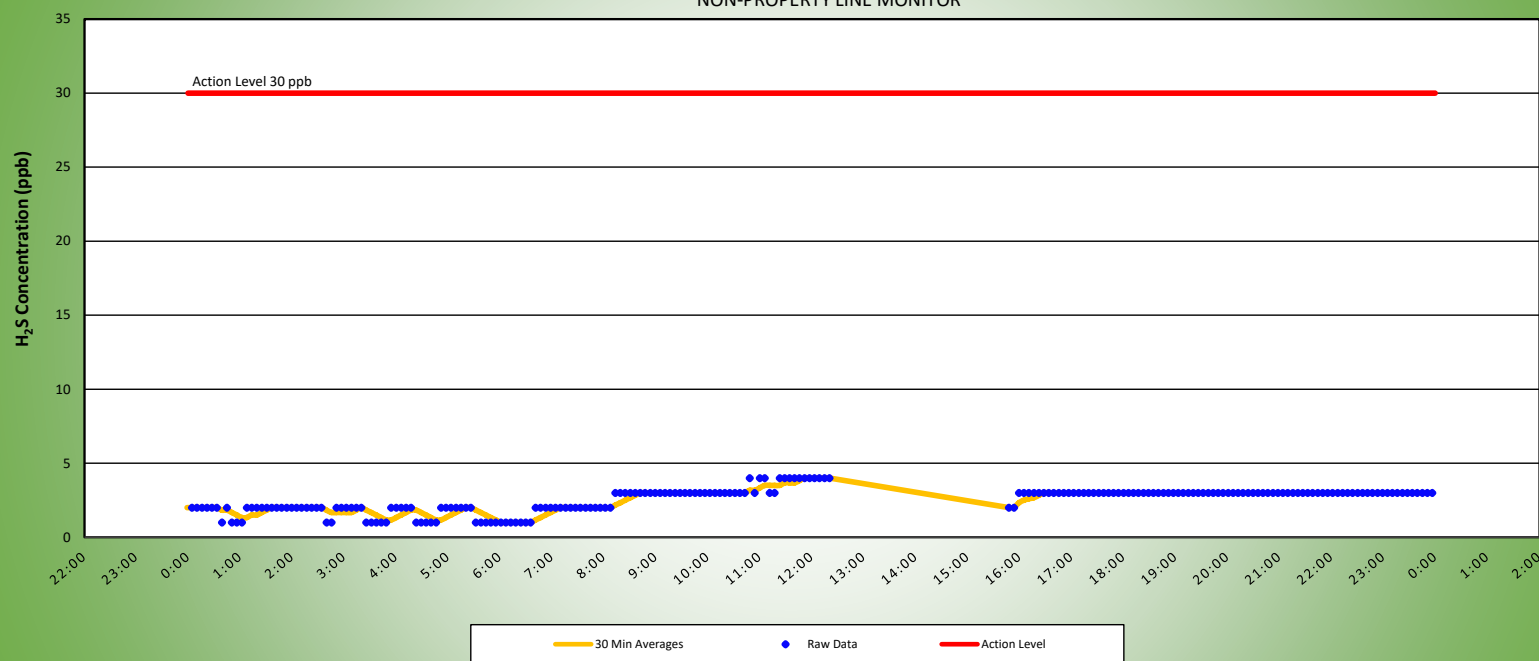
# MS2 H2S MONITORING RESULTS - 01/27/21

| Station Location Area | Work | Daily Avg. 30 Min H <sub>2</sub> S Concentration (ppb) | Max 30 Min H <sub>2</sub> S Concentration (ppb) | Time of Max 30 Min H <sub>2</sub> S Reading | Corresponding Wind Direction |
|---|---|---|---|---|---|
| MS-2 | | 2.5 | 4.0 | 11:51 | NNW |

NON-PROPERTY LINE MONITOR

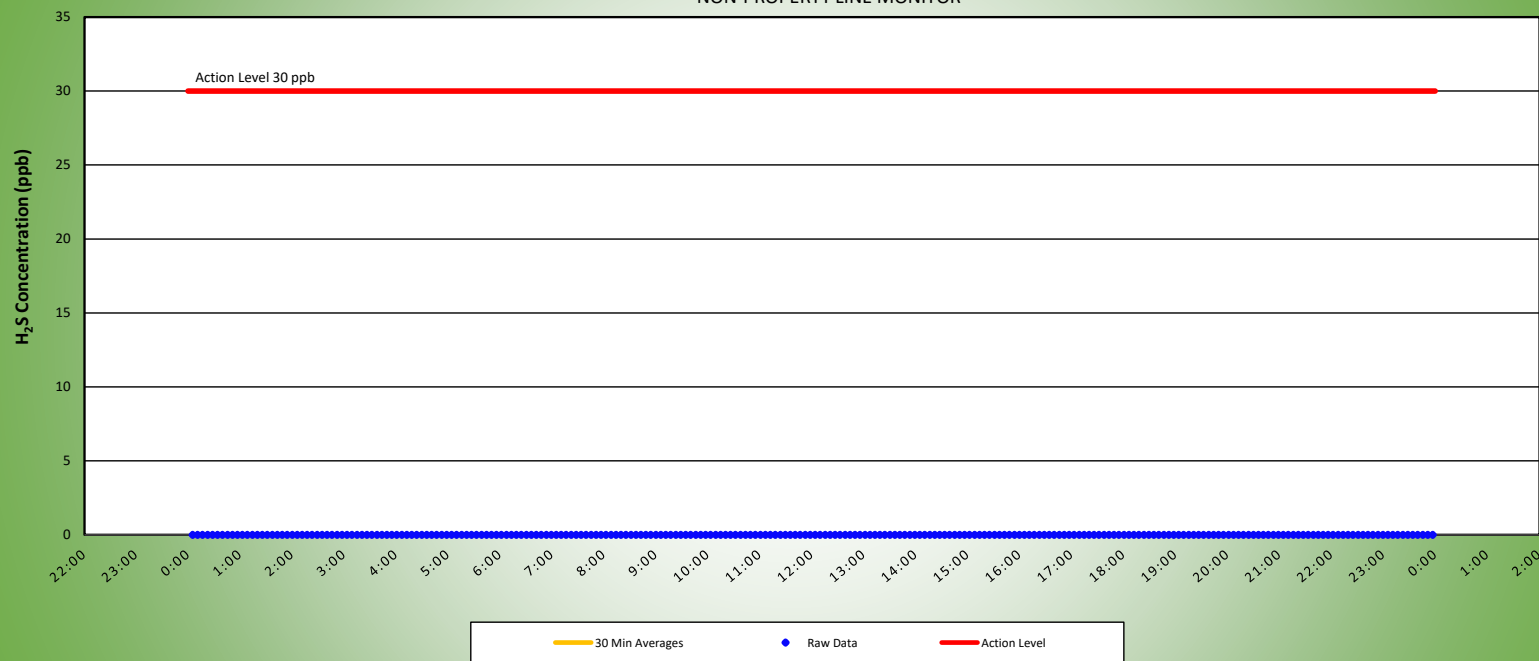
### MS3 H2S MONITORING RESULTS - 01/27/21

| Station Location Area | Work | Daily Avg. 30 Min H <sub>2</sub> S Concentration (ppb) | Max 30 Min H <sub>2</sub> S Concentration (ppb) | Time of Max 30 Min H <sub>2</sub> S Reading | Corresponding Wind Direction |
|---|---|---|---|---|---|
| MS-3 | | 0.0 | 0.0 | 0:05 | NNE |

NON-PROPERTY LINE MONITOR

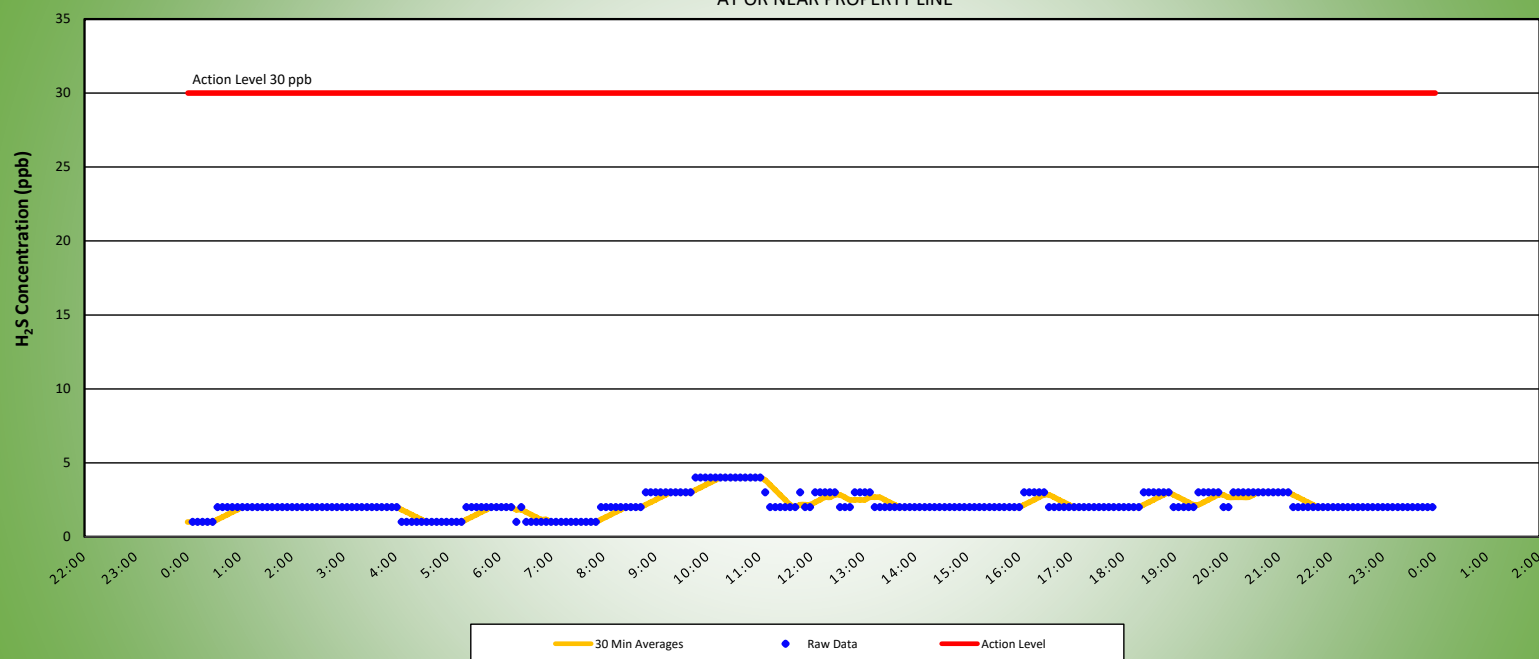
# MS4 H2S MONITORING RESULTS - 01/27/21

| Station Location Area | Work | Daily Avg. 30 Min H <sub>2</sub> S Concentration (ppb) | Max 30 Min H <sub>2</sub> S Concentration (ppb) | Time of Max 30 Min H <sub>2</sub> S Reading | Corresponding Wind Direction |
|---|---|---|---|---|---|
| MS-4 | | 2.2 | 4.0 | 10:14 | WNW |

AT OR NEAR PROPERTY LINE

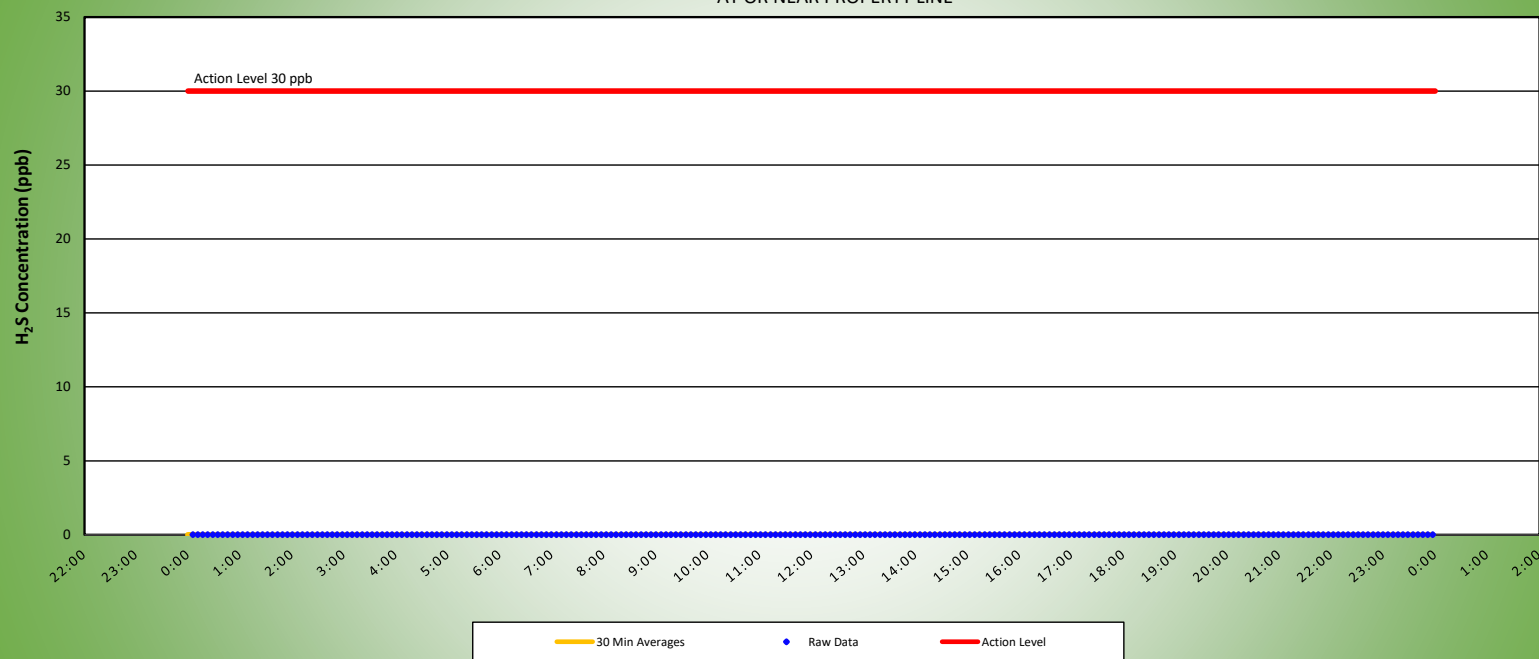
# MS5 H2S MONITORING RESULTS - 01/27/21

| Station Location Area | Work | Daily Avg. 30 Min H <sub>2</sub> S Concentration (ppb) | Max 30 Min H <sub>2</sub> S Concentration (ppb) | Time of Max 30 Min H <sub>2</sub> S Reading | Corresponding Wind Direction |
|---|---|---|---|---|---|
| MS-5 | | 0.0 | 0.0 | 23:59 | NNE |

AT OR NEAR PROPERTY LINE

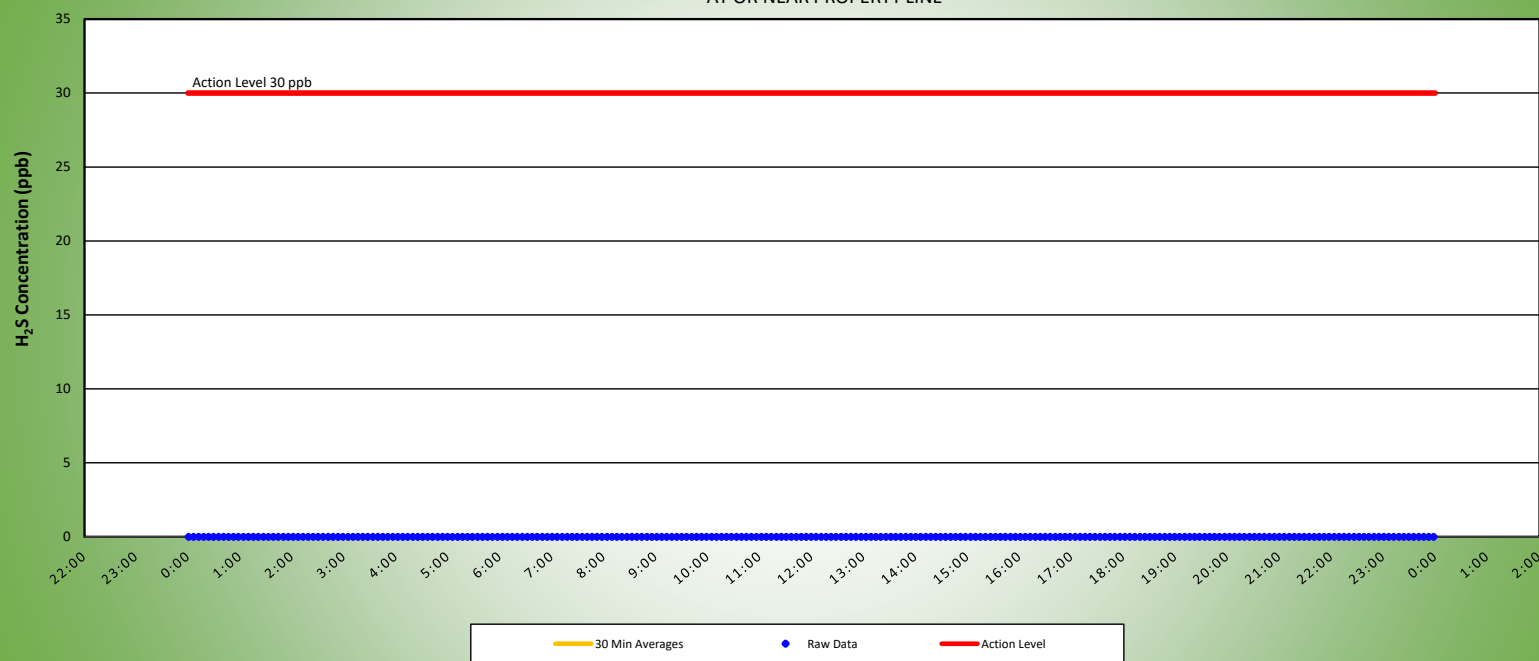
# MS6 H2S MONITORING RESULTS - 01/27/21

| Station Location Area | Work | Daily Avg. 30 Min H <sub>2</sub> S Concentration (ppb) | Max 30 Min H <sub>2</sub> S Concentration (ppb) | Time of Max 30 Min H <sub>2</sub> S Reading | Corresponding Wind Direction |
|---|---|---|---|---|---|
| MS-6 | | 0.0 | 0.0 | 0:00 | N |

AT OR NEAR PROPERTY LINE

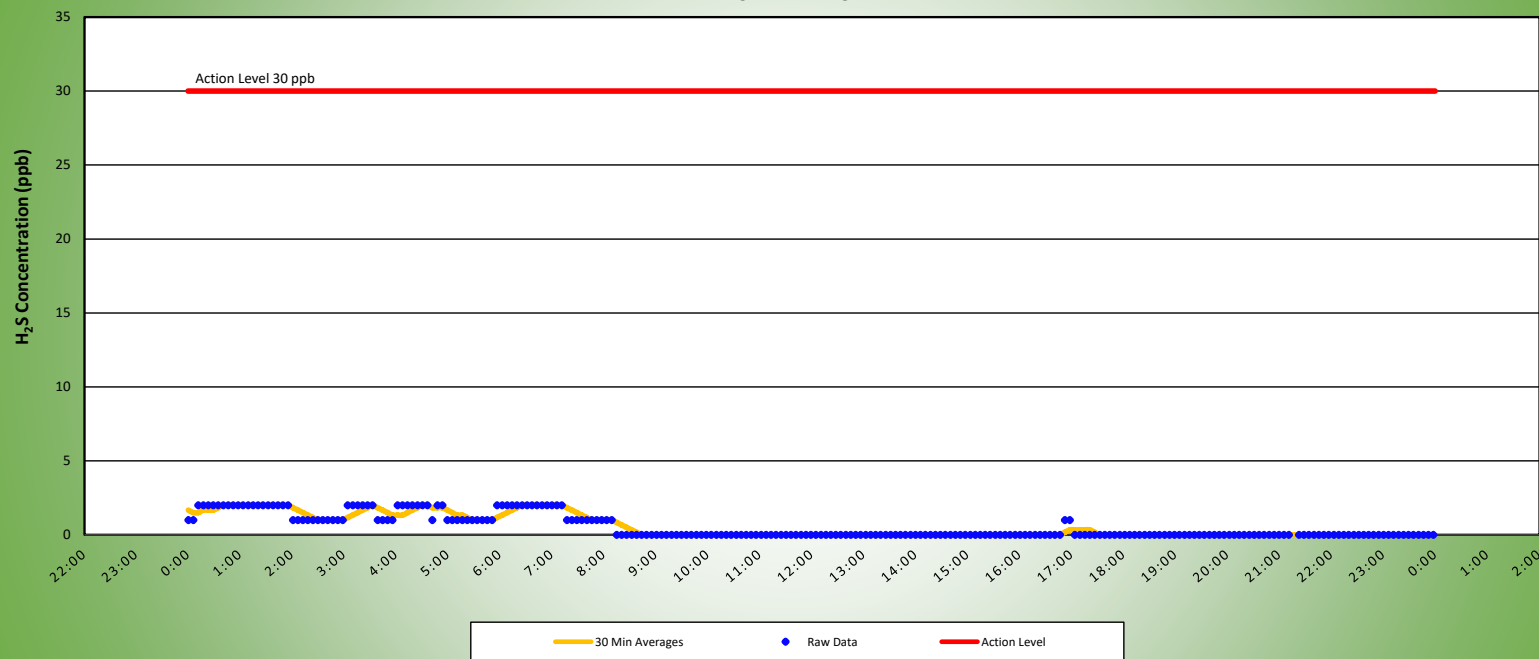
# MS7 H2S MONITORING RESULTS - 01/27/21

| Station Location Area | Work | Daily Avg. 30 Min H <sub>2</sub> S Concentration (ppb) | Max 30 Min H <sub>2</sub> S Concentration (ppb) | Time of Max 30 Min H <sub>2</sub> S Reading | Corresponding Wind Direction |
|---|---|---|---|---|---|
| MS-7 | | 0.6 | 2.0 | 0:40 | W |

AT OR NEAR PROPERTY LINE

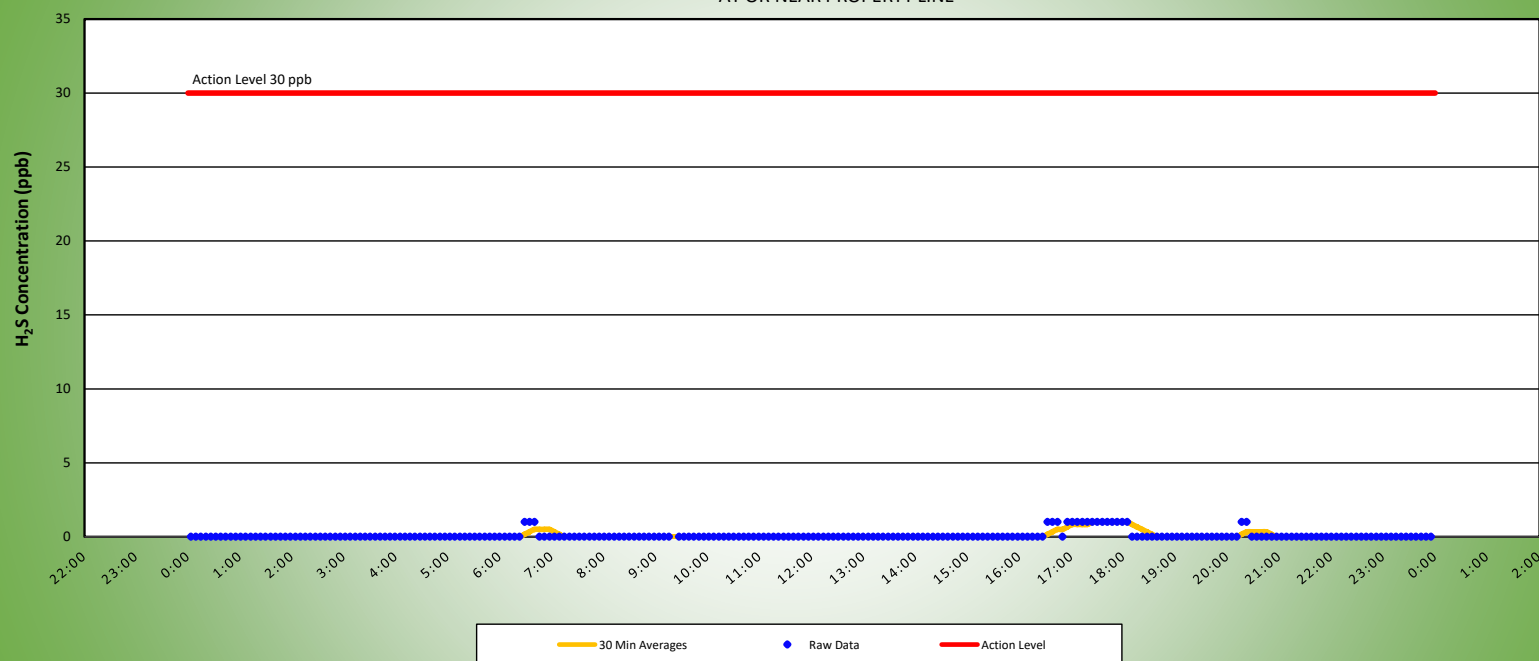
# MS8 H2S MONITORING RESULTS - 01/27/21

| Station Location Area | Work | Daily Avg. 30 Min H <sub>2</sub> S Concentration (ppb) | Max 30 Min H <sub>2</sub> S Concentration (ppb) | Time of Max 30 Min H <sub>2</sub> S Reading | Corresponding Wind Direction |
|---|---|---|---|---|---|
| MS-8 | | 0.1 | 1.0 | 17:24 | NNW |

AT OR NEAR PROPERTY LINE
