| <b>Keegan Landfill Monitoring Project</b><br><br> | <b>DAILY AIR MONITORING REPORT</b><br><b>NON-PROPERTY LINE</b><br><b>Keegan Landfill Monitoring Stations</b><br><b>Kearny, New Jersey</b> | | | | 03/27/22 | |

| <b>Keegan Landfill Monitoring Project</b><br><br> | <b>DAILY AIR MONITORING REPORT<br/>AT OR NEAR PROPERTY LINE<br/>Keegan Landfill Monitoring Stations<br/>Kearny, New Jersey</b> | 03/27/22 | |

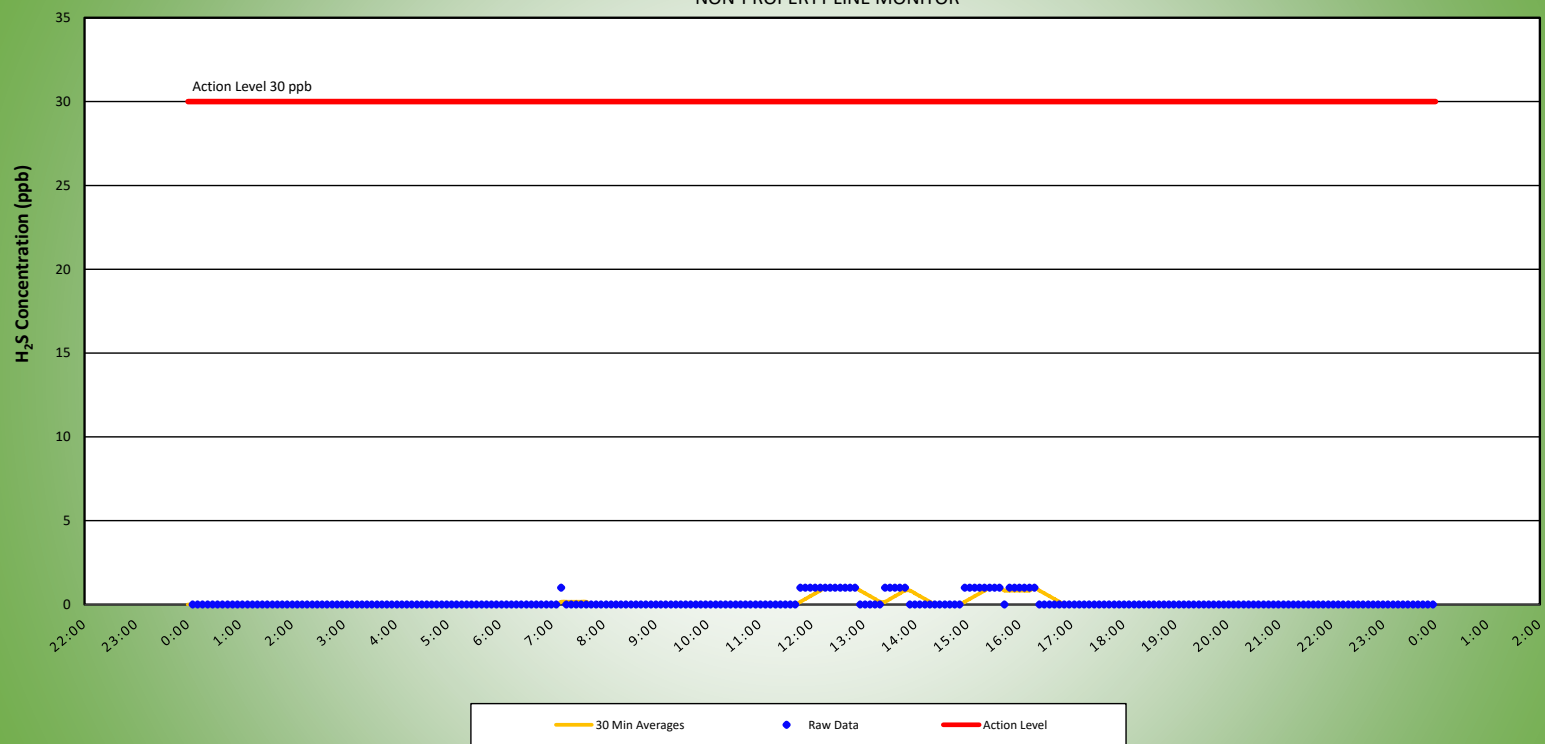
# MS1 H2S MONITORING RESULTS - 03/27/22

| Station Location Area | Work | Daily Avg. 30 Min H <sub>2</sub> S Concentration (ppb) | Max 30 Min H <sub>2</sub> S Concentration (ppb) | Time of Max 30 Min H <sub>2</sub> S Reading | Corresponding Wind Direction |
|---|---|---|---|---|---|
| MS-1 | | 0.1 | 1.0 | 12:15 | WSW |

NON-PROPERTY LINE MONITOR

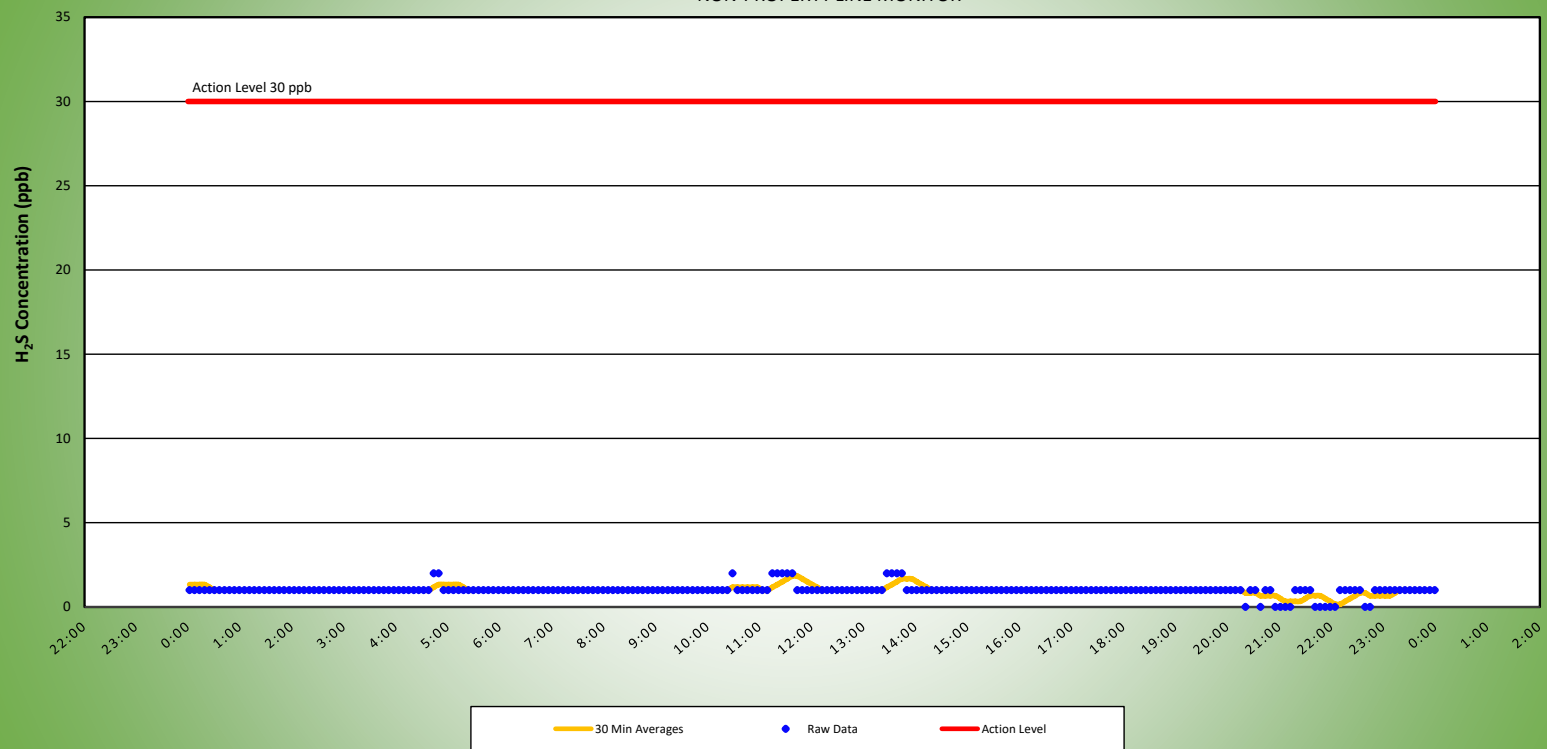
# MS2 H2S MONITORING RESULTS - 03/27/22

| Station Location Area | Work | Daily Avg. 30 Min H <sub>2</sub> S Concentration (ppb) | Max 30 Min H <sub>2</sub> S Concentration (ppb) | Time of Max 30 Min H <sub>2</sub> S Reading | Corresponding Wind Direction |
|---|---|---|---|---|---|
| MS-2 | | 1.0 | 1.8 | 11:37 | WNW |

NON-PROPERTY LINE MONITOR

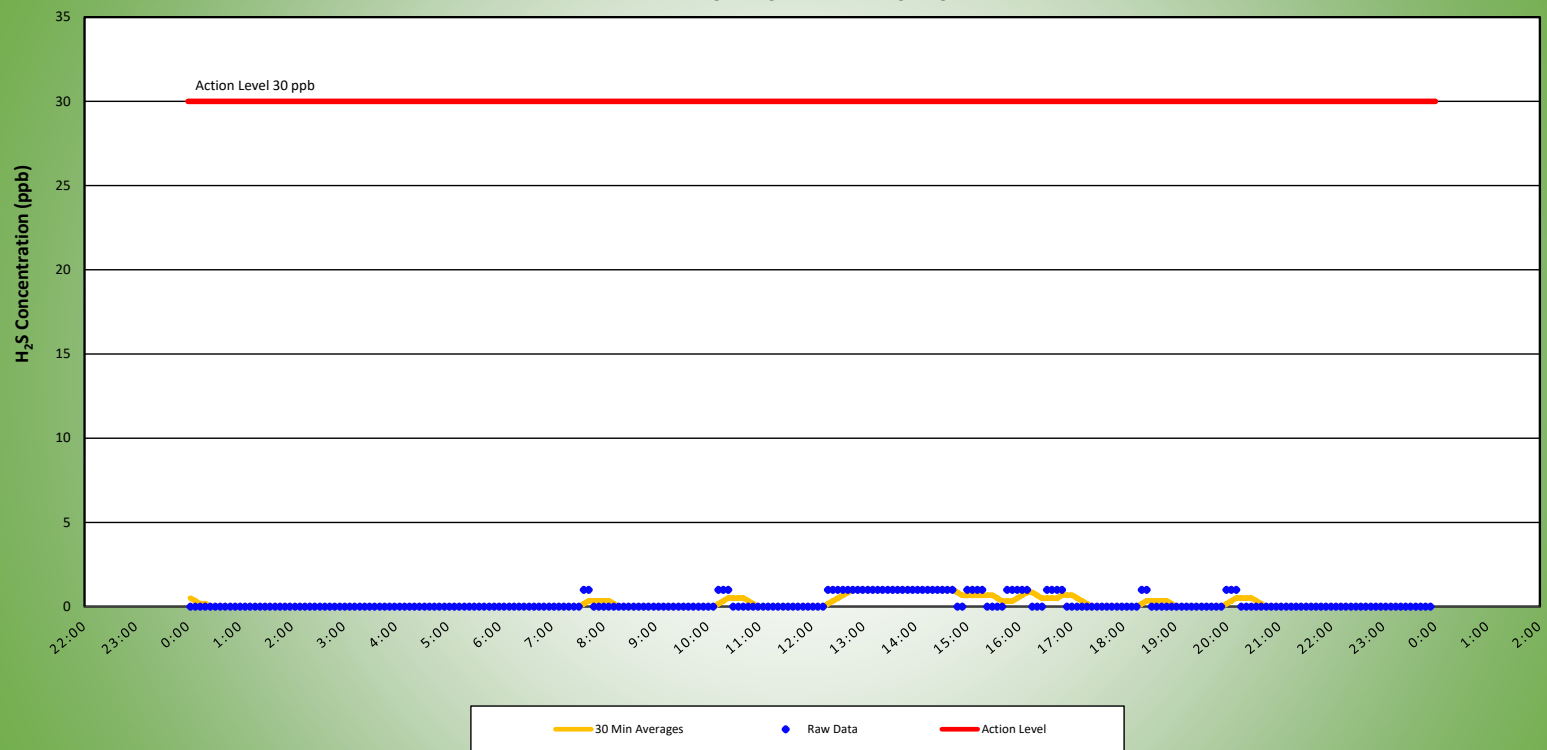
# MS3 H2S MONITORING RESULTS - 03/27/22

| Station Location Area | Work | Daily Avg. 30 Min H <sub>2</sub> S Concentration (ppb) | Max 30 Min H <sub>2</sub> S Concentration (ppb) | Time of Max 30 Min H <sub>2</sub> S Reading | Corresponding Wind Direction |
|---|---|---|---|---|---|
| MS-3 | | 0.2 | 1.0 | 12:47 | SW |

NON-PROPERTY LINE MONITOR

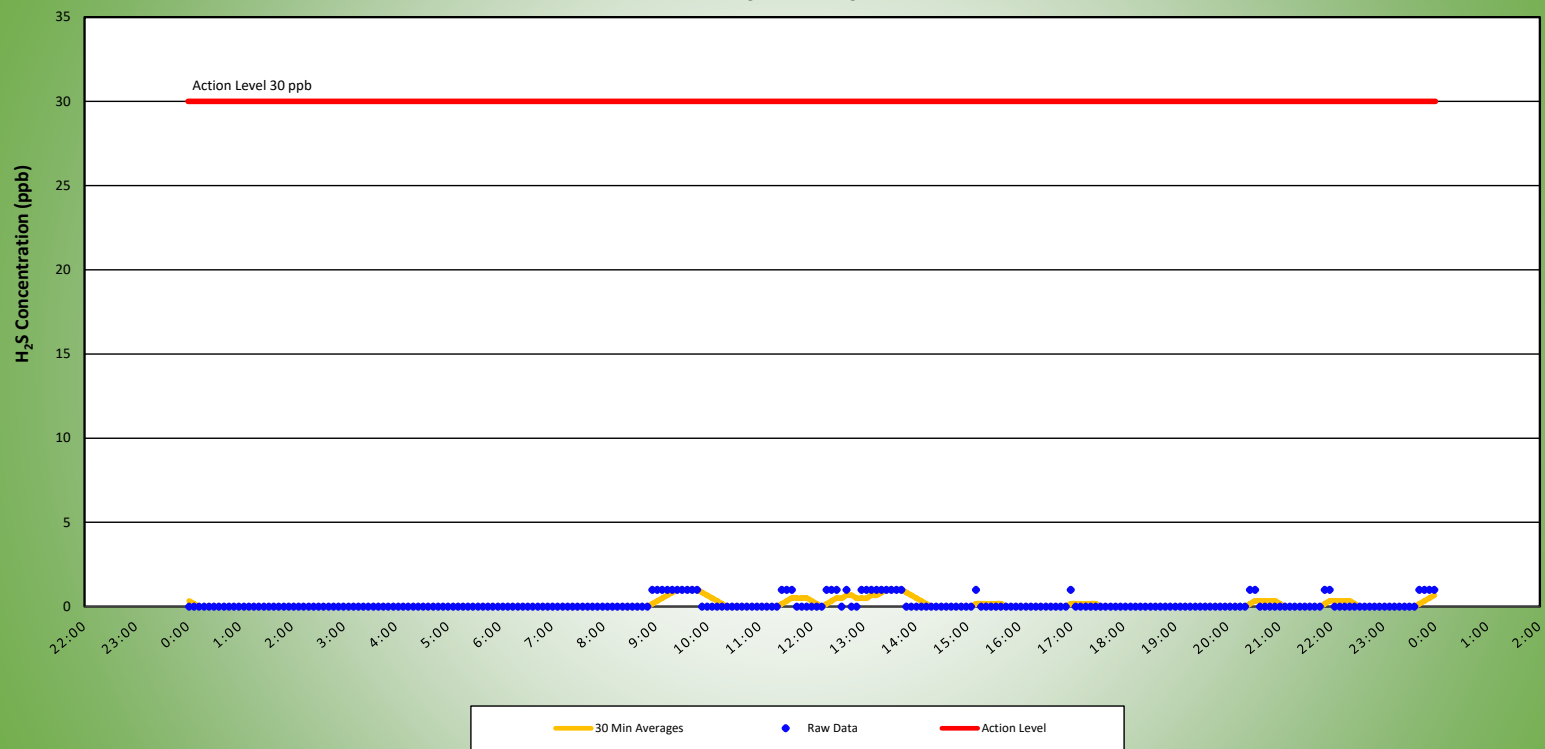
# MS4 H2S MONITORING RESULTS - 03/27/22

| Station Location Area | Work | Daily Avg. 30 Min H <sub>2</sub> S Concentration (ppb) | Max 30 Min H <sub>2</sub> S Concentration (ppb) | Time of Max 30 Min H <sub>2</sub> S Reading | Corresponding Wind Direction |
|---|---|---|---|---|---|
| MS-4 | | 0.1 | 1.0 | 9:24 | WNW |

AT OR NEAR PROPERTY LINE

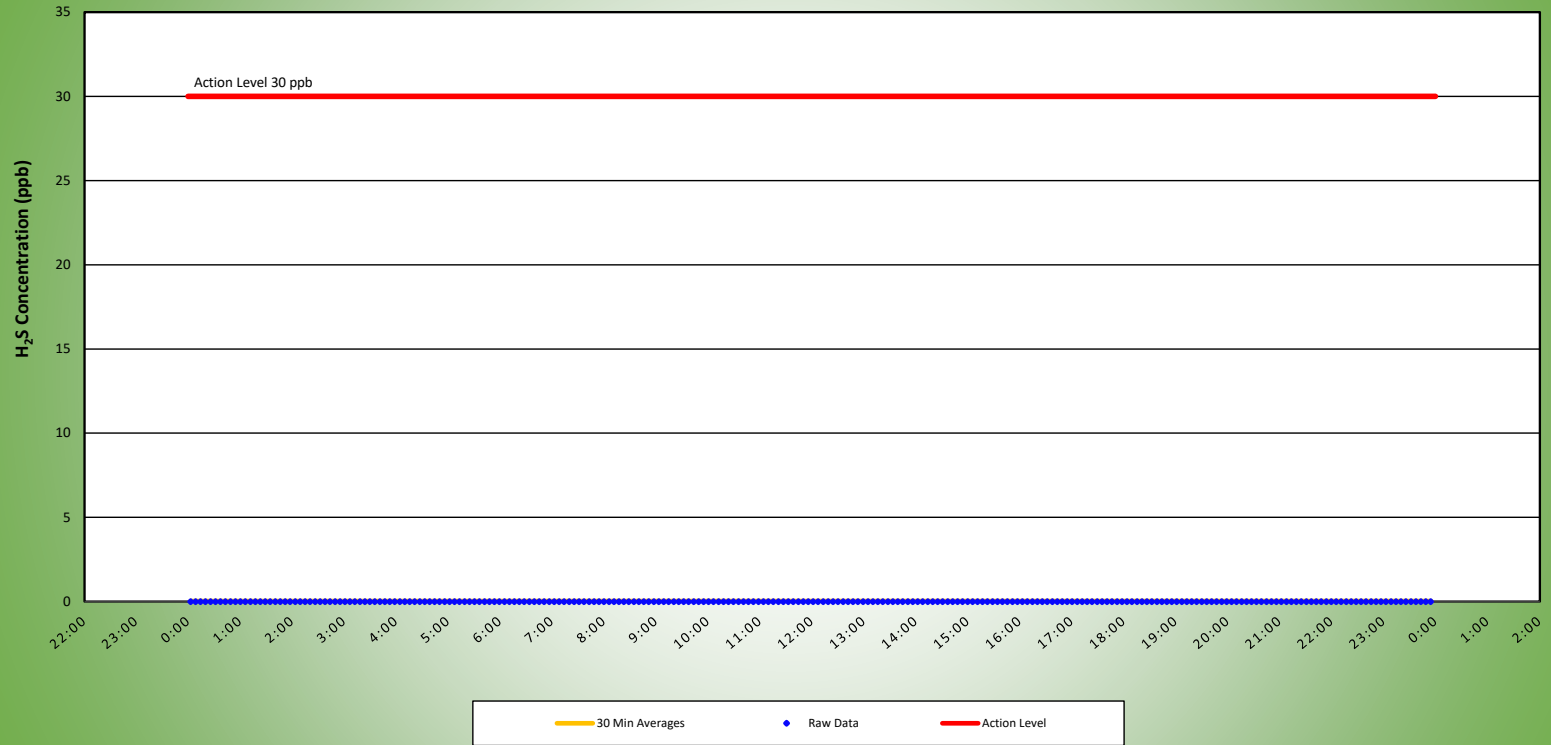
# MS5 H2S MONITORING RESULTS - 03/27/22

| Station Location Area | Work | Daily Avg. 30 Min H <sub>2</sub> S Concentration (ppb) | Max 30 Min H <sub>2</sub> S Concentration (ppb) | Time of Max 30 Min H <sub>2</sub> S Reading | Corresponding Wind Direction |
|---|---|---|---|---|---|
| MS-5 | | 0.0 | 0.0 | 0:03 | W |

AT OR NEAR PROPERTY LINE

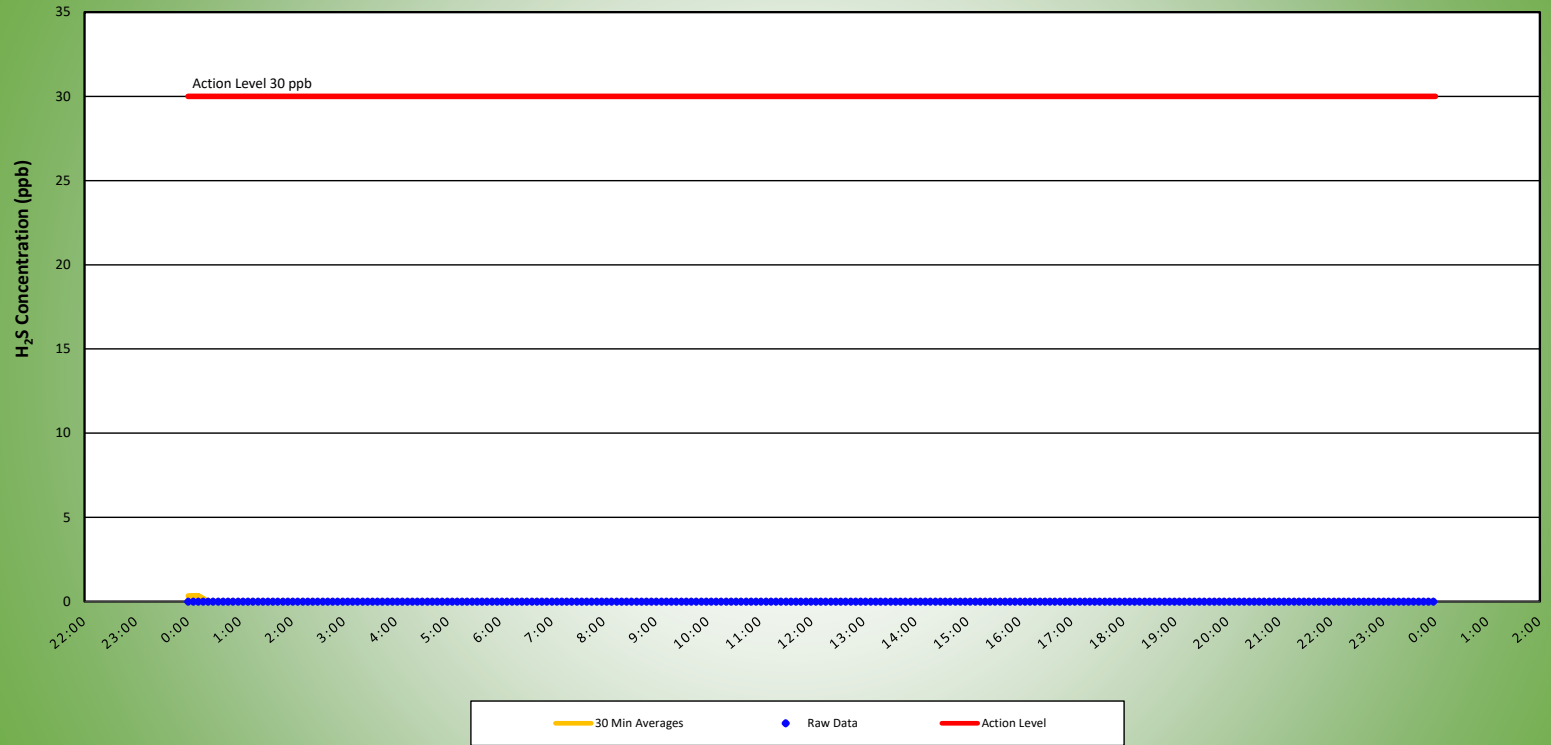
# MS6 H2S MONITORING RESULTS - 03/27/22

| Station Location Area | Work | Daily Avg. 30 Min H <sub>2</sub> S Concentration (ppb) | Max 30 Min H <sub>2</sub> S Concentration (ppb) | Time of Max 30 Min H <sub>2</sub> S Reading | Corresponding Wind Direction |
|---|---|---|---|---|---|
| MS-6 | | 0.0 | 0.3 | 0:00 | WNW |

AT OR NEAR PROPERTY LINE

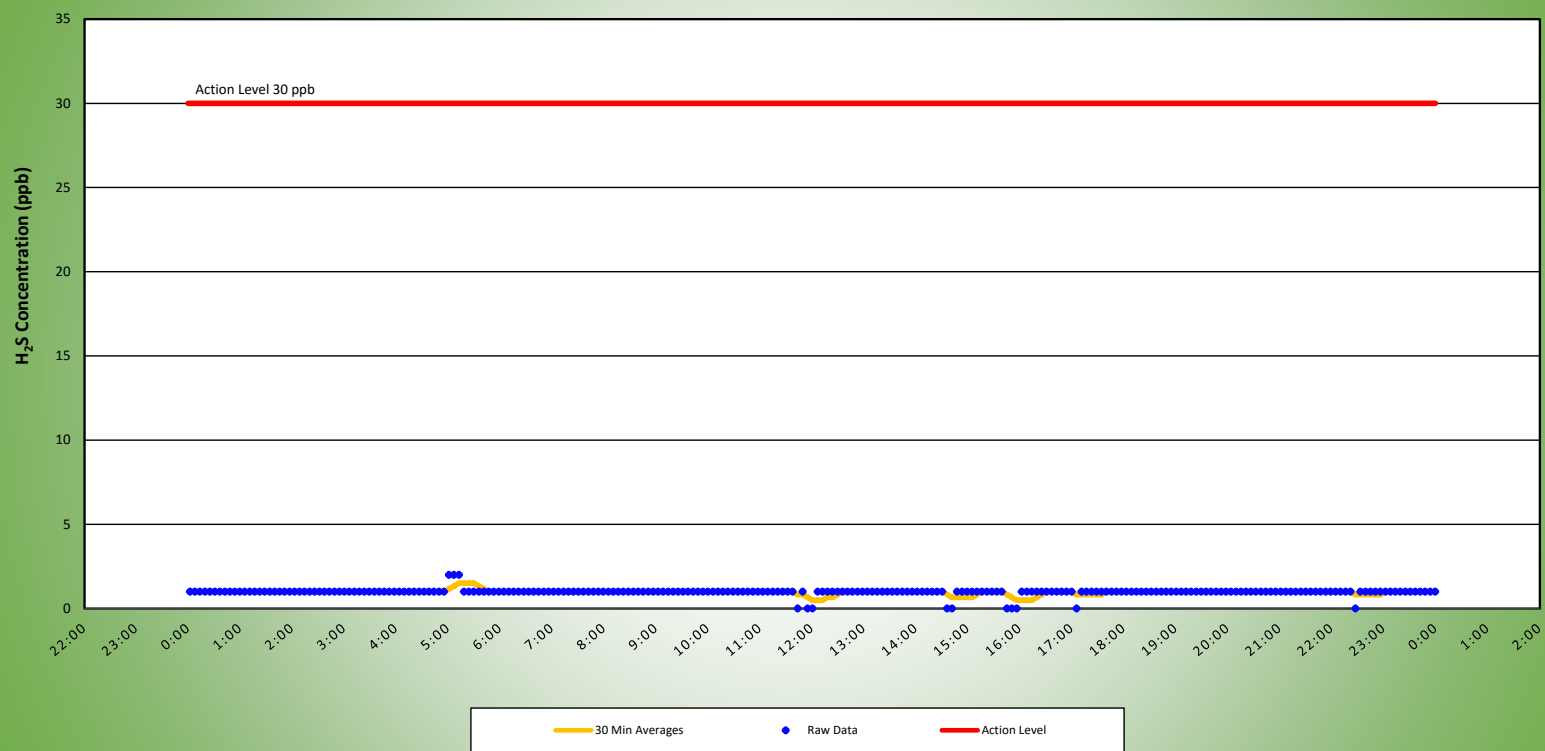
# MS7 H2S MONITORING RESULTS - 03/27/22

| Station Location Area | Work | Daily Avg. 30 Min H <sub>2</sub> S Concentration (ppb) | Max 30 Min H <sub>2</sub> S Concentration (ppb) | Time of Max 30 Min H <sub>2</sub> S Reading | Corresponding Wind Direction |
|---|---|---|---|---|---|
| MS-7 | | 1.0 | 1.5 | 5:12 | S |

AT OR NEAR PROPERTY LINE

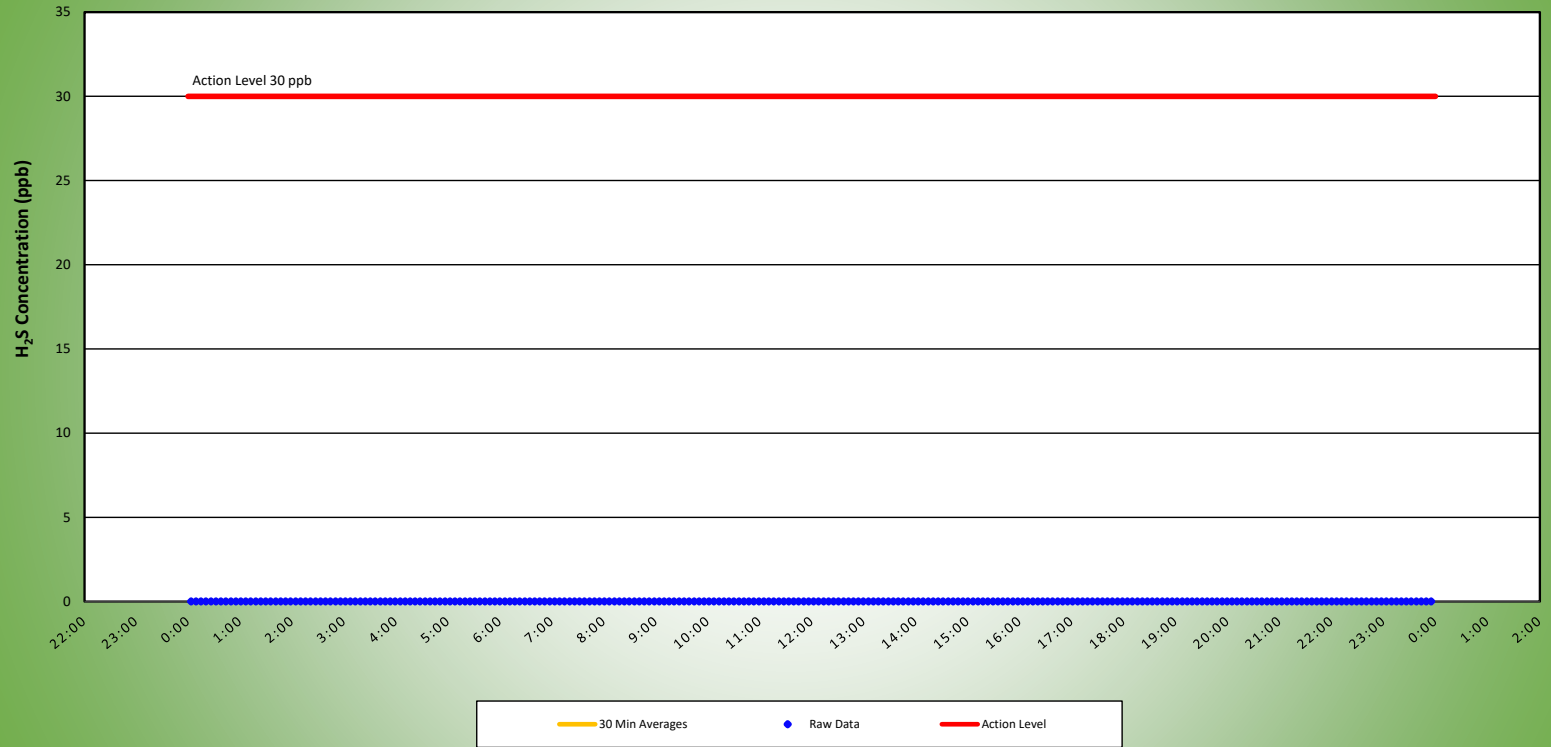
# MS8 H2S MONITORING RESULTS - 03/27/22

| Station Location Area | Work | Daily Avg. 30 Min H <sub>2</sub> S Concentration (ppb) | Max 30 Min H <sub>2</sub> S Concentration (ppb) | Time of Max 30 Min H <sub>2</sub> S Reading | Corresponding Wind Direction |
|---|---|---|---|---|---|
| MS-8 | | 0.0 | 0.0 | 0:03 | W |

AT OR NEAR PROPERTY LINE
