| <b>Keegan Landfill Monitoring Project</b><br><br> | <b>DAILY AIR MONITORING REPORT</b><br><b>NON-PROPERTY LINE</b><br><b>Keegan Landfill Monitoring Stations</b><br><b>Kearny, New Jersey</b> | | | | 01/20/23 | |

| <b>Keegan Landfill Monitoring Project</b><br><br> | <b>DAILY AIR MONITORING REPORT<br/>AT OR NEAR PROPERTY LINE<br/>Keegan Landfill Monitoring Stations<br/>Kearny, New Jersey</b> | 01/20/23 | |

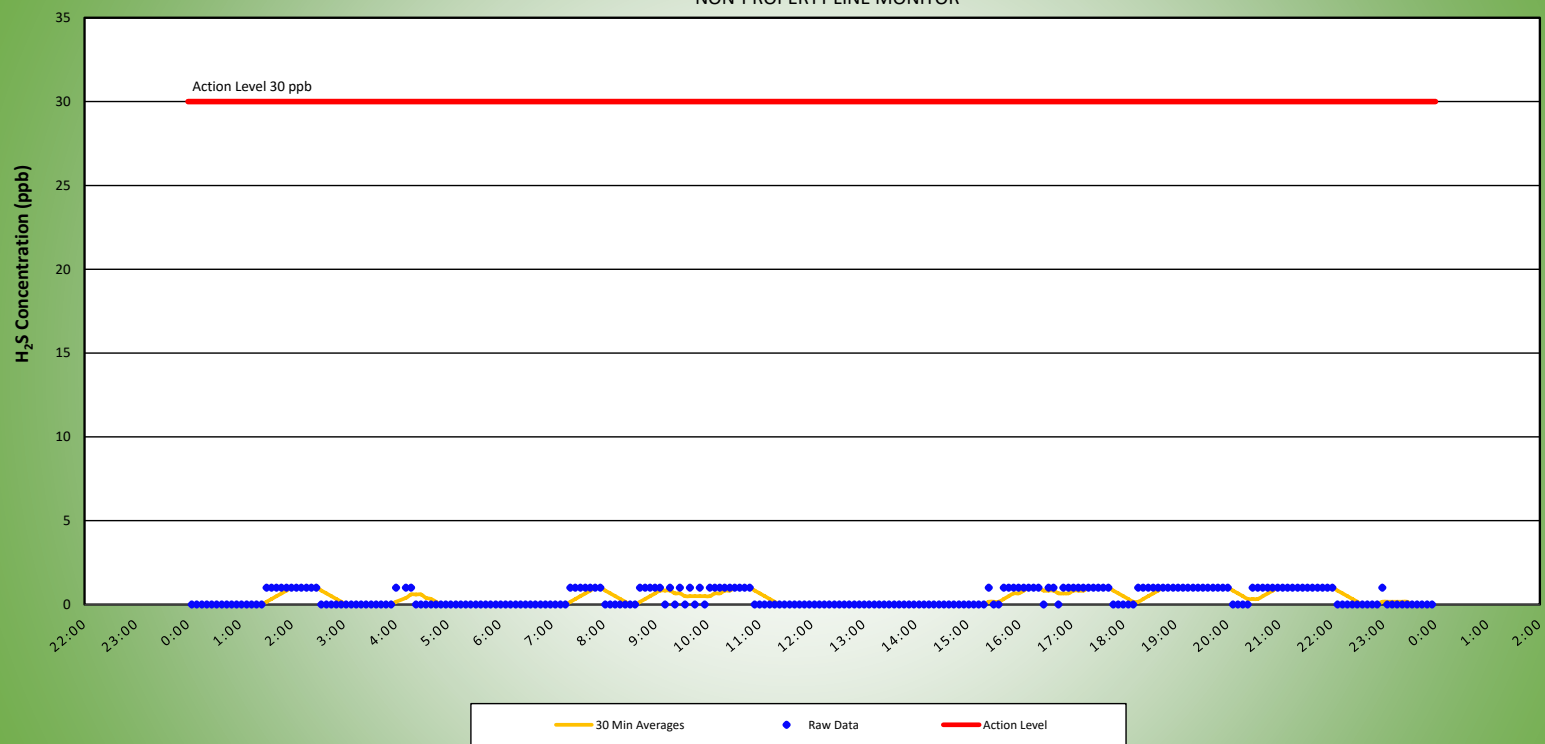
# MS1 H2S MONITORING RESULTS - 01/20/23

| Station Location Area | Work | Daily Avg. 30 Min H <sub>2</sub> S Concentration (ppb) | Max 30 Min H <sub>2</sub> S Concentration (ppb) | Time of Max 30 Min H <sub>2</sub> S Reading | Corresponding Wind Direction |
|---|---|---|---|---|---|
| MS-1 | | 0.4 | 1.0 | 1:59 | W |

NON-PROPERTY LINE MONITOR

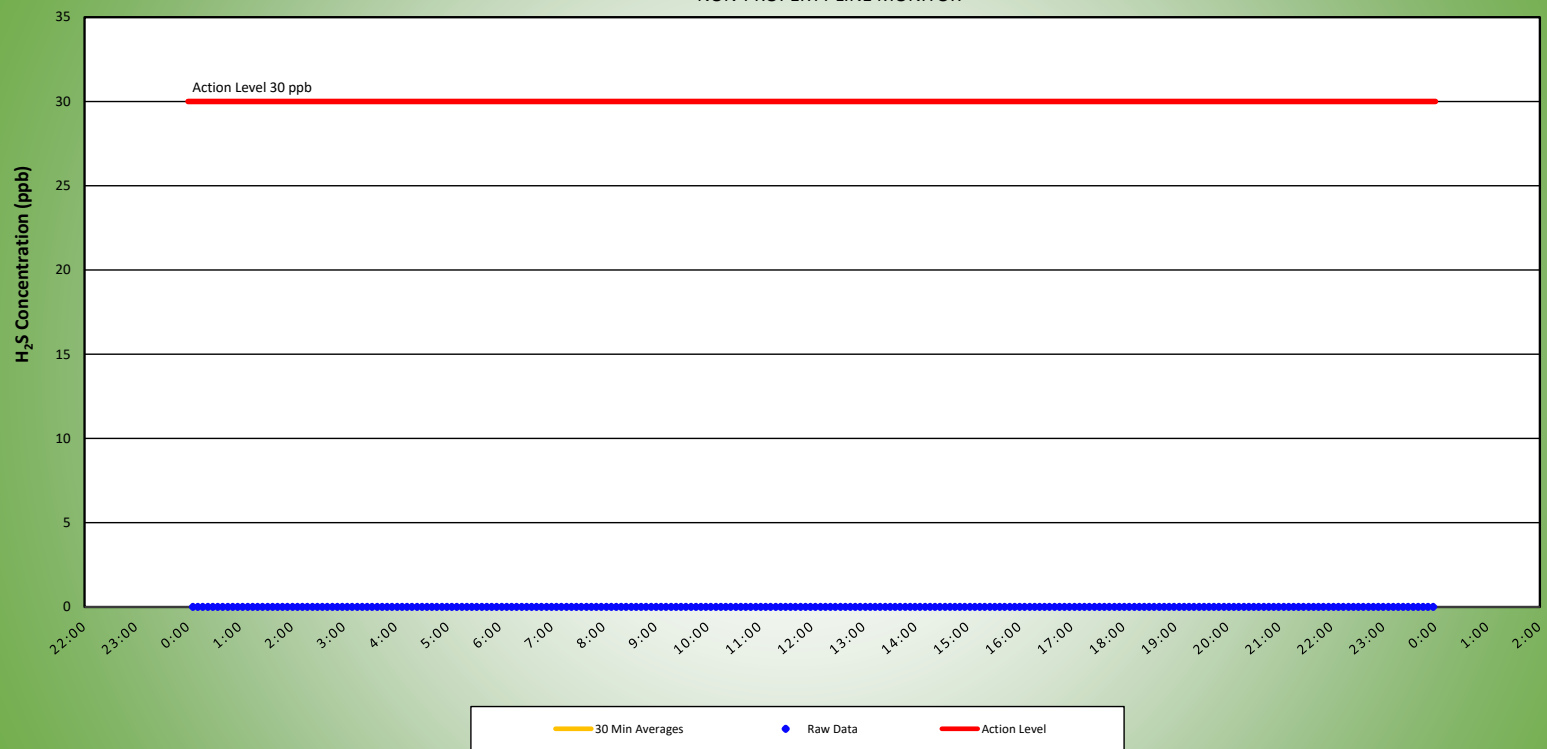
# MS2 H2S MONITORING RESULTS - 01/20/23

| Station Location Area | Work | Daily Avg. 30 Min H <sub>2</sub> S Concentration (ppb) | Max 30 Min H <sub>2</sub> S Concentration (ppb) | Time of Max 30 Min H <sub>2</sub> S Reading | Corresponding Wind Direction |
|---|---|---|---|---|---|
| MS-2 | | 0.0 | 0.0 | 0:05 | NNW |

NON-PROPERTY LINE MONITOR

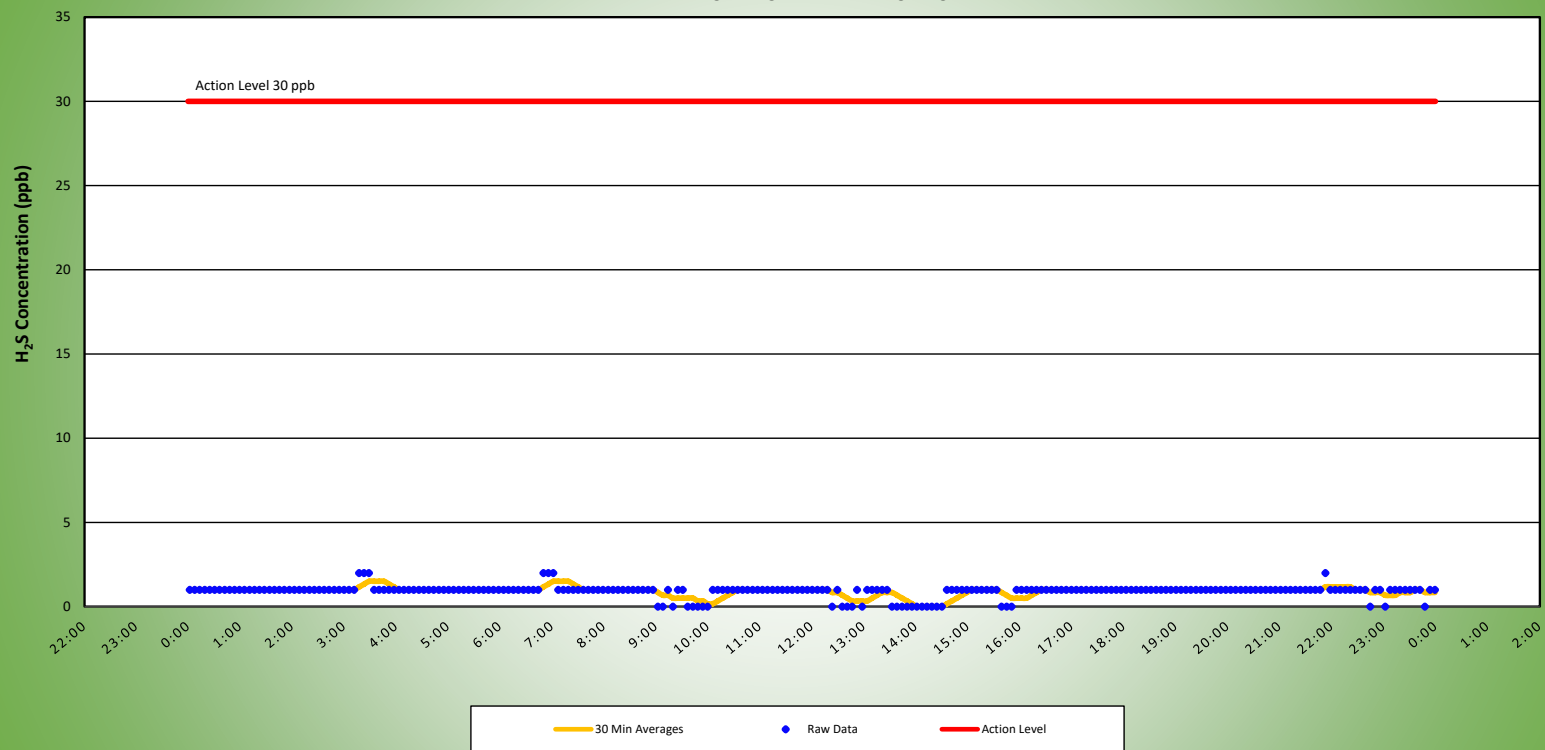
# MS3 H2S MONITORING RESULTS - 01/20/23

| Station Location Area | Work | Daily Avg. 30 Min H <sub>2</sub> S Concentration (ppb) | Max 30 Min H <sub>2</sub> S Concentration (ppb) | Time of Max 30 Min H <sub>2</sub> S Reading | Corresponding Wind Direction |
|---|---|---|---|---|---|
| MS-3 | | 0.9 | 1.5 | 3:29 | NNW |

NON-PROPERTY LINE MONITOR

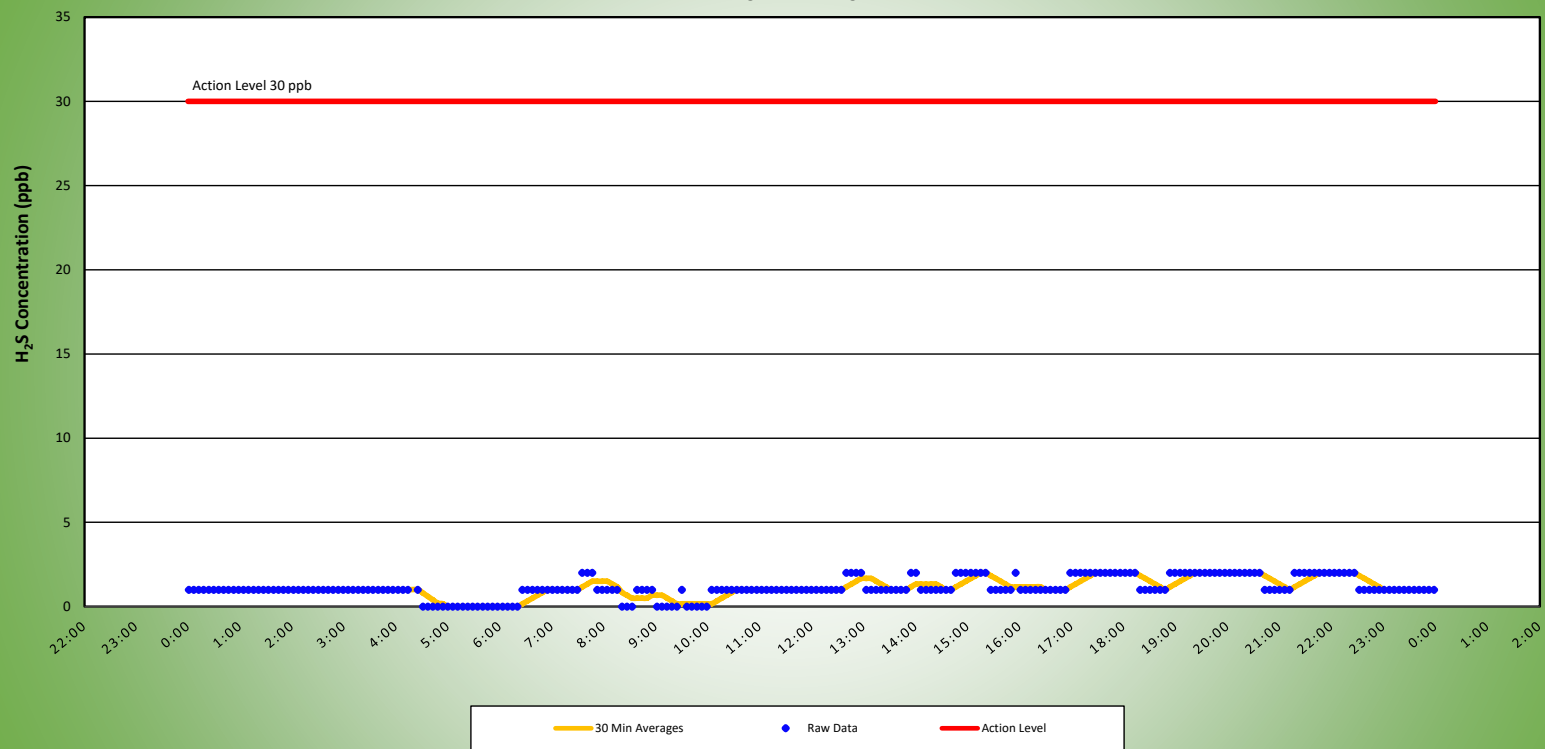
# MS4 H2S MONITORING RESULTS - 01/20/23

| Station Location Area | Work | Daily Avg. 30 Min H <sub>2</sub> S Concentration (ppb) | Max 30 Min H <sub>2</sub> S Concentration (ppb) | Time of Max 30 Min H <sub>2</sub> S Reading | Corresponding Wind Direction |
|---|---|---|---|---|---|
| MS-4 | | 1.1 | 2.0 | 15:15 | WSW |

AT OR NEAR PROPERTY LINE

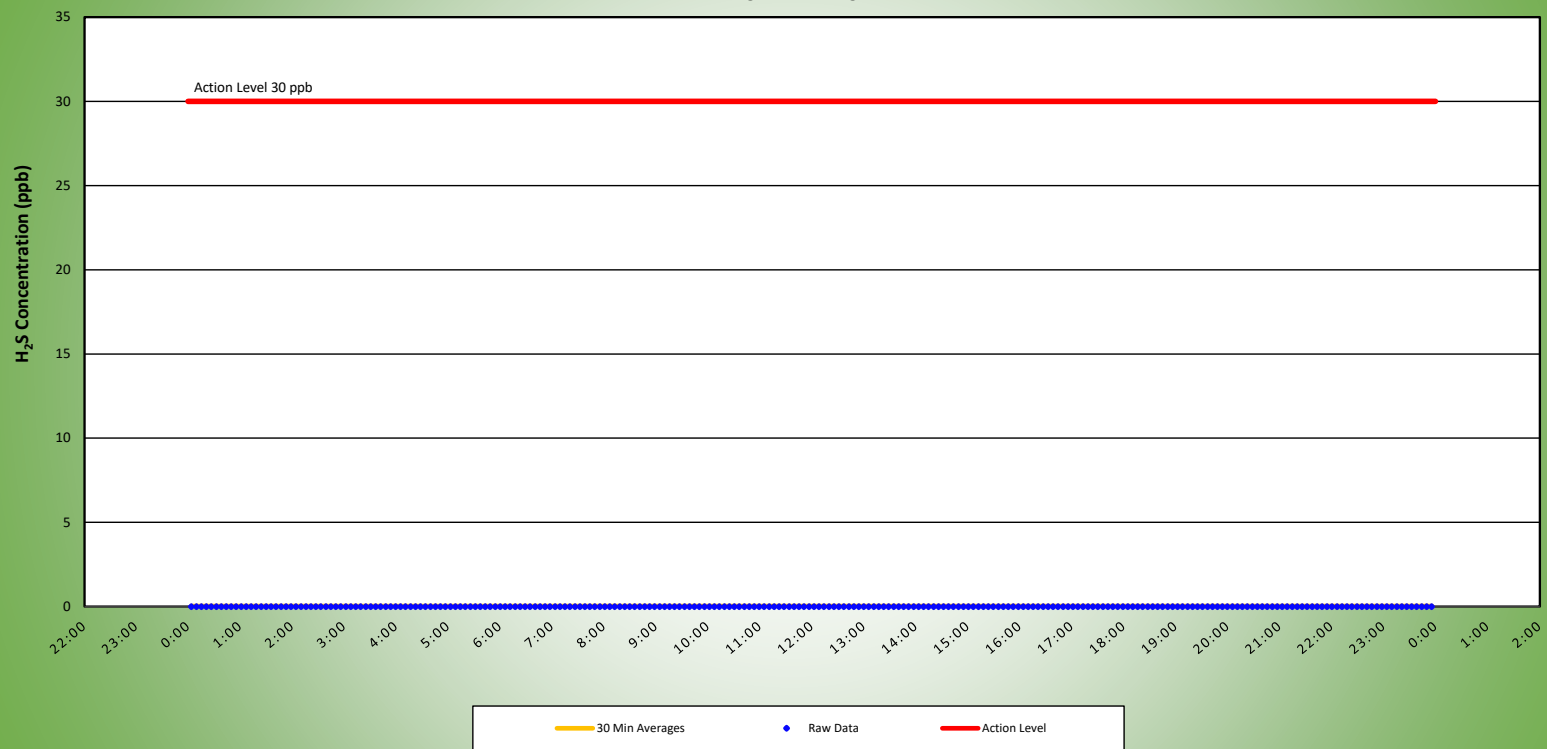
# MS5 H2S MONITORING RESULTS - 01/20/23

| Station Location Area | Work | Daily Avg. 30 Min H <sub>2</sub> S Concentration (ppb) | Max 30 Min H <sub>2</sub> S Concentration (ppb) | Time of Max 30 Min H <sub>2</sub> S Reading | Corresponding Wind Direction |
|---|---|---|---|---|---|
| MS-5 | | 0.0 | 0.0 | 0:03 | NNW |

AT OR NEAR PROPERTY LINE

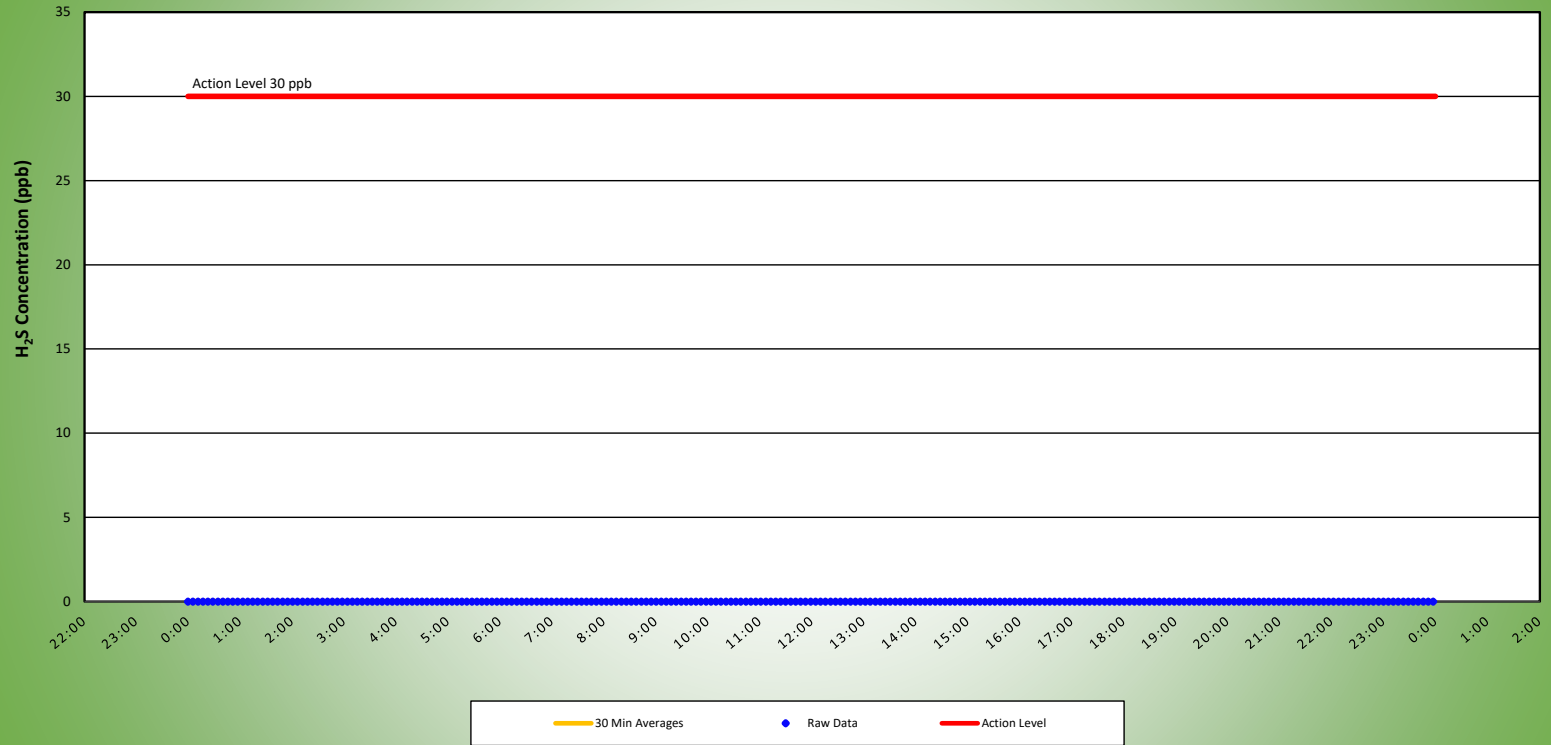
# MS6 H2S MONITORING RESULTS - 01/20/23

| Station Location Area | Work | Daily Avg. 30 Min H <sub>2</sub> S Concentration (ppb) | Max 30 Min H <sub>2</sub> S Concentration (ppb) | Time of Max 30 Min H <sub>2</sub> S Reading | Corresponding Wind Direction |
|---|---|---|---|---|---|
| MS-6 | | 0.0 | 0.0 | 0:05 | NNW |

AT OR NEAR PROPERTY LINE

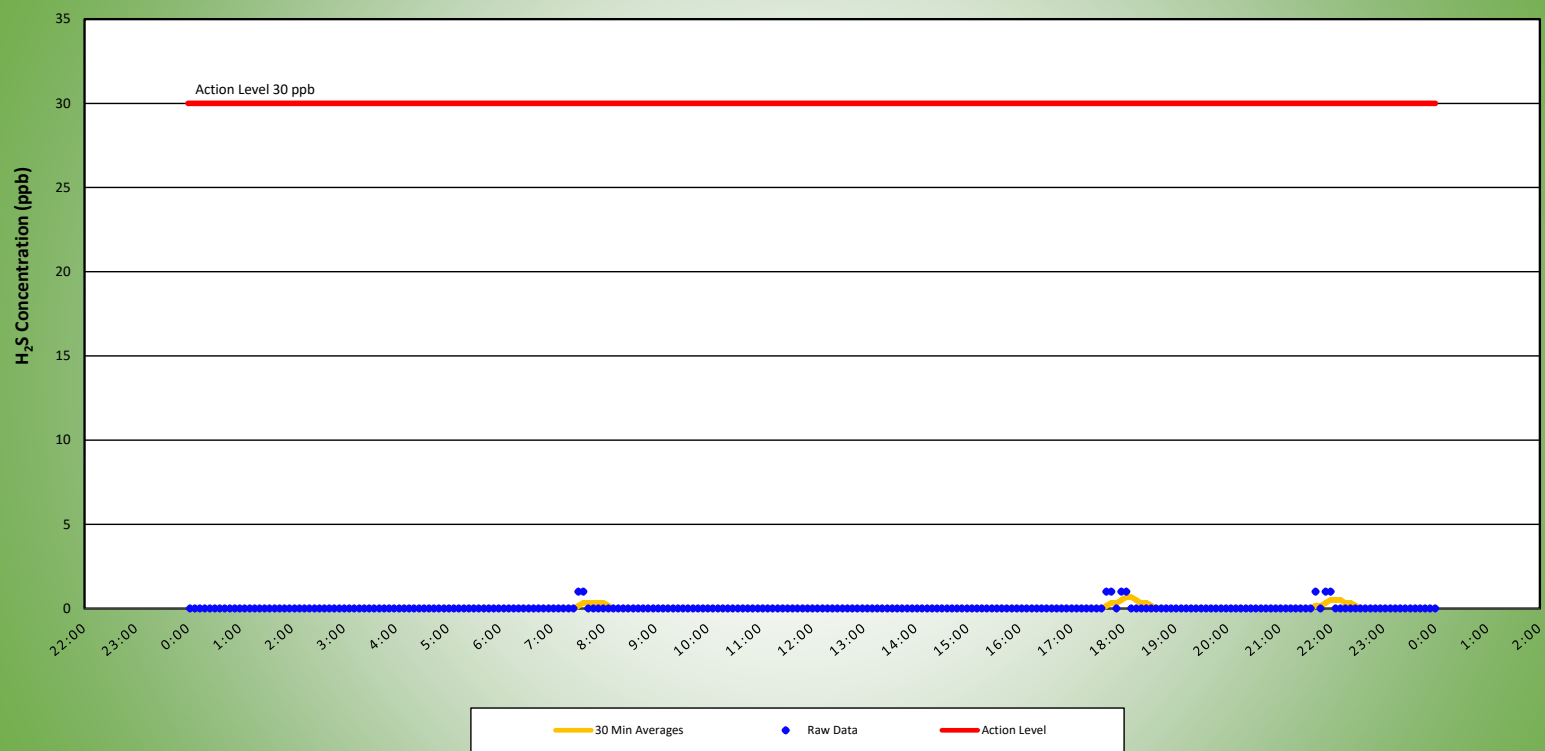
# MS7 H2S MONITORING RESULTS - 01/20/23

| Station Location Area | Work | Daily Avg. 30 Min H <sub>2</sub> S Concentration (ppb) | Max 30 Min H <sub>2</sub> S Concentration (ppb) | Time of Max 30 Min H <sub>2</sub> S Reading | Corresponding Wind Direction |
|---|---|---|---|---|---|
| MS-7 | | 0.0 | 0.7 | 18:03 | SSW |

AT OR NEAR PROPERTY LINE

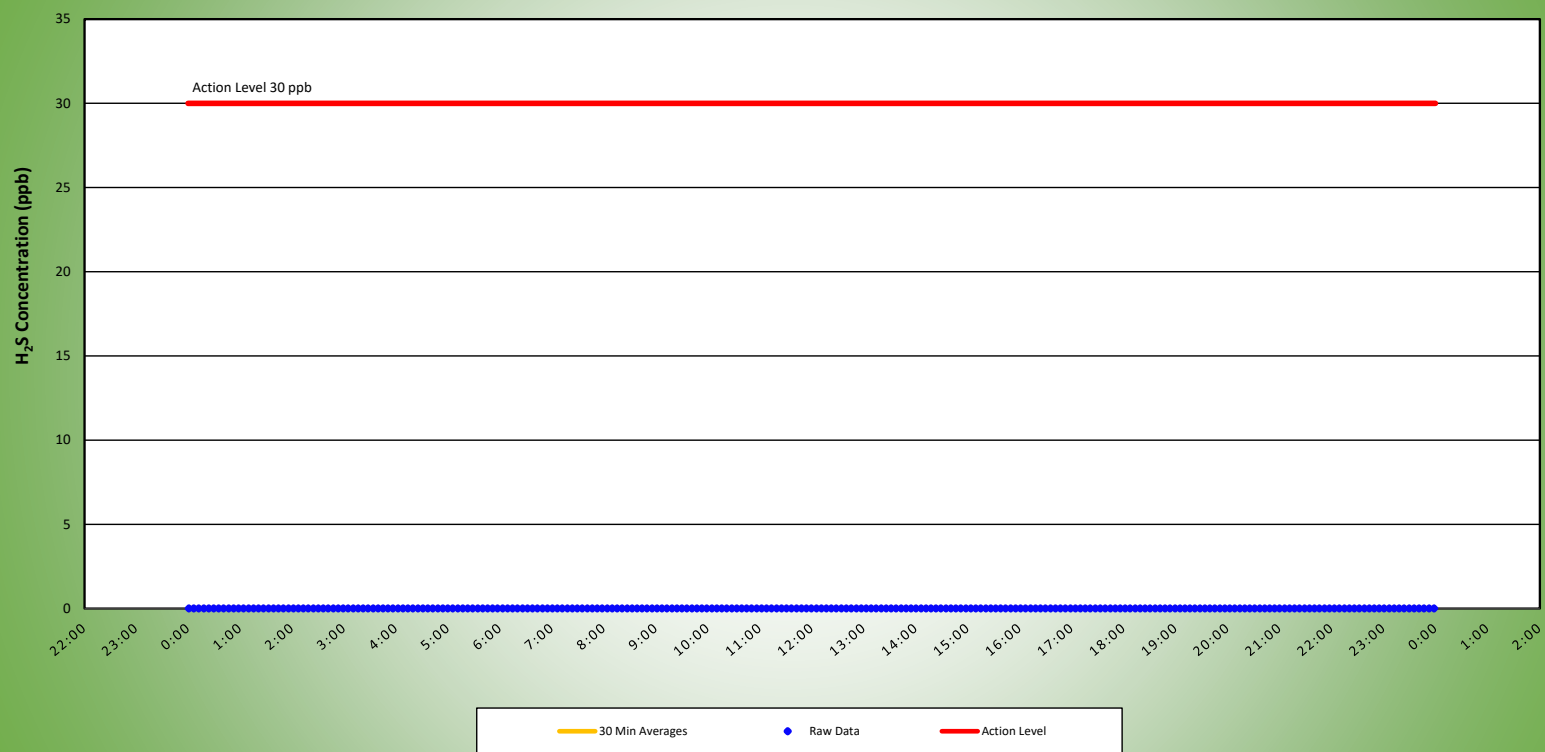
# MS8 H2S MONITORING RESULTS - 01/20/23

| Station Location Area | Work | Daily Avg. 30 Min H <sub>2</sub> S Concentration (ppb) | Max 30 Min H <sub>2</sub> S Concentration (ppb) | Time of Max 30 Min H <sub>2</sub> S Reading | Corresponding Wind Direction |
|---|---|---|---|---|---|
| MS-8 | | 0.0 | 0.0 | 0:01 | NNE |

AT OR NEAR PROPERTY LINE
