| <b>Keegan Landfill Monitoring Project</b><br><br> | <b>DAILY AIR MONITORING REPORT</b><br><b>NON-PROPERTY LINE</b><br><br><b>Keegan Landfill Monitoring Stations</b><br><b>Kearny, New Jersey</b> | | | | 03/14/23 | |

| <b>Keegan Landfill Monitoring Project</b><br><br> | <b>DAILY AIR MONITORING REPORT<br/>AT OR NEAR PROPERTY LINE<br/>Keegan Landfill Monitoring Stations<br/>Kearny, New Jersey</b> | 03/14/23 | |

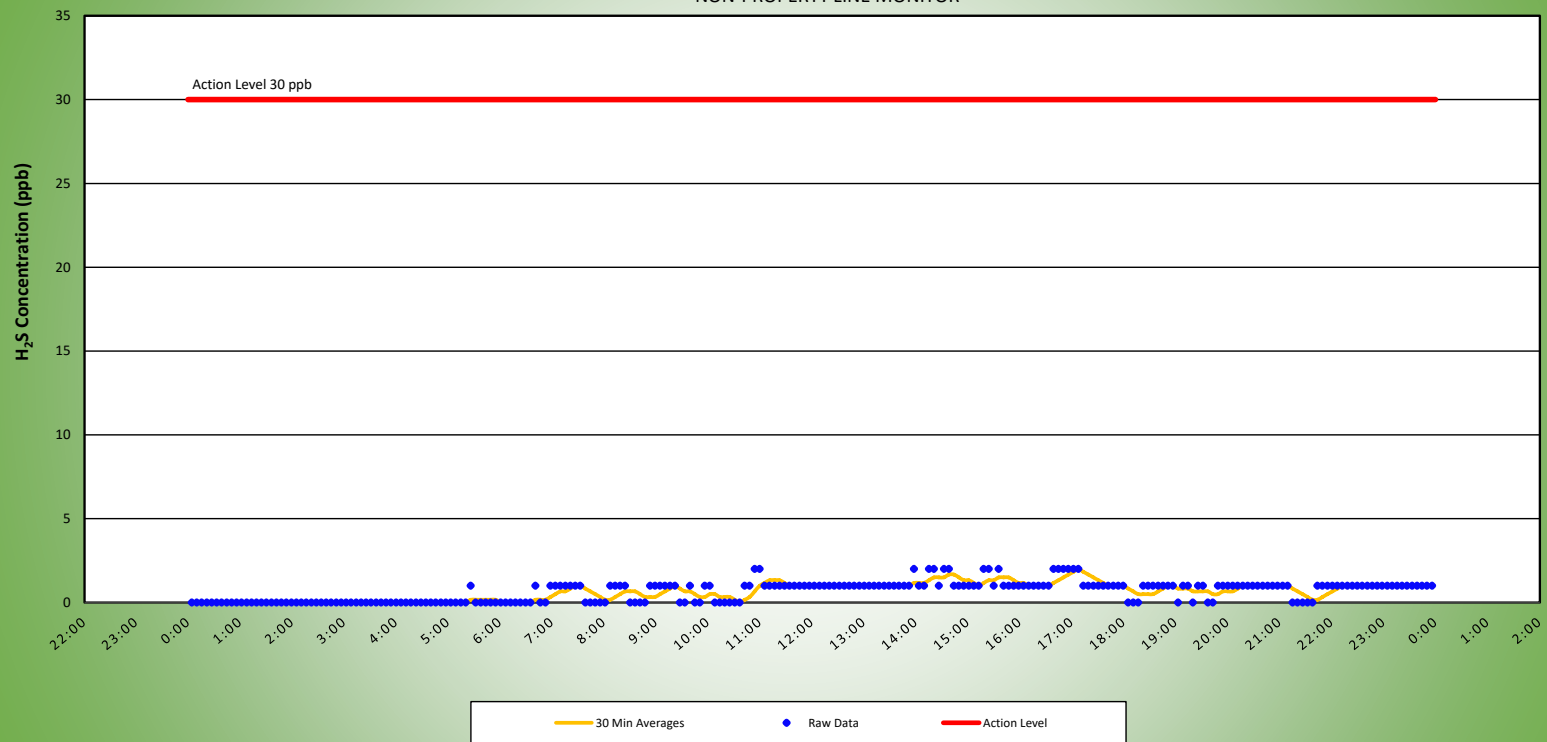
# MS1 H2S MONITORING RESULTS - 03/14/23

| Station Location Area | Work | Daily Avg. 30 Min H <sub>2</sub> S Concentration (ppb) | Max 30 Min H <sub>2</sub> S Concentration (ppb) | Time of Max 30 Min H <sub>2</sub> S Reading | Corresponding Wind Direction |
|---|---|---|---|---|---|
| MS-1 | | 0.7 | 2.0 | 17:07 | WSW |

NON-PROPERTY LINE MONITOR

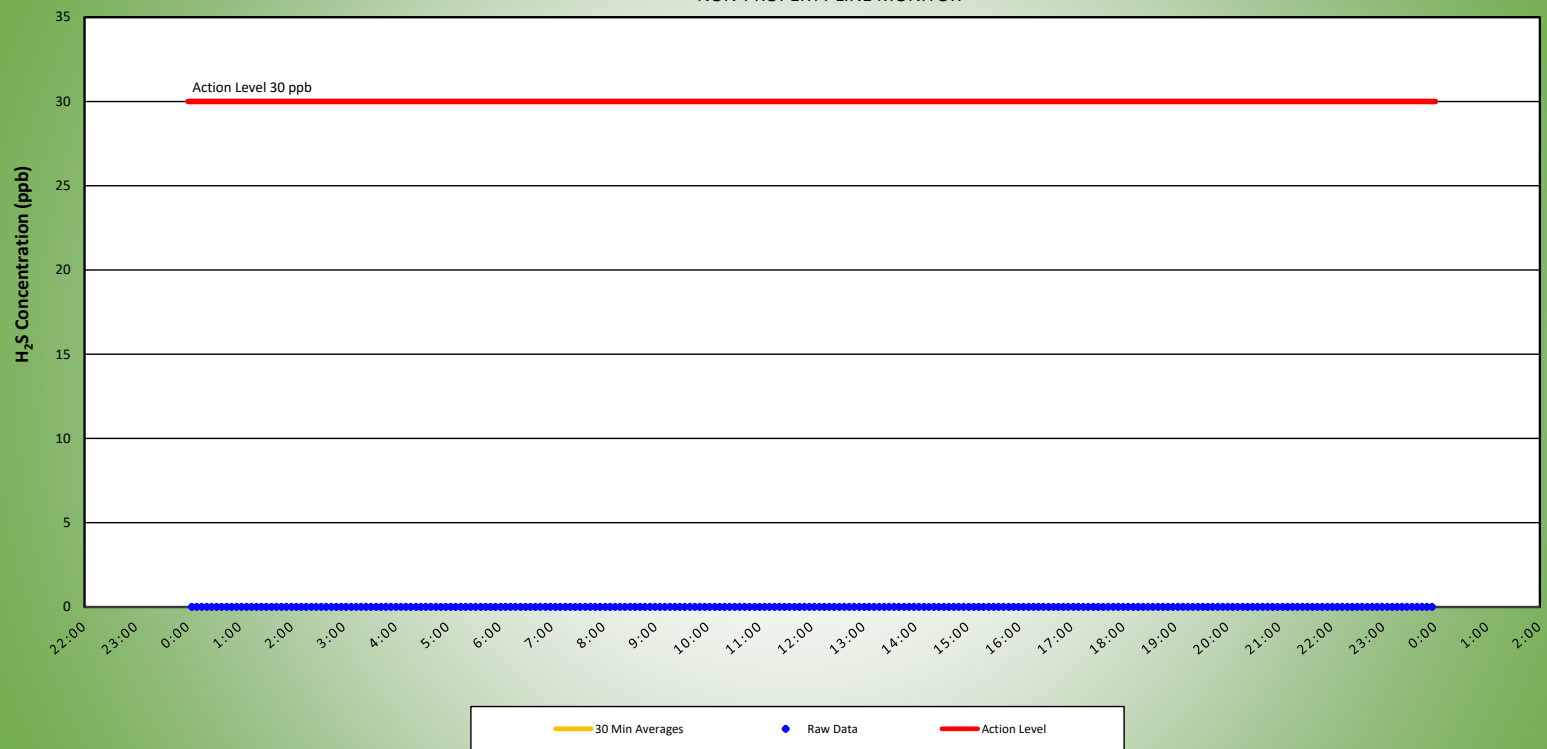
# MS2 H2S MONITORING RESULTS - 03/14/23

| Station Location Area | Work | Daily Avg. 30 Min H <sub>2</sub> S Concentration (ppb) | Max 30 Min H <sub>2</sub> S Concentration (ppb) | Time of Max 30 Min H <sub>2</sub> S Reading | Corresponding Wind Direction |
|---|---|---|---|---|---|
| MS-2 | | 0.0 | 0.0 | 0:04 | NNW |

NON-PROPERTY LINE MONITOR

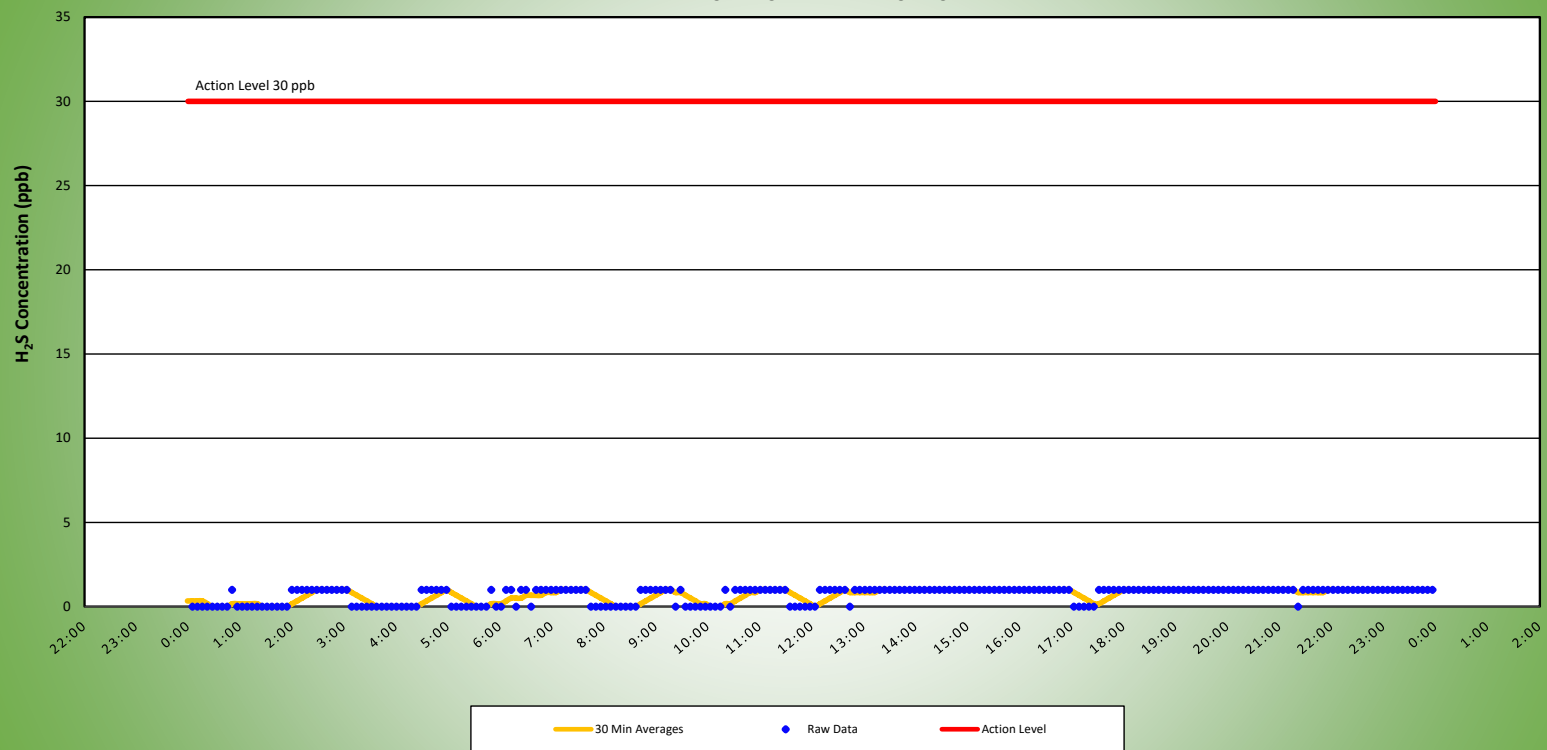
# MS3 H2S MONITORING RESULTS - 03/14/23

| Station Location Area | Work | Daily Avg. 30 Min H <sub>2</sub> S Concentration (ppb) | Max 30 Min H <sub>2</sub> S Concentration (ppb) | Time of Max 30 Min H <sub>2</sub> S Reading | Corresponding Wind Direction |
|---|---|---|---|---|---|
| MS-3 | | 0.7 | 1.0 | 2:28 | N |

NON-PROPERTY LINE MONITOR

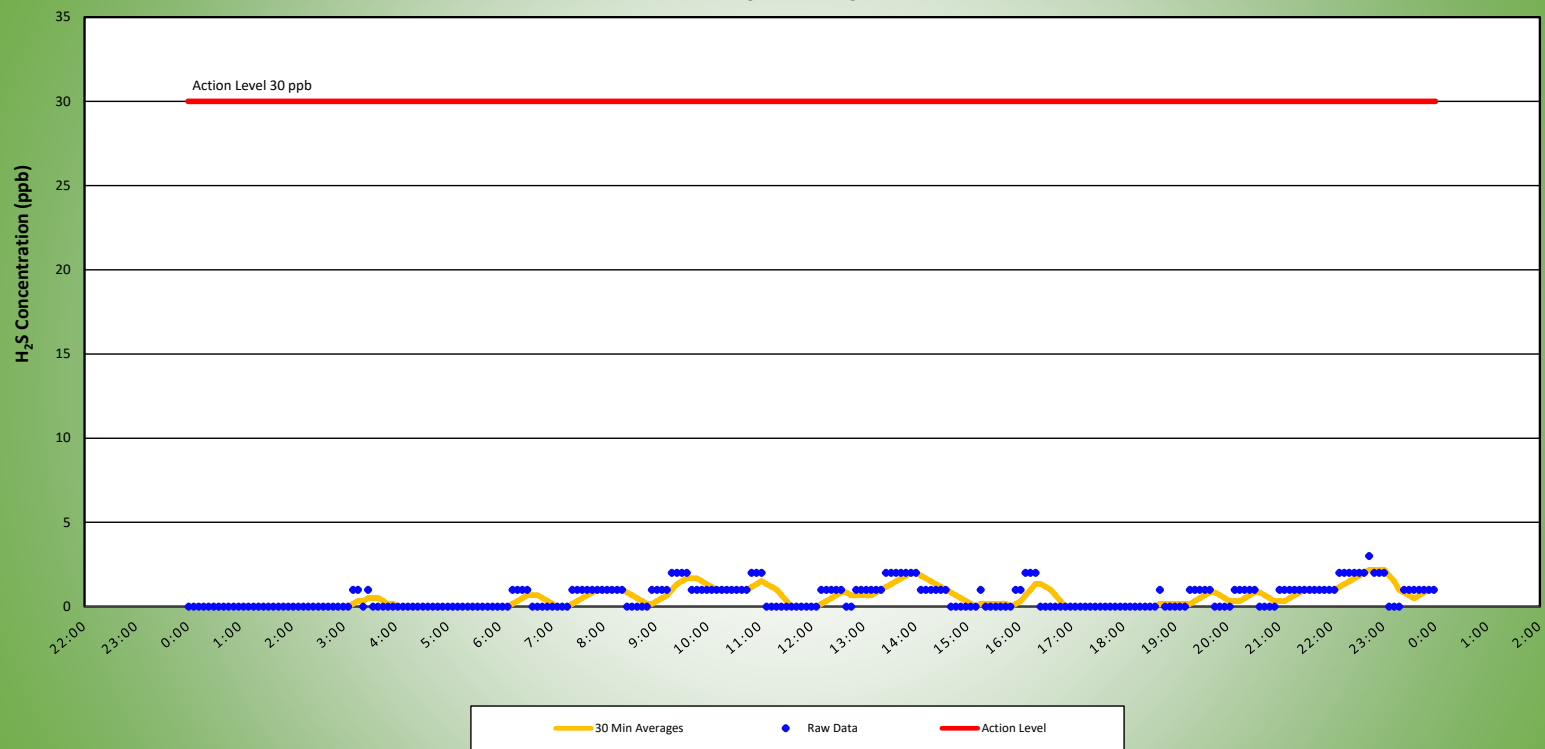
# MS4 H2S MONITORING RESULTS - 03/14/23

| Station Location Area | Work | Daily Avg. 30 Min H <sub>2</sub> S Concentration (ppb) | Max 30 Min H <sub>2</sub> S Concentration (ppb) | Time of Max 30 Min H <sub>2</sub> S Reading | Corresponding Wind Direction |
|---|---|---|---|---|---|
| MS-4 | | 0.5 | 2.2 | 22:43 | W |

AT OR NEAR PROPERTY LINE

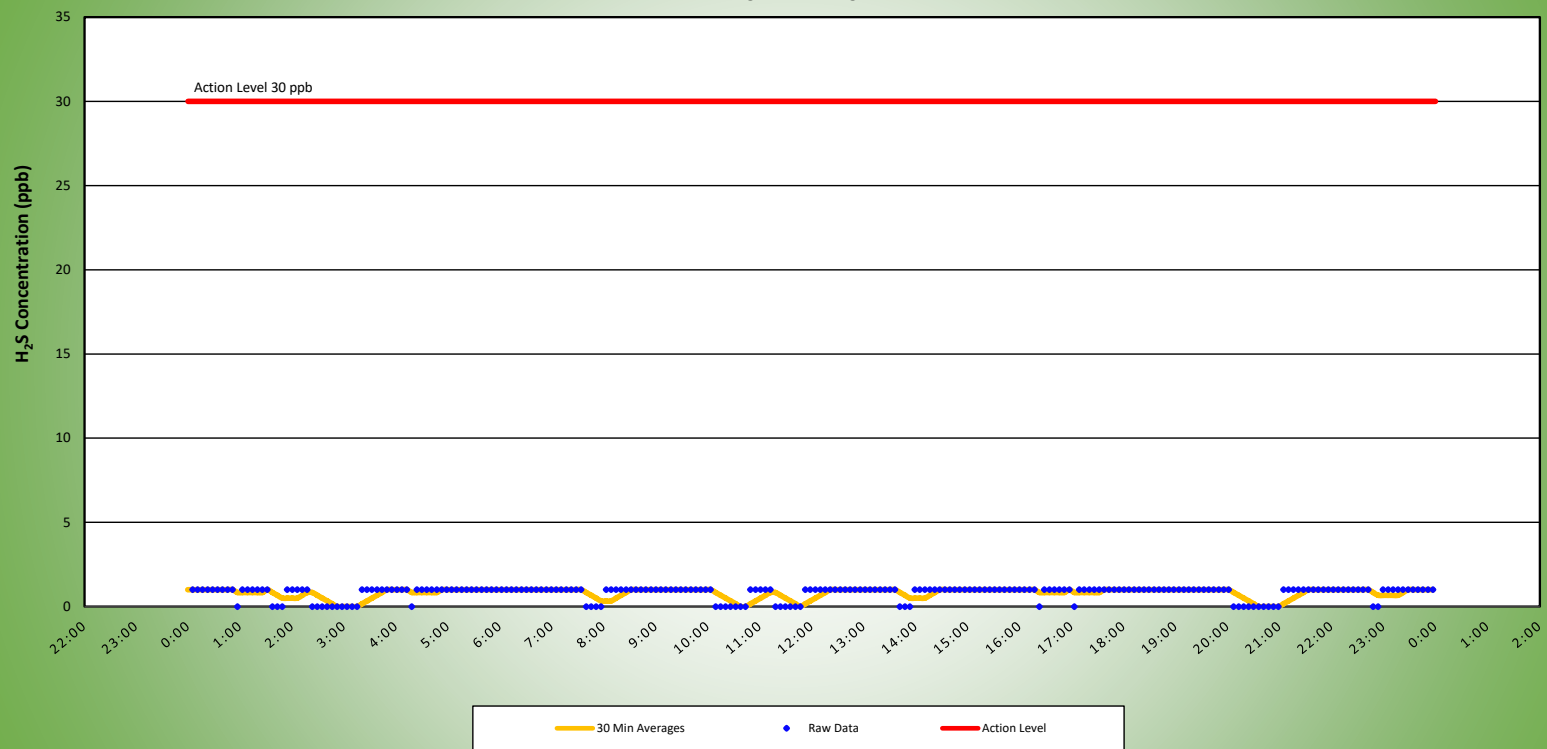
# MS5 H2S MONITORING RESULTS - 03/14/23

| Station Location Area | Work | Daily Avg. 30 Min H <sub>2</sub> S Concentration (ppb) | Max 30 Min H <sub>2</sub> S Concentration (ppb) | Time of Max 30 Min H <sub>2</sub> S Reading | Corresponding Wind Direction |
|---|---|---|---|---|---|
| MS-5 | | 0.8 | 1.0 | 23:59 | NW |

AT OR NEAR PROPERTY LINE

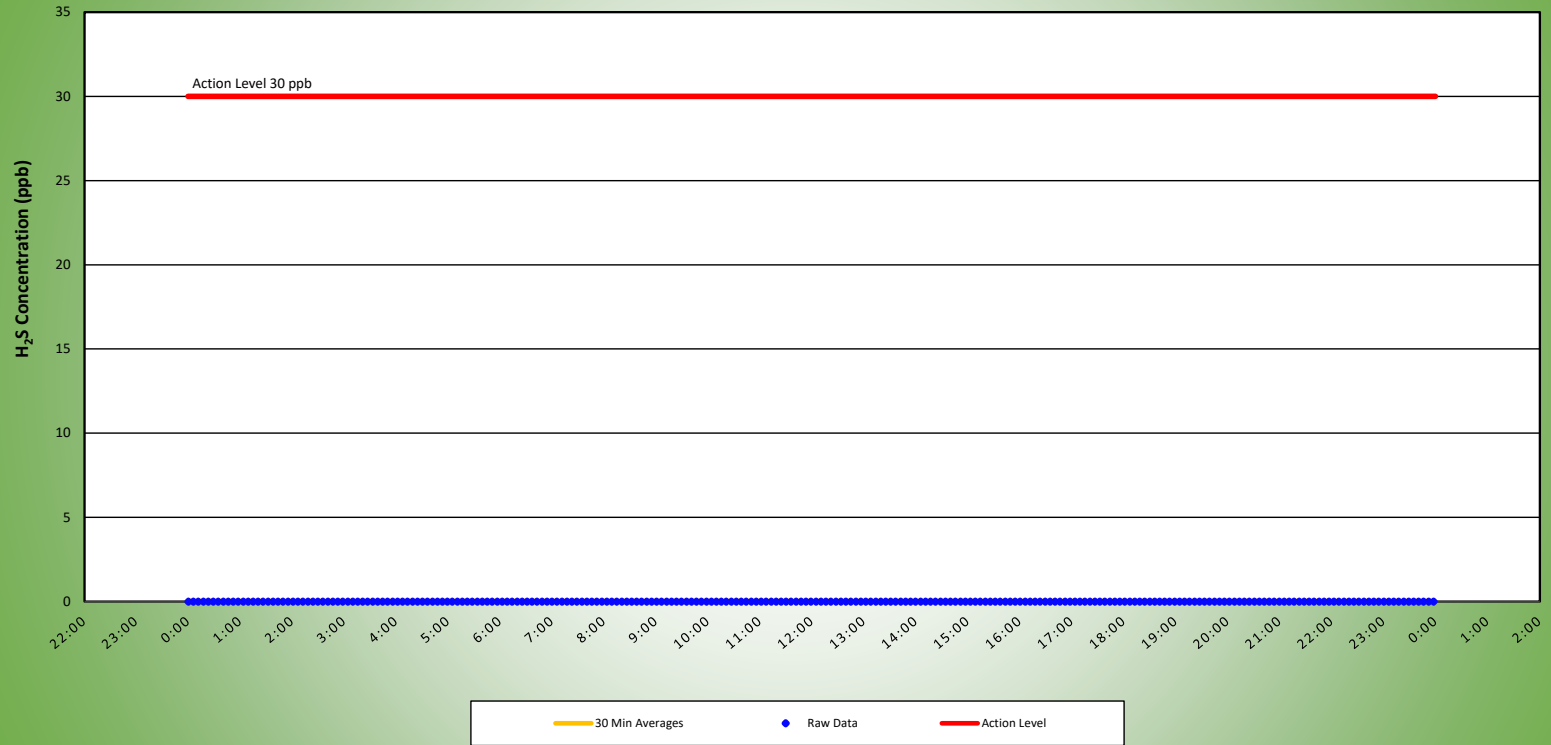
# MS6 H2S MONITORING RESULTS - 03/14/23

| Station Location Area | Work | Daily Avg. 30 Min H <sub>2</sub> S Concentration (ppb) | Max 30 Min H <sub>2</sub> S Concentration (ppb) | Time of Max 30 Min H <sub>2</sub> S Reading | Corresponding Wind Direction |
|---|---|---|---|---|---|
| MS-6 | | 0.0 | 0.0 | 0:00 | NNW |

AT OR NEAR PROPERTY LINE

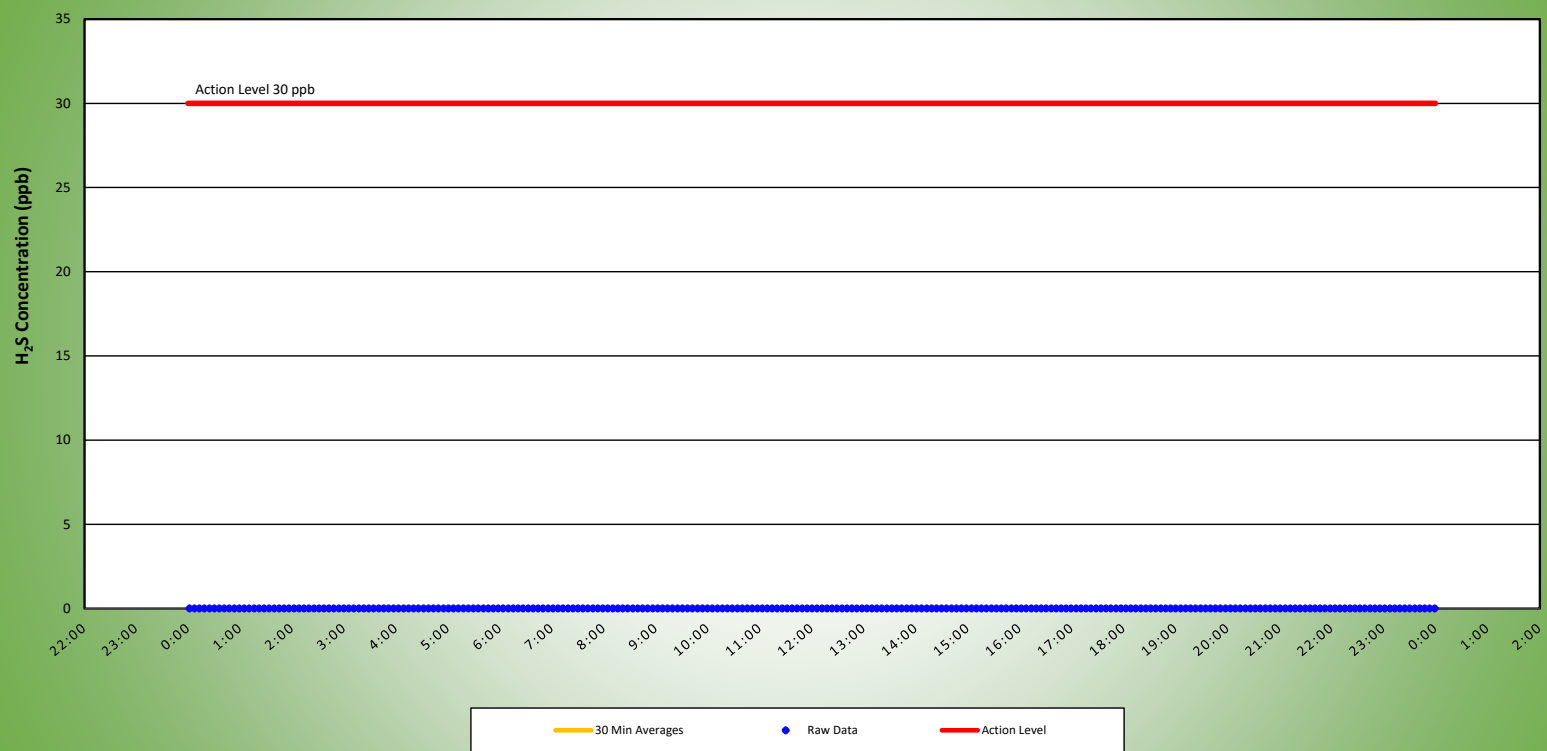
# MS7 H2S MONITORING RESULTS - 03/14/23

| Station Location Area | Work | Daily Avg. 30 Min H <sub>2</sub> S Concentration (ppb) | Max 30 Min H <sub>2</sub> S Concentration (ppb) | Time of Max 30 Min H <sub>2</sub> S Reading | Corresponding Wind Direction |
|---|---|---|---|---|---|
| MS-7 | | 0.0 | 0.0 | 0:01 | SW |

AT OR NEAR PROPERTY LINE

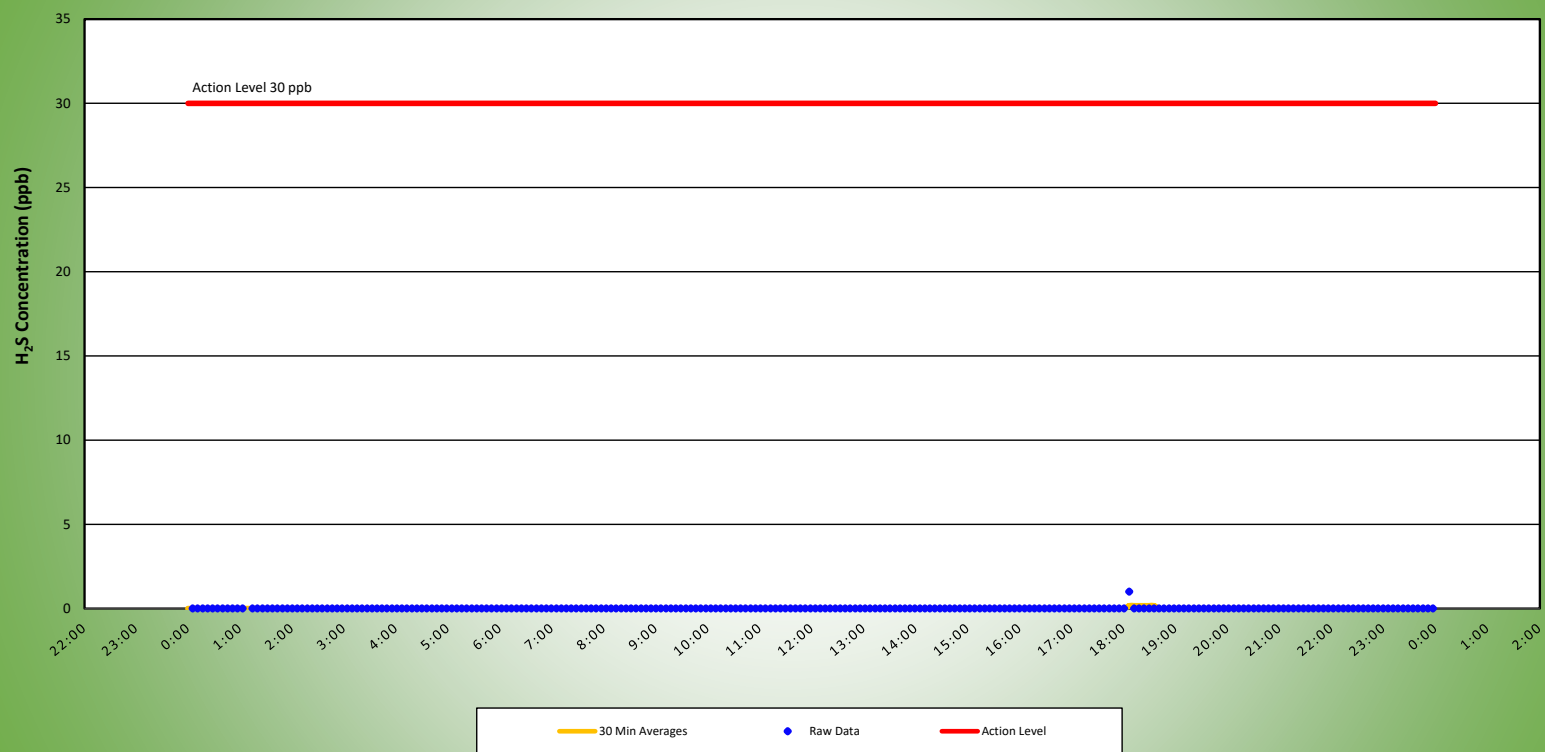
# MS8 H2S MONITORING RESULTS - 03/14/23

| Station Location Area | Work | Daily Avg. 30 Min H <sub>2</sub> S Concentration (ppb) | Max 30 Min H <sub>2</sub> S Concentration (ppb) | Time of Max 30 Min H <sub>2</sub> S Reading | Corresponding Wind Direction |
|---|---|---|---|---|---|
| MS-8 | | 0.0 | 0.2 | 18:06 | W |

AT OR NEAR PROPERTY LINE
