Keegan Landfill Monitoring Project

DAILY AIR MONITORING REPORT NON-PROPERTY LINE Keegan Landfill Monitoring Stations Kearny, New Jersey				03/18/26	
	Field Operations					
	Page 1 of 1				Rev. No. 0	
	Submitted By:					
				30 Minute Avg H ₂ S Action Level		30 ppb

DAILY AIR MONITORING REPORT AT OR NEAR PROPERTY LINE Keegan Landfill Monitoring Stations Kearny, New Jersey			03/18/26 Field Operations	
				Page 1 of 1 Submitted By:	Rev. No. 0
			30 Minute Avg H₂S Action Level	30 ppb

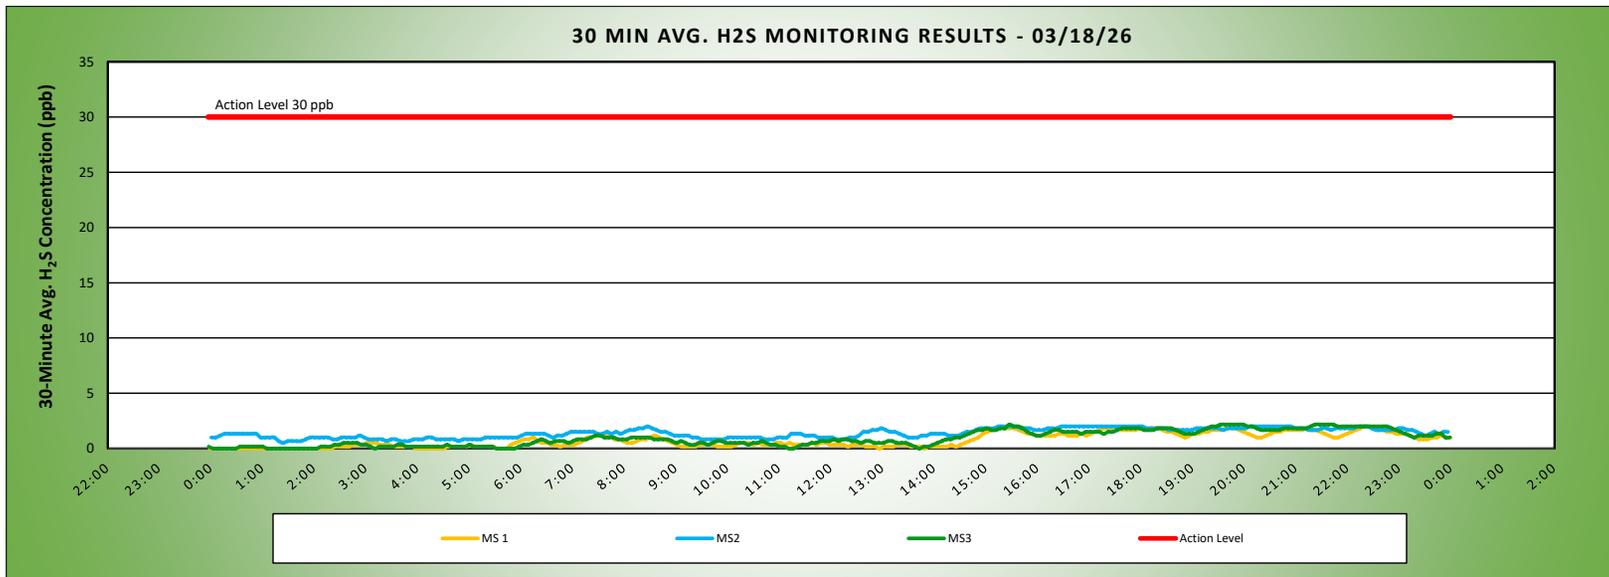
Station Location Area	Work	Daily Avg. 30 Min H ₂ S Concentration (ppb)	Max 30 Min H ₂ S Concentration (ppb)	Time of Max 30 Min H ₂ S Reading	Corresponding Wind Direction
MS-1		0.8	2.0	15:17	SSW
MS-2		1.4	2.0	8:27	WNW
MS-3		0.9	2.2	15:27	S

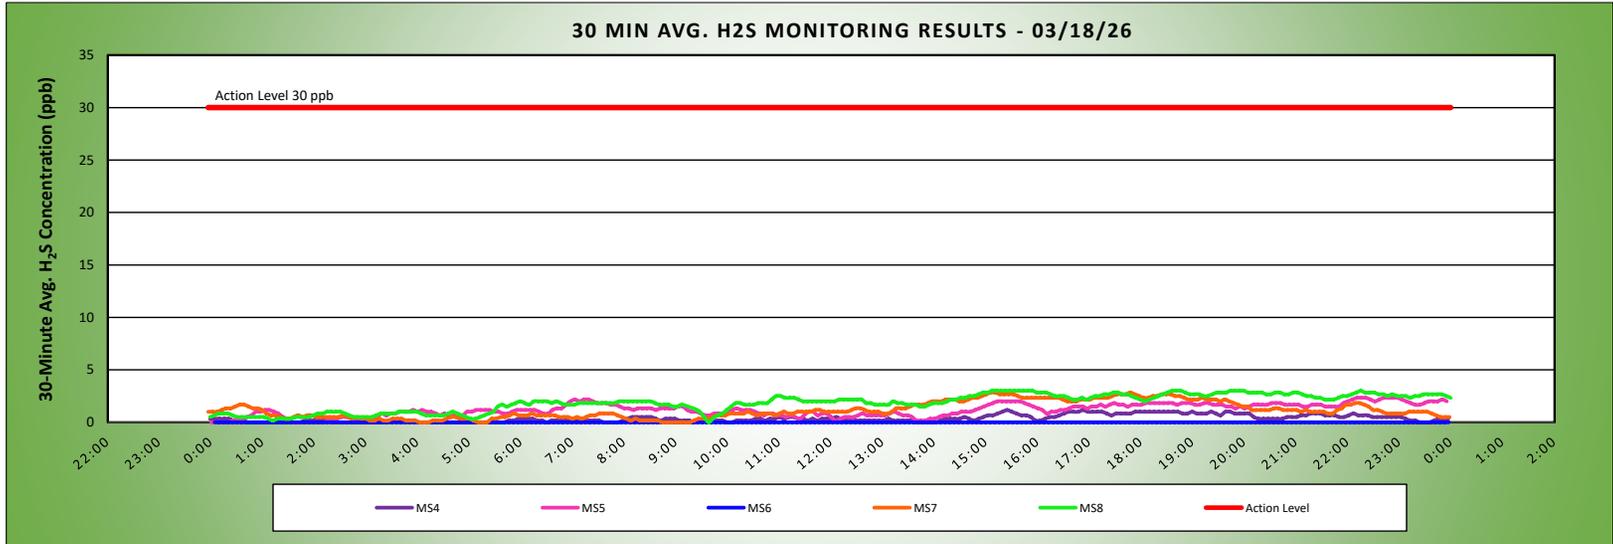
Station Location Area	Work	Daily Avg. 30 Min H ₂ S Concentration (ppb)	Max 30 Min H ₂ S Concentration (ppb)	Time of Max 30 Min H ₂ S Reading	Corresponding Wind Direction
MS-4		0.4	1.2	15:24	WSW
MS-5		1.2	2.3	22:11	S
MS-6		0.0	0.0	0:04	NNW
MS-7		1.2	2.8	15:05	S
MS-8		1.9	3.0	15:07	S
