| <b>Keegan Landfill Monitoring Project</b><br> | <b>DAILY AIR MONITORING REPORT</b><br><b>NON-PROPERTY LINE</b><br><b>Keegan Landfill Monitoring Stations</b><br><b>Kearny, New Jersey</b> | | | | 09/14/26 | |

| <b>Keegan Landfill Monitoring Project</b><br> | <b>DAILY AIR MONITORING REPORT</b><br><b>AT OR NEAR PROPERTY LINE</b><br><b>Keegan Landfill Monitoring Stations</b><br><b>Kearny, New Jersey</b> | | 09/14/26 | |

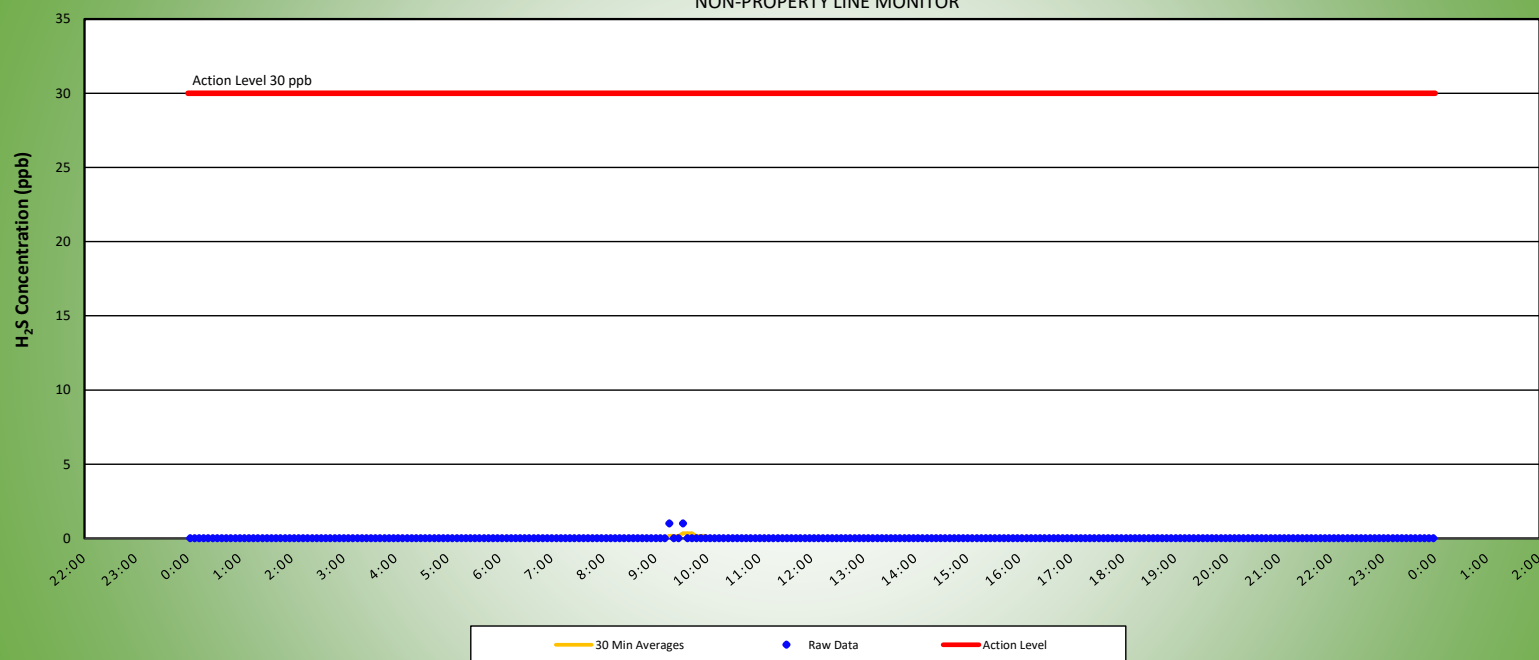
# MS1 H2S MONITORING RESULTS - 09/14/26

| Station Location Area | Work | Daily Avg. 30 Min H <sub>2</sub> S Concentration (ppb) | Max 30 Min H <sub>2</sub> S Concentration (ppb) | Time of Max 30 Min H <sub>2</sub> S Reading | Corresponding Wind Direction |
|---|---|---|---|---|---|
| MS-1 | | 0.0 | 0.3 | 9:31 | W |

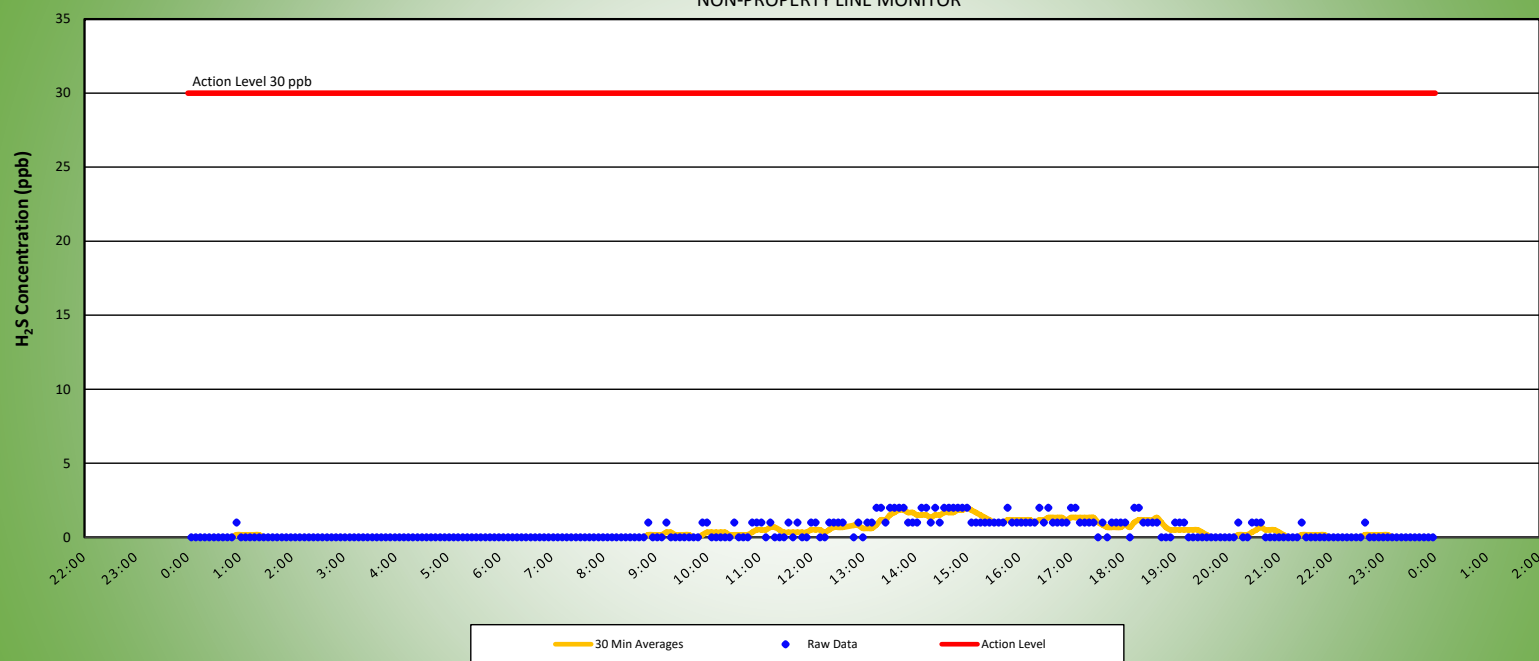
# MS2 H2S MONITORING RESULTS - 09/14/26

| Station Location Area | Work | Daily Avg. 30 Min H <sub>2</sub> S Concentration (ppb) | Max 30 Min H <sub>2</sub> S Concentration (ppb) | Time of Max 30 Min H <sub>2</sub> S Reading | Corresponding Wind Direction |
|---|---|---|---|---|---|
| MS-2 | | 0.4 | 2.0 | 14:59 | NNW |

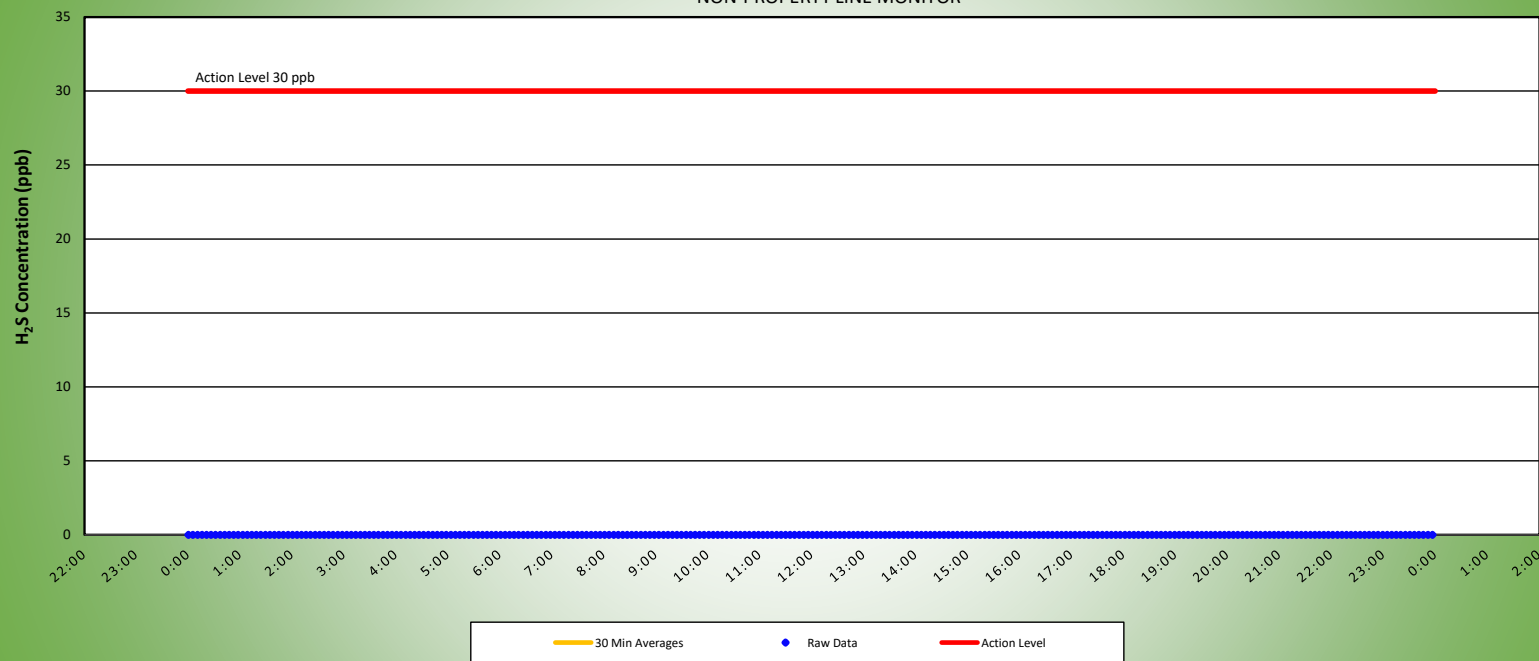
# MS3 H2S MONITORING RESULTS - 09/14/26

| Station Location Area | Work | Daily Avg. 30 Min H <sub>2</sub> S Concentration (ppb) | Max 30 Min H <sub>2</sub> S Concentration (ppb) | Time of Max 30 Min H <sub>2</sub> S Reading | Corresponding Wind Direction |
|---|---|---|---|---|---|
| MS-3 | | 0.0 | 0.0 | 0:00 | NW |

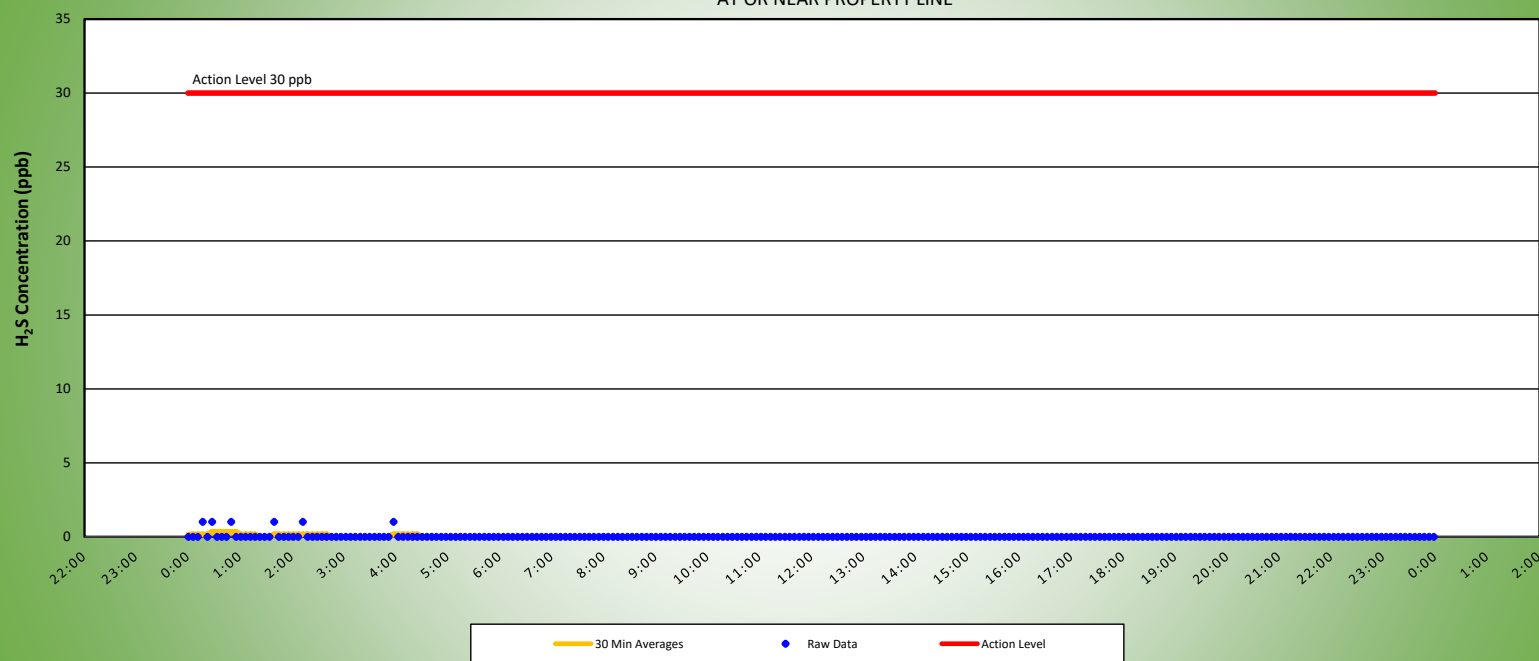
# MS4 H2S MONITORING RESULTS - 09/14/26

| Station Location Area | Work | Daily Avg. 30 Min H <sub>2</sub> S Concentration (ppb) | Max 30 Min H <sub>2</sub> S Concentration (ppb) | Time of Max 30 Min H <sub>2</sub> S Reading | Corresponding Wind Direction |
|---|---|---|---|---|---|
| MS-4 | | 0.0 | 0.3 | 0:27 | NE |

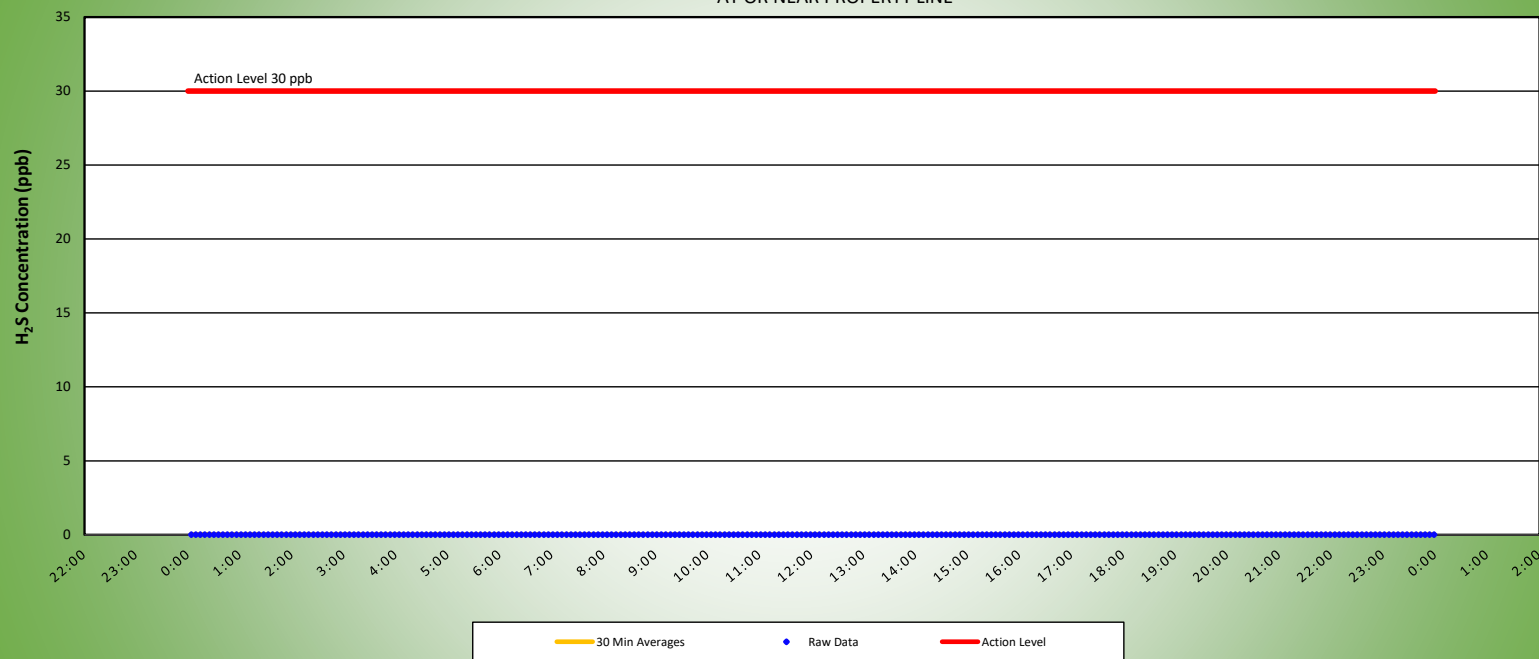
# MS5 H2S MONITORING RESULTS - 09/14/26

| Station Location Area | Work | Daily Avg. 30 Min H <sub>2</sub> S Concentration (ppb) | Max 30 Min H <sub>2</sub> S Concentration (ppb) | Time of Max 30 Min H <sub>2</sub> S Reading | Corresponding Wind Direction |
|---|---|---|---|---|---|
| MS-5 | | 0.0 | 0.0 | 0:03 | SSE |

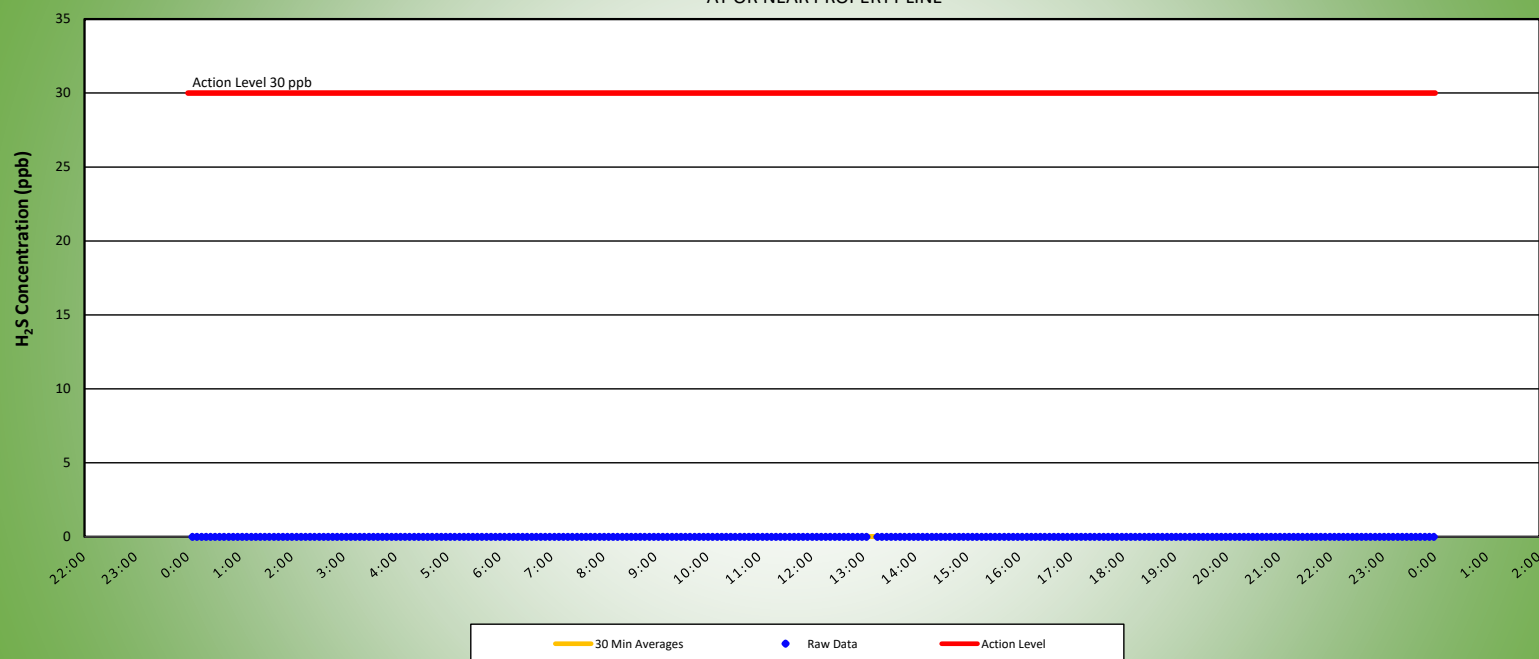
# MS6 H2S MONITORING RESULTS - 09/14/26

| Station Location Area | Work | Daily Avg. 30 Min H <sub>2</sub> S Concentration (ppb) | Max 30 Min H <sub>2</sub> S Concentration (ppb) | Time of Max 30 Min H <sub>2</sub> S Reading | Corresponding Wind Direction |
|---|---|---|---|---|---|
| MS-6 | | 0.0 | 0.0 | 0:05 | SW |

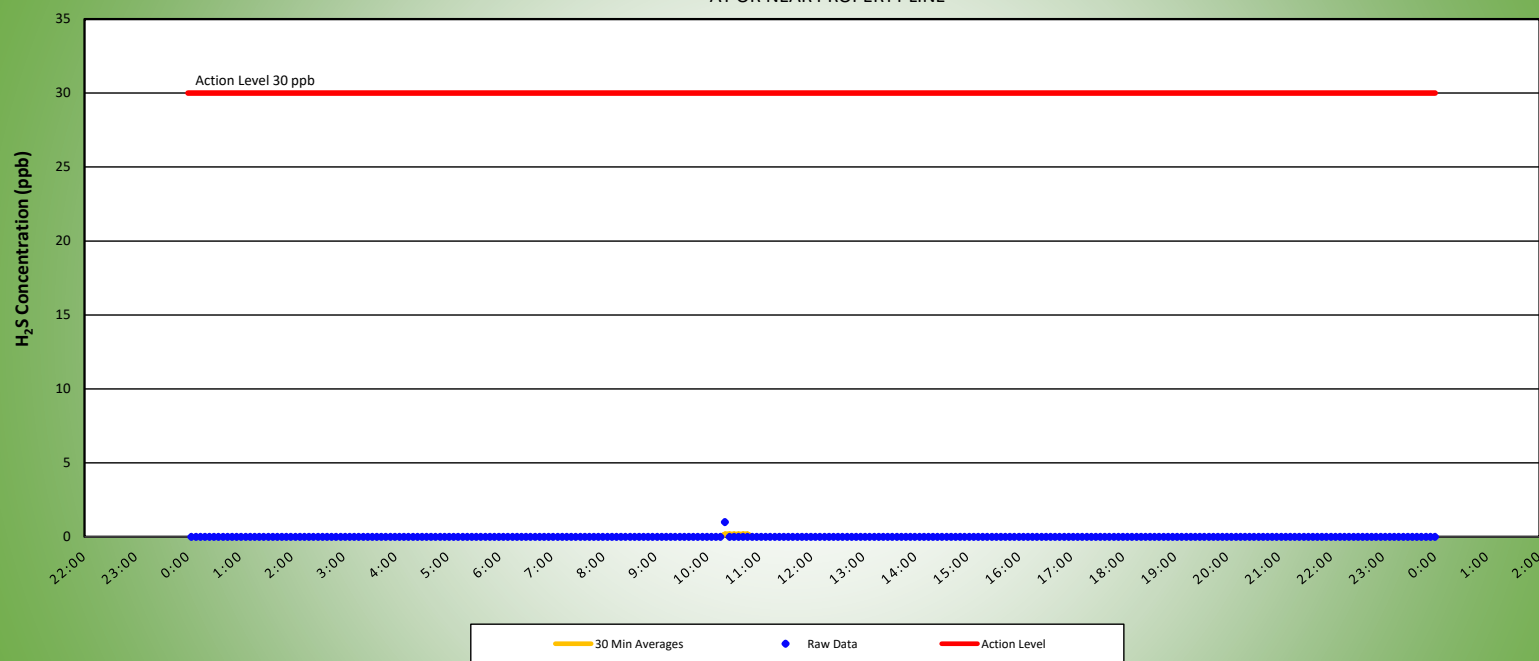
# MS7 H2S MONITORING RESULTS - 09/14/26

| Station Location Area | Work | Daily Avg. 30 Min H <sub>2</sub> S Concentration (ppb) | Max 30 Min H <sub>2</sub> S Concentration (ppb) | Time of Max 30 Min H <sub>2</sub> S Reading | Corresponding Wind Direction |
|---|---|---|---|---|---|
| MS-7 | | 0.0 | 0.2 | 10:20 | NNW |

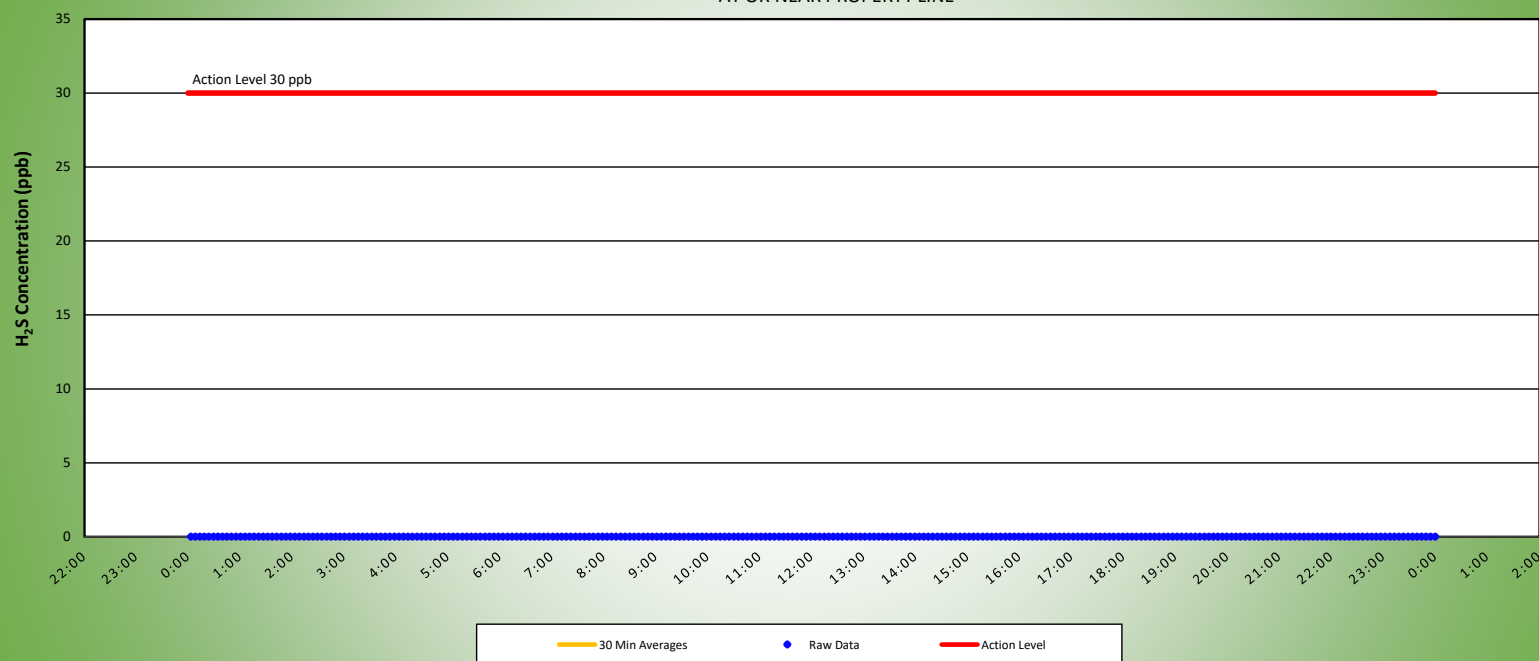
# MS8 H2S MONITORING RESULTS - 09/14/26

| Station Location Area | Work | Daily Avg. 30 Min H <sub>2</sub> S Concentration (ppb) | Max 30 Min H <sub>2</sub> S Concentration (ppb) | Time of Max 30 Min H <sub>2</sub> S Reading | Corresponding Wind Direction |
|---|---|---|---|---|---|
| MS-8 | | 0.0 | 0.0 | 0:03 | S |
