New Jersey Sports & Exposition Authority Drainage Ditch Inspection Report

**The National Flood Insurance Program
Community Rating System**

The New Jersey Sports and Exposition Authority

October 13, 2022

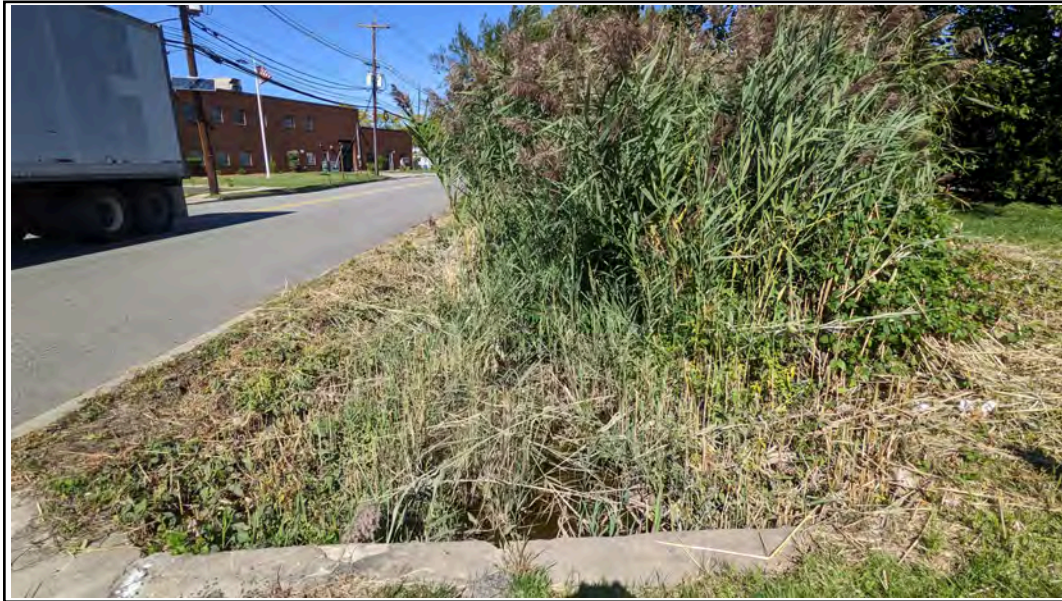
Figure 1: Upstream view of ditch at headwall

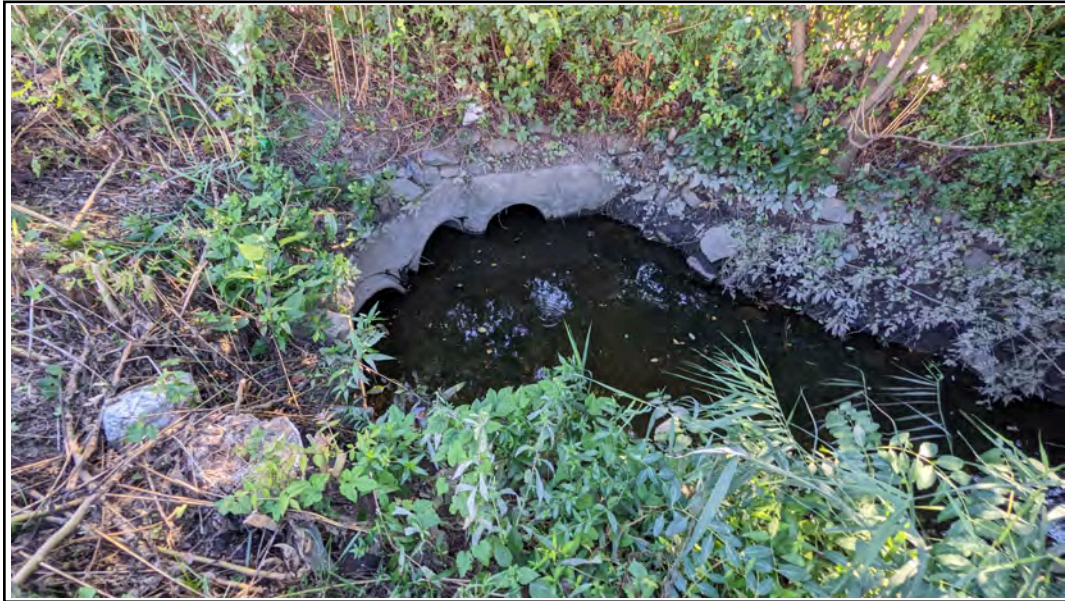
Figure 1: Upstream view of ditch

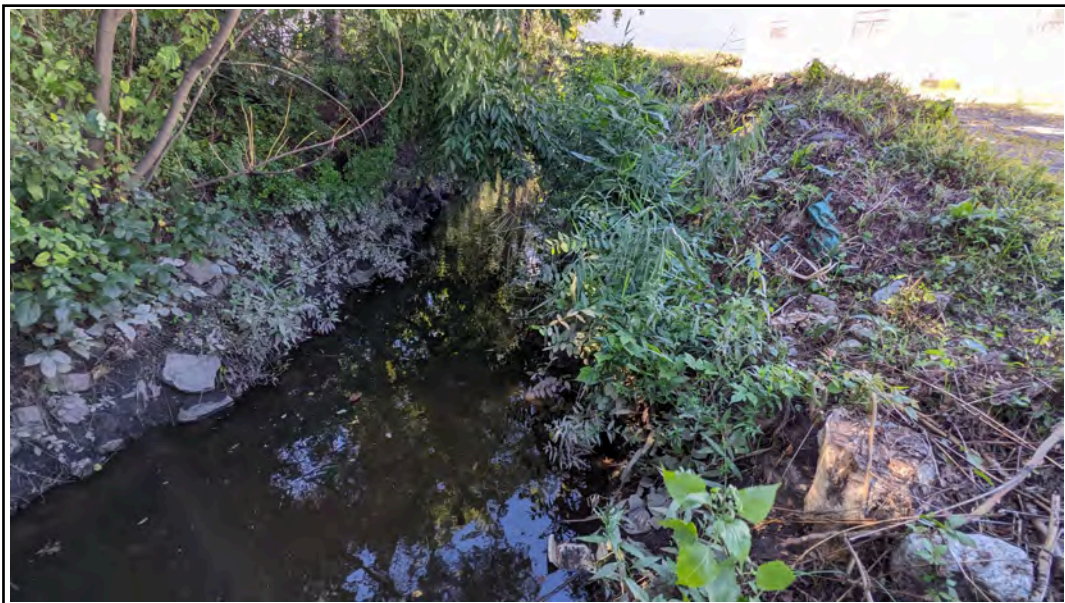
Figure 2: Downstream view of ditch

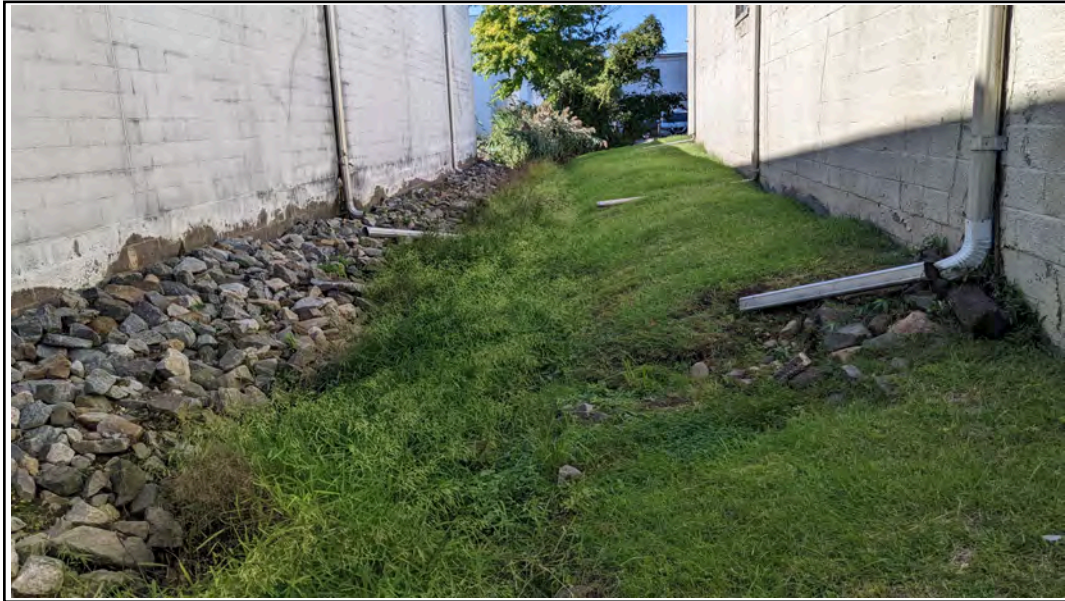
Figure 1: Upstream view of ditch

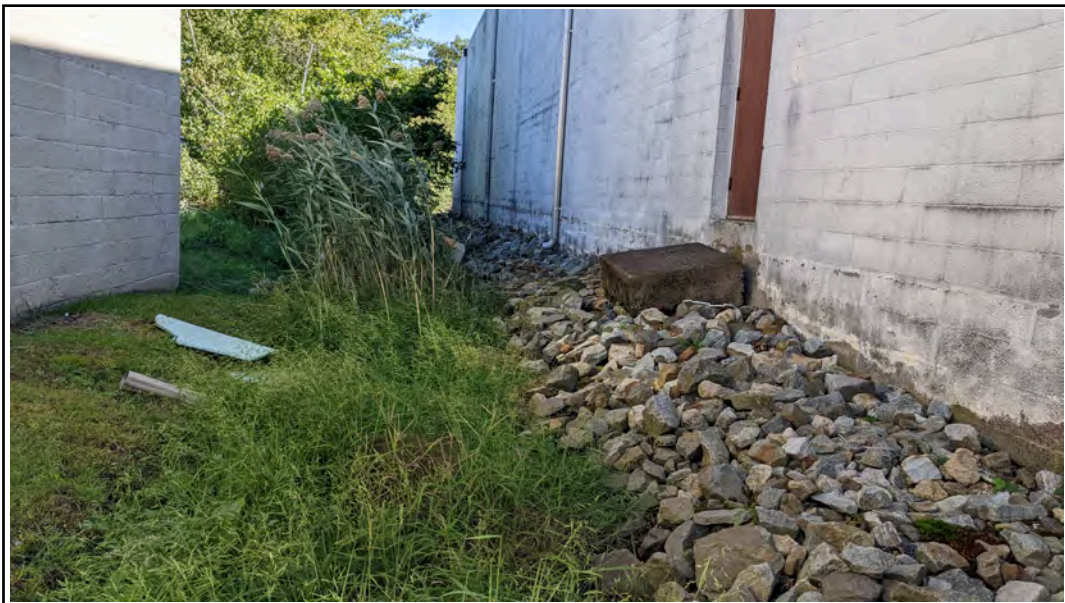
Figure 2: Downstream view of ditch

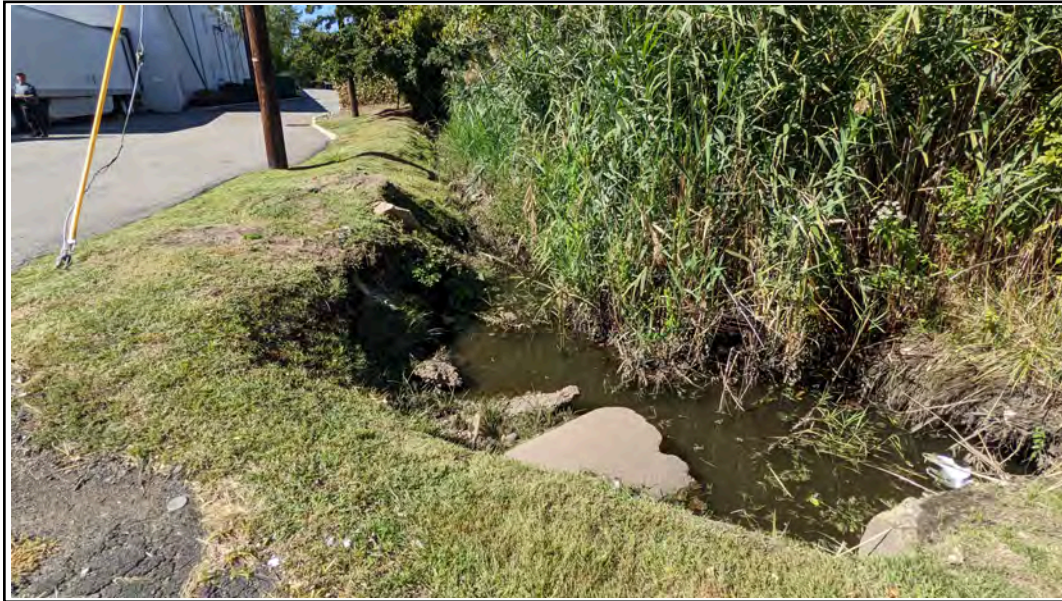
Figure 1: Upstream view of ditch

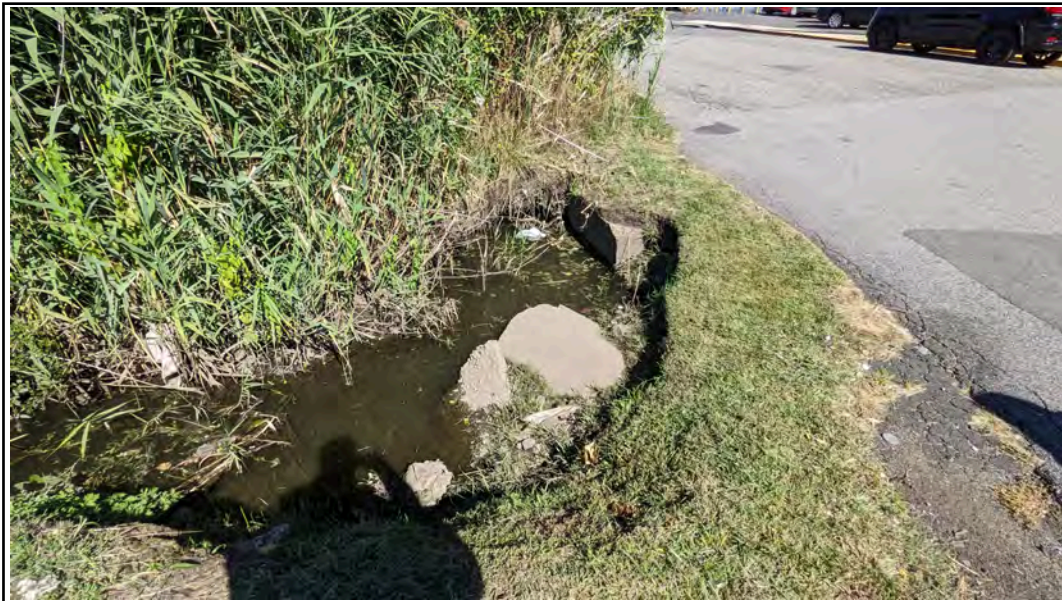
Figure 2: Downstream view of ditch

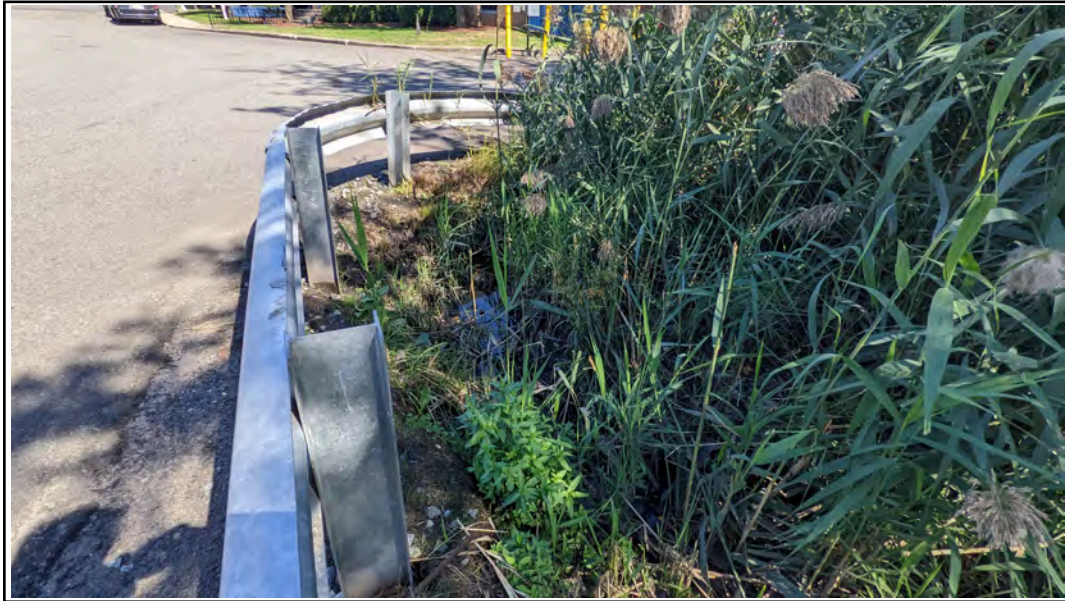
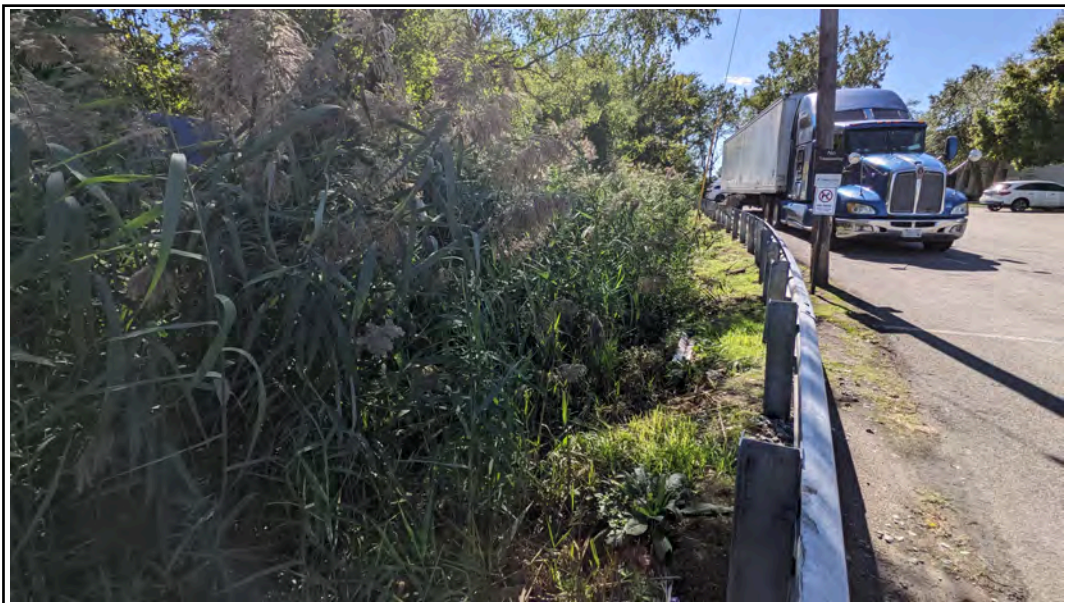
Figure 1: Upstream view of ditch

Figure 2: Downstream view of ditch

Notes on Condition / Problems:
Ditch is clear of debris.
Notes on Maintenance:
DPW has cleared vegetation and removed silt from two large culverts at this location.
Other Notes:

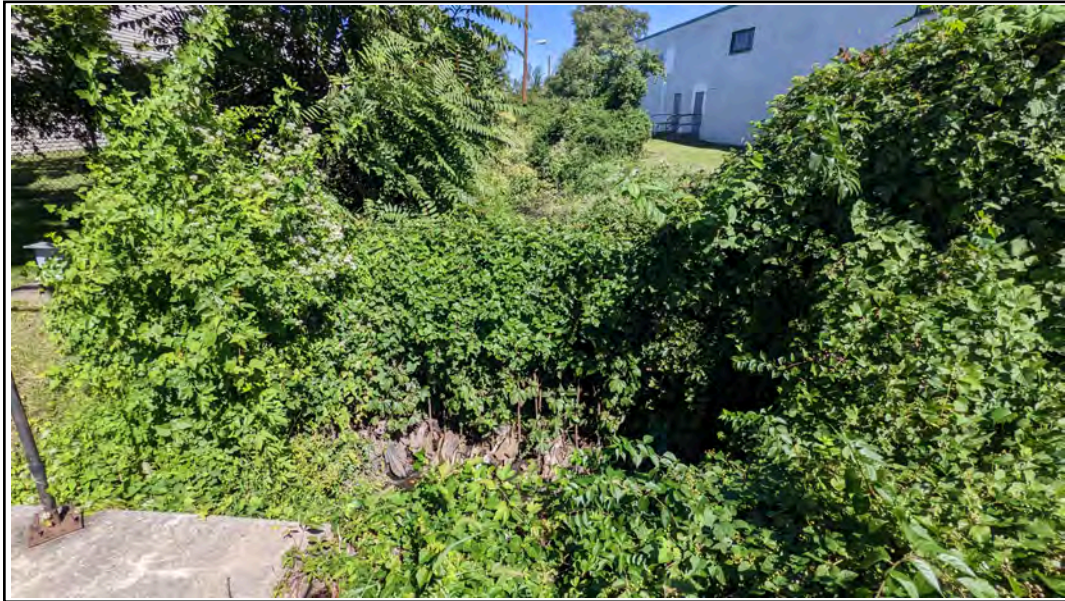
Figure 1: Upstream view of ditch at headwall

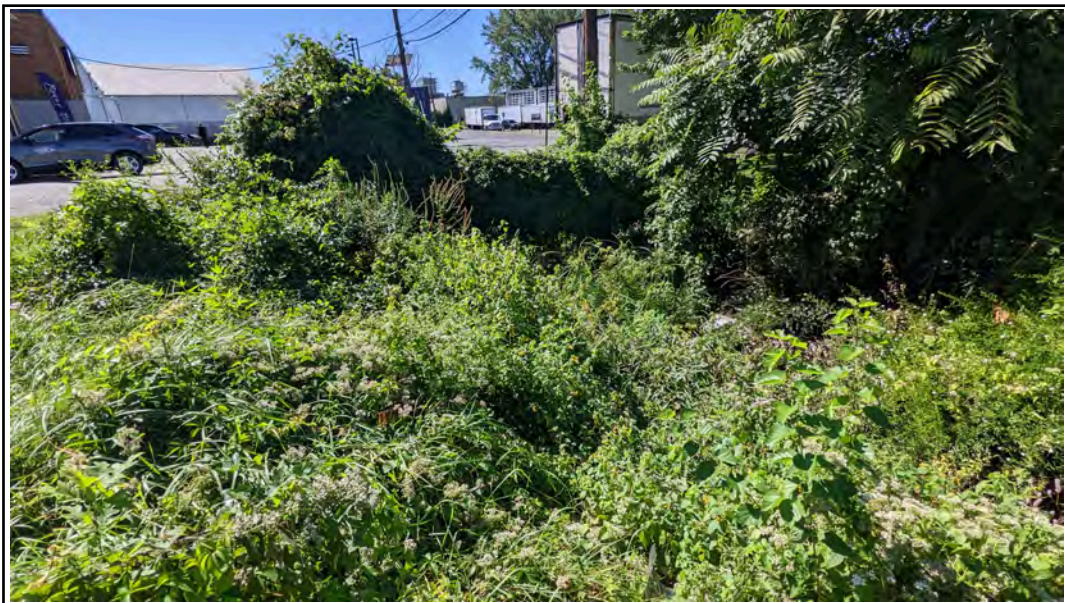
Figure 2: Downstream view of ditch at headwall

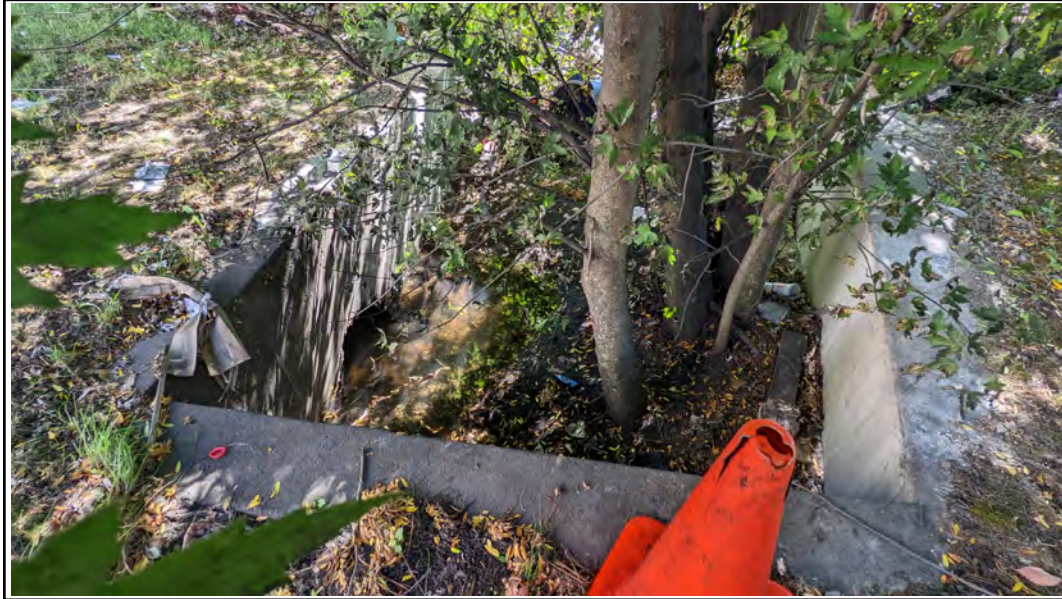
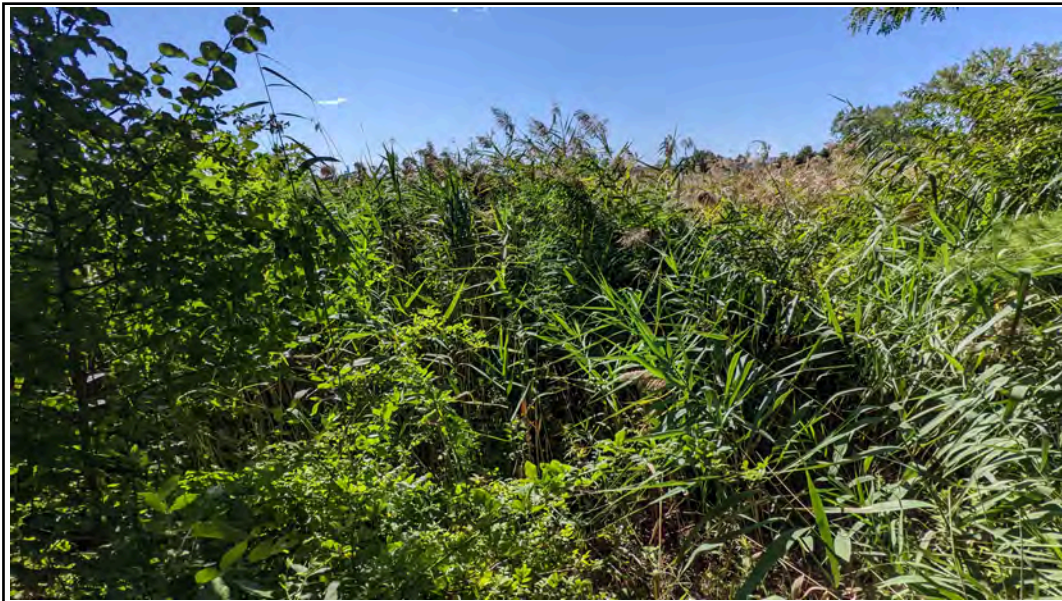
Type of Inspection:		Notes on Condition / Problems:	
<input checked="" type="checkbox"/> Yearly	<input checked="" type="checkbox"/> Ditch	Ditch is not accessible due to heavy vegetation	
<input type="checkbox"/> Post-Storm	<input type="checkbox"/> Tide Gate	but is clear downstream.	
<input type="checkbox"/> Complaint	<input type="checkbox"/> Pump System		
System Designation:			
<input checked="" type="checkbox"/> Natural Stream	<input type="checkbox"/> Culvert		
<input type="checkbox"/> Manmade Channel	<input type="checkbox"/> Outfall		
<input type="checkbox"/> Catch Basin	<input type="checkbox"/> Other: _____	Notes on Maintenance:	
Overall Functionality:			
<input checked="" type="checkbox"/> Fully Functional			
<input type="checkbox"/> Functional with Restrictions			
<input type="checkbox"/> Non-Functional			
Maintenance Required:		Other Notes:	
<input type="checkbox"/> Immediate			
<input type="checkbox"/> Repair

Figure 1: Upstream view of ditch at culvert

Figure 2: Downstream view of ditch

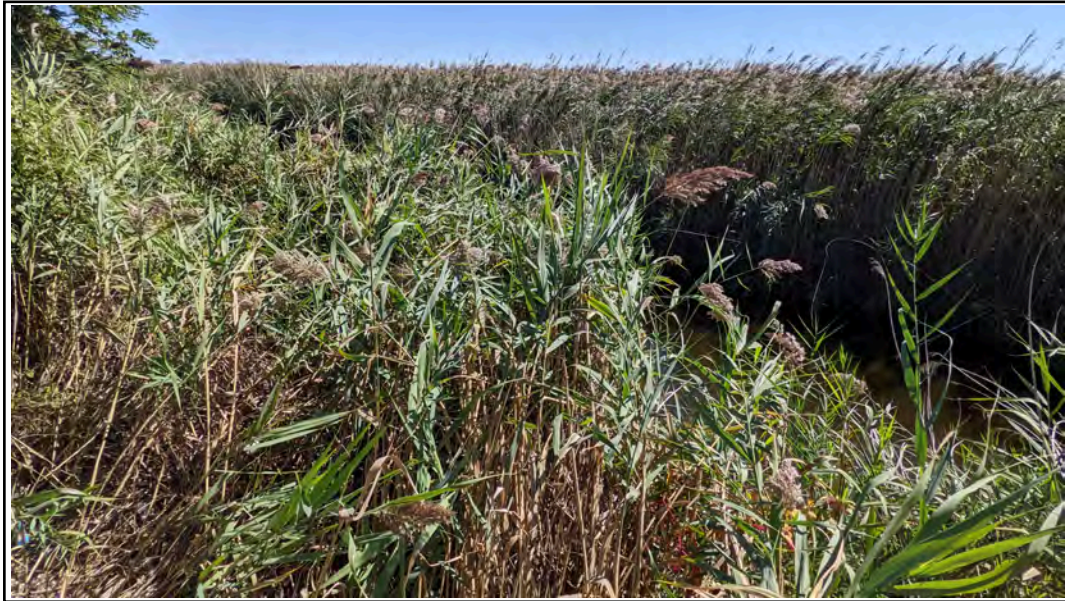
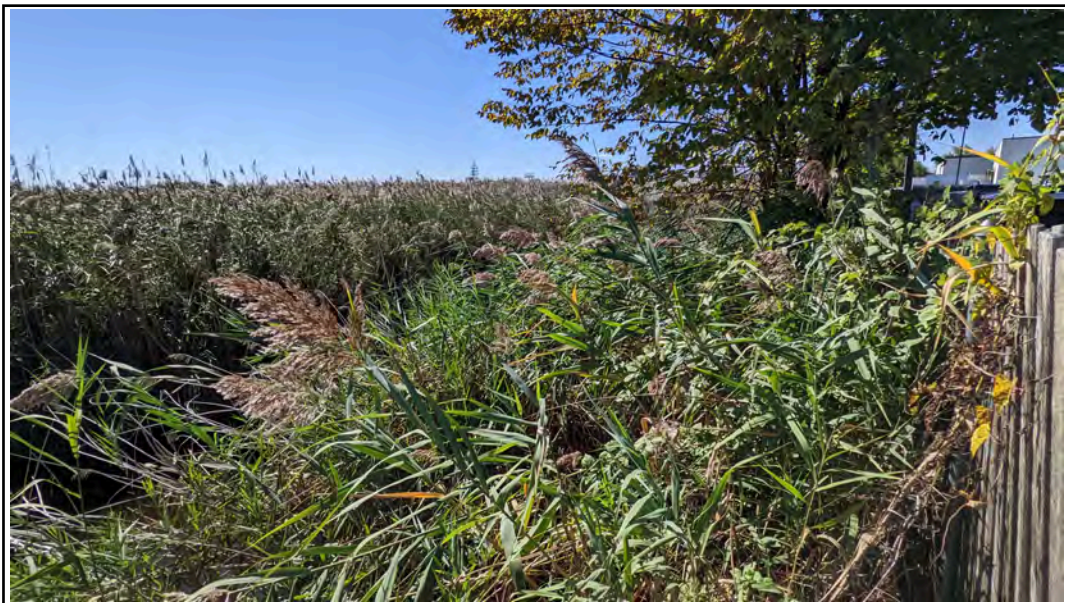
Type of Inspection:		Notes on Condition / Problems:	
<input checked="" type="checkbox"/> Yearly	<input checked="" type="checkbox"/> Ditch	Ditch is flowing clear.	
<input type="checkbox"/> Post-Storm	<input type="checkbox"/> Tide Gate	Banks are overgrown.	
<input type="checkbox"/> Complaint	<input type="checkbox"/> Pump System		
System Designation:			
<input checked="" type="checkbox"/> Natural Stream	<input type="checkbox"/> Culvert		
<input type="checkbox"/> Manmade Channel	<input type="checkbox"/> Outfall		
<input type="checkbox"/> Catch Basin	<input type="checkbox"/> Other: _____	Notes on Maintenance:	
Overall Functionality:			
<input checked="" type="checkbox"/> Fully Functional			
<input type="checkbox"/> Functional with Restrictions			
<input type="checkbox"/> Non-Functional			
Maintenance Required:		Other Notes:	
<input type="checkbox"/> Immediate			
<input type="checkbox"/> Repair			
<input type="checkbox"/> Continued Upkeep

Figure 1: Upstream view of ditch

Figure 2: Downstream view of ditch

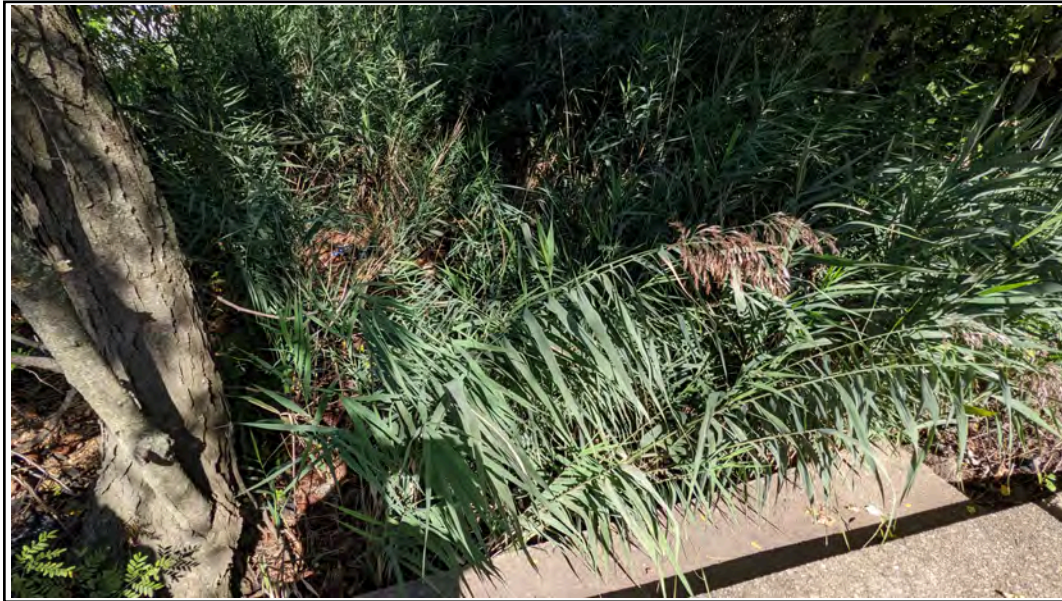
Type of Inspection:		Notes on Condition / Problems:	
<input checked="" type="checkbox"/> Yearly	<input checked="" type="checkbox"/> Ditch	Ditch is clear downstream, but overgrown upstream.	
<input type="checkbox"/> Post-Storm	<input type="checkbox"/> Tide Gate	Inlet silted to top of grate.	
<input type="checkbox"/> Complaint	<input type="checkbox"/> Pump System		
System Designation:			
<input checked="" type="checkbox"/> Natural Stream	<input checked="" type="checkbox"/> Culvert		
<input type="checkbox"/> Manmade Channel	<input type="checkbox"/> Outfall		
<input type="checkbox"/> Catch Basin	<input type="checkbox"/> Other: _____	Notes on Maintenance:	
Overall Functionality:		Contact Carlstadt DPW about silted inlet and roadway ponding.	
<input checked="" type="checkbox"/> Fully Functional			
<input type="checkbox"/> Functional with Restrictions			
<input type="checkbox"/> Non-Functional			
Maintenance Required:		Other Notes:

Figure 1: Upstream view of ditch

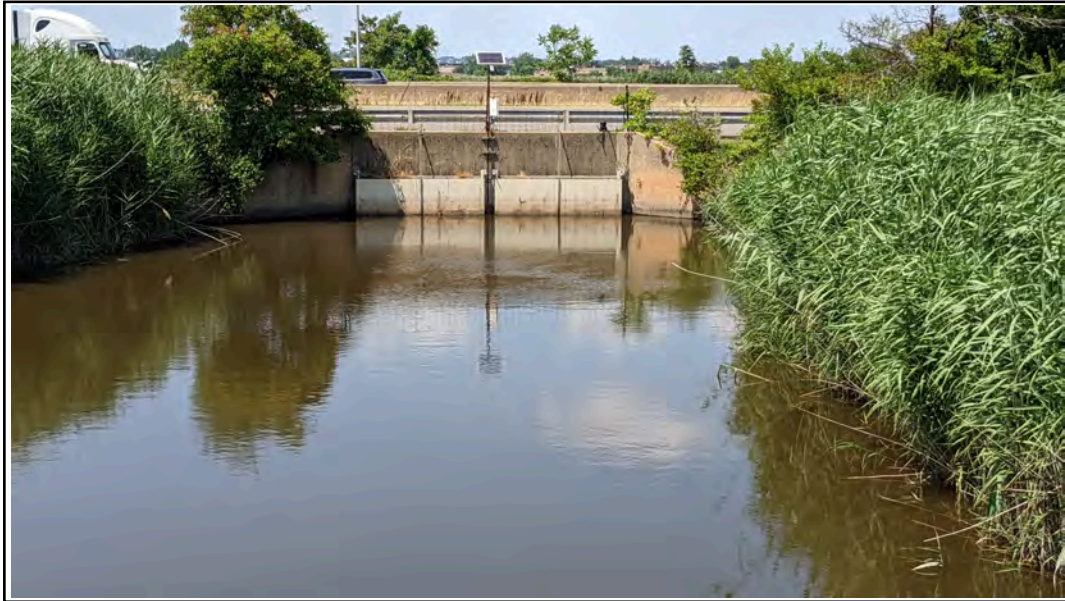
Figure 1: Upstream view at tide gate

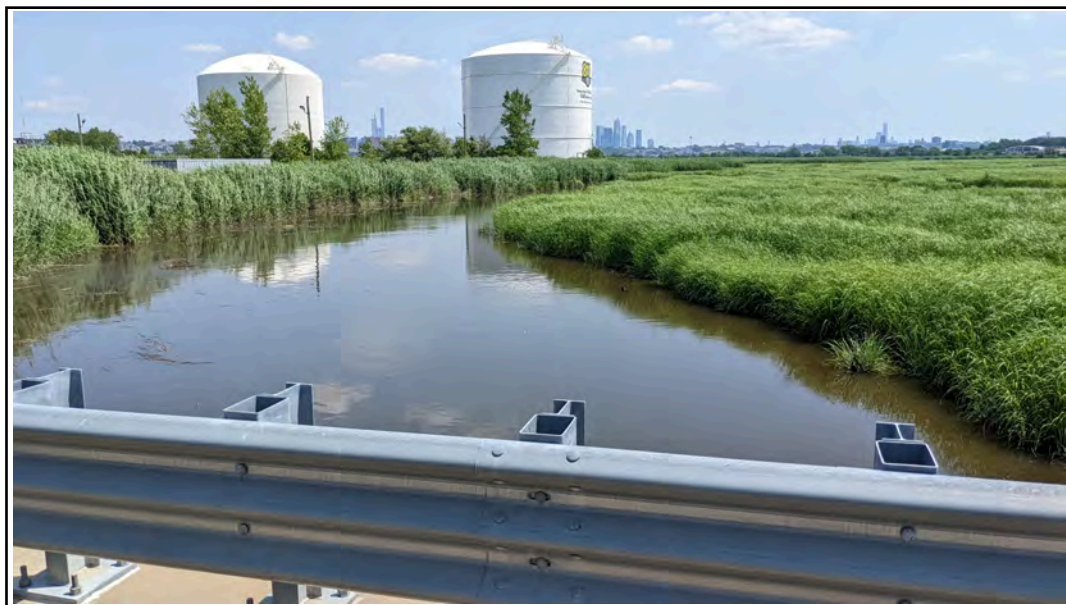
Figure 2: Downstream view of ditch at bridge

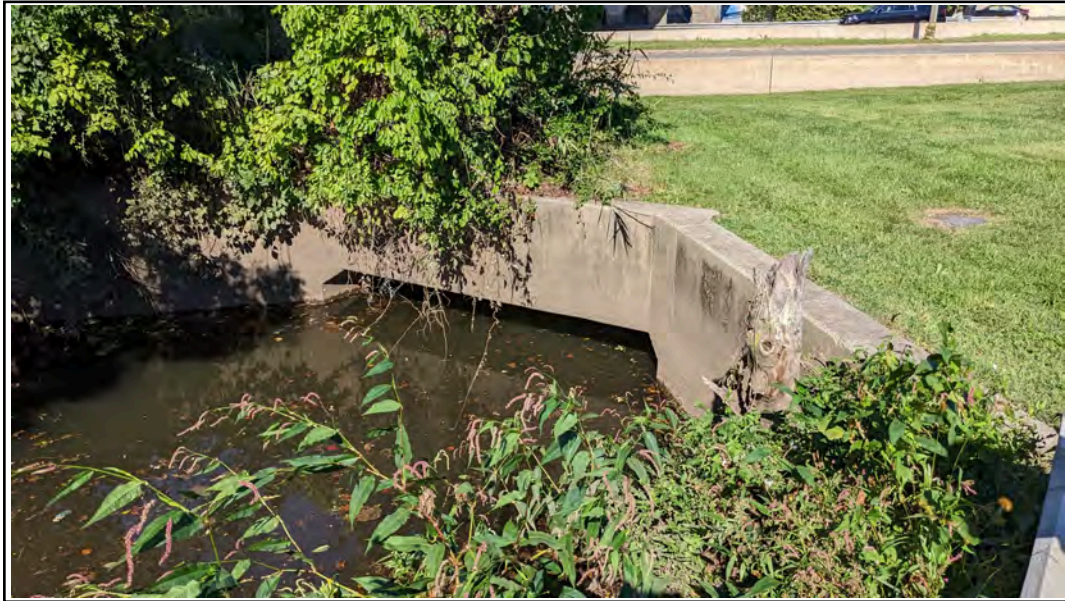
Figure 1: Upstream view of ditch at culvert

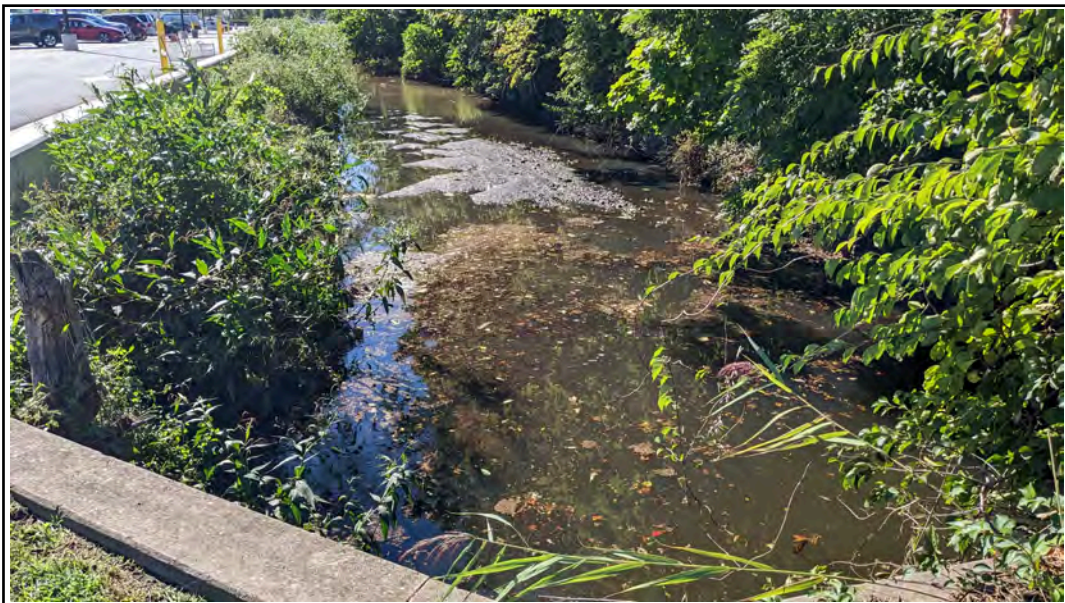
Figure 2: Downstream view of ditch at culvert

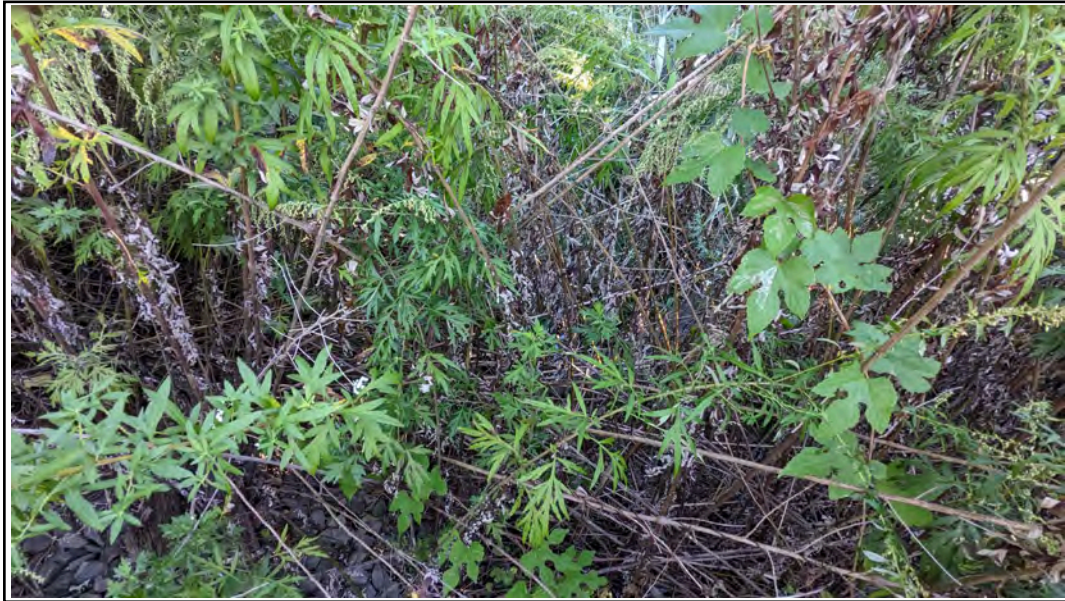
Figure 1: Upstream view of ditch

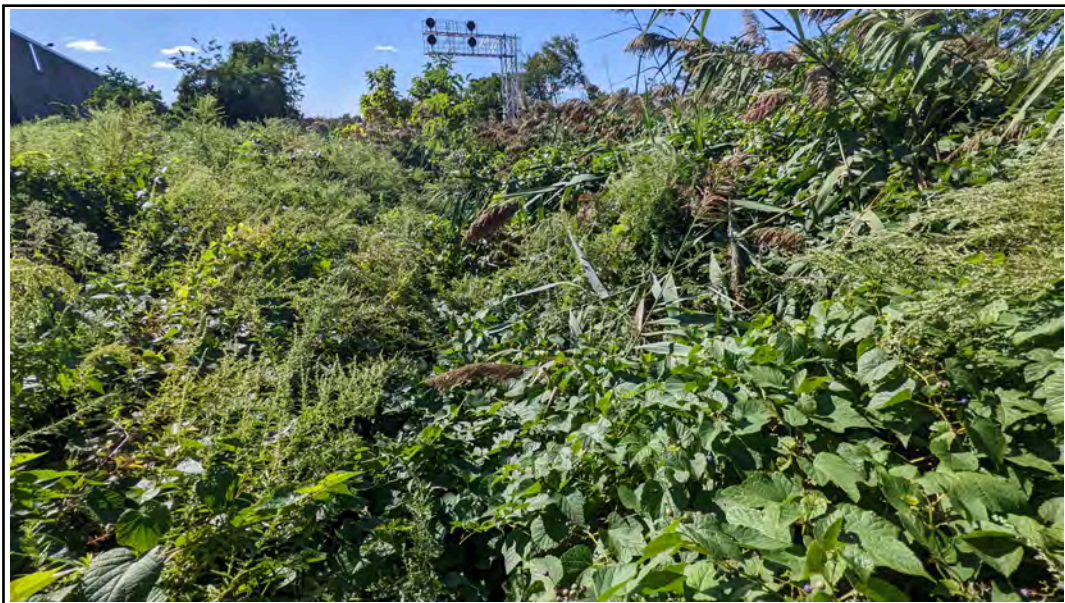
Figure 2: Downstream view of ditch

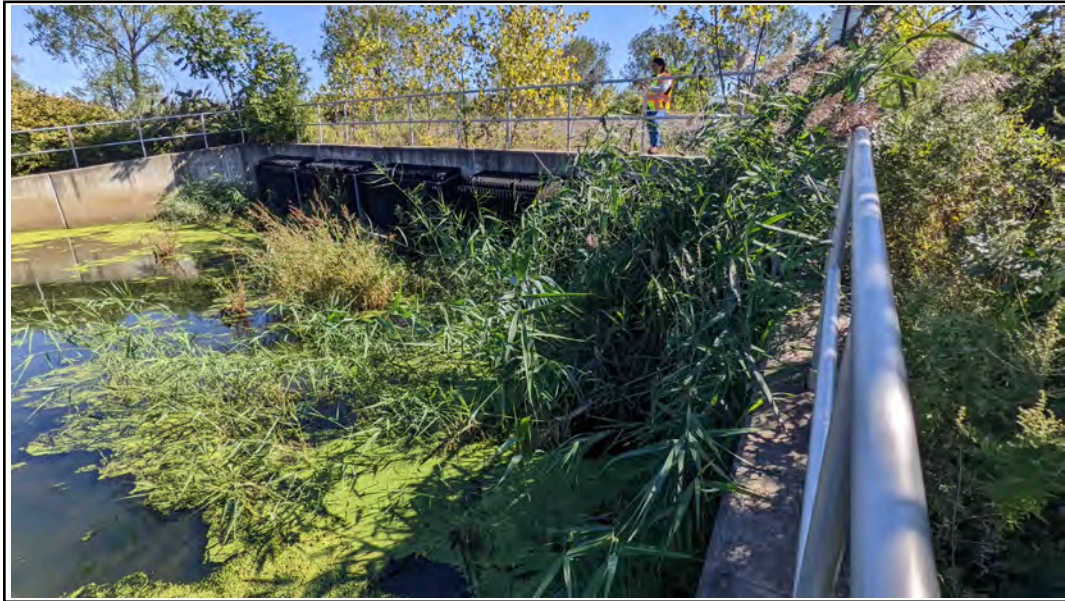
<input type="checkbox"/> Immediate		Other Notes:	
<input type="checkbox"/> Repair		All five tide gates are functional.	
<input checked="" type="checkbox"/> Continued Upkeep			
<input type="checkbox"/> None

Figure 1: Upstream view at tide gate

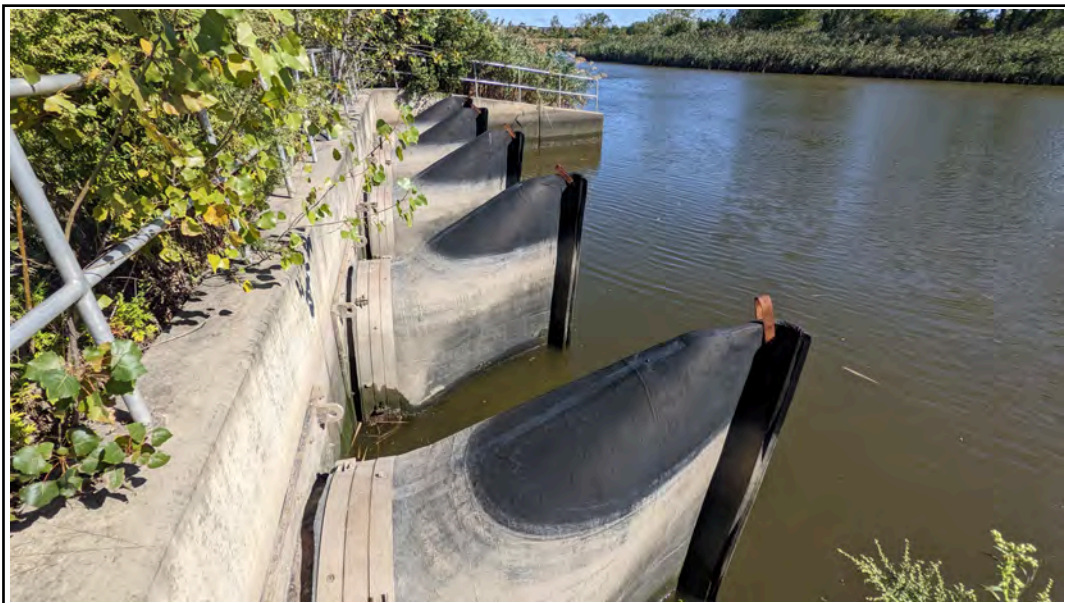
Figure 2: Downstream view at tide gate

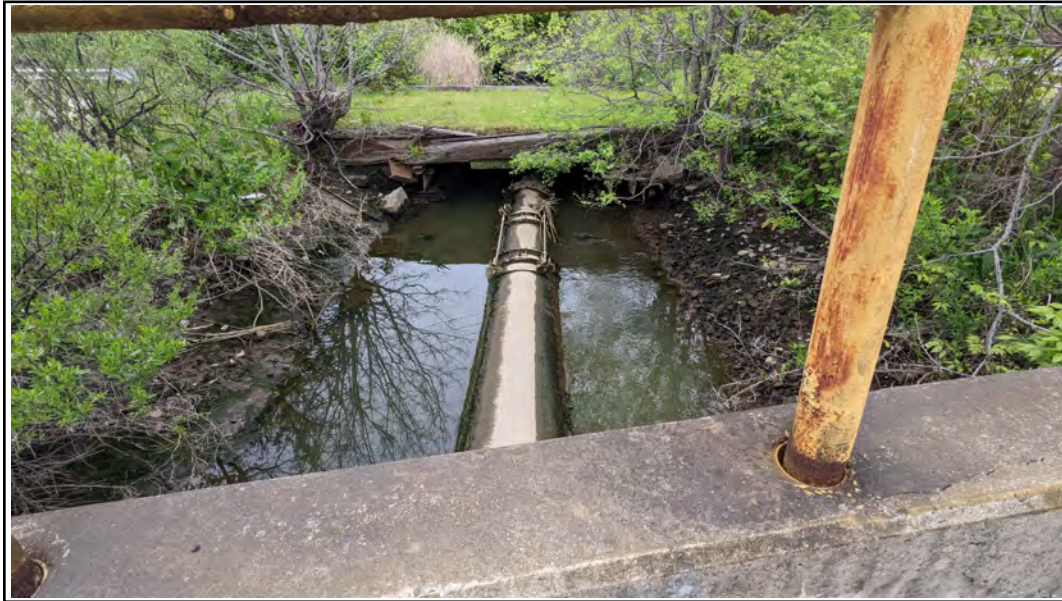
Figure 1: Upstream view of ditch at bridge

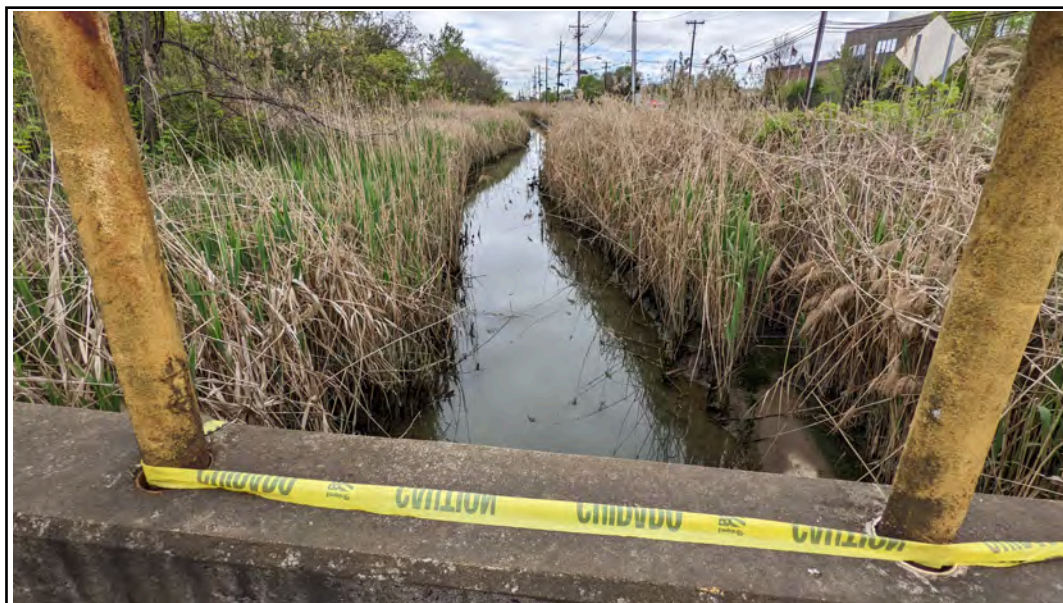
Figure 2: Downstream view of ditch at bridge

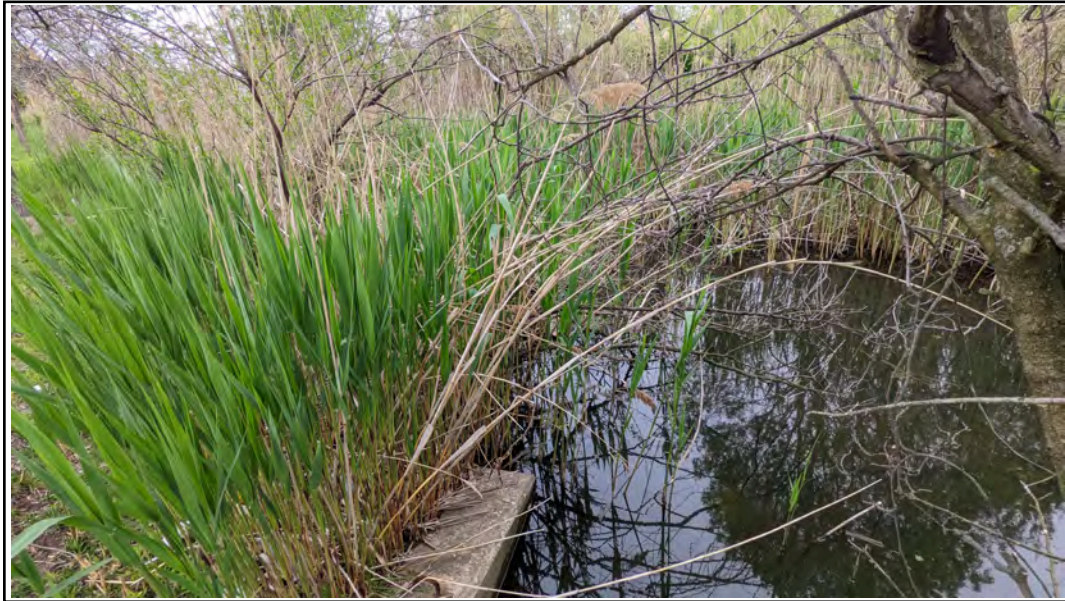
Figure 1: Upstream view of ditch

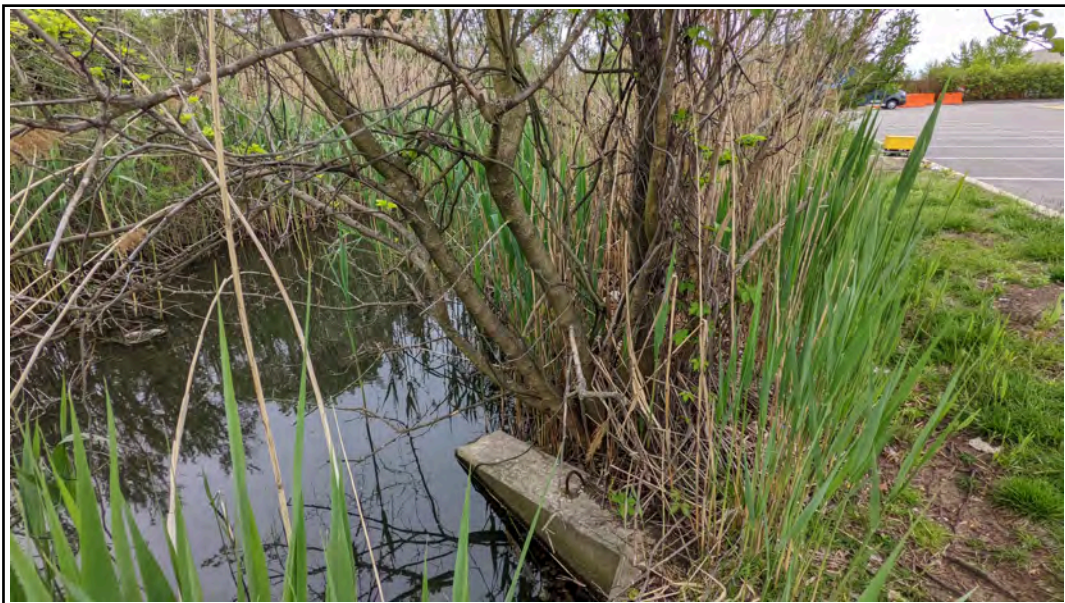
Figure 2: Downstream view of ditch

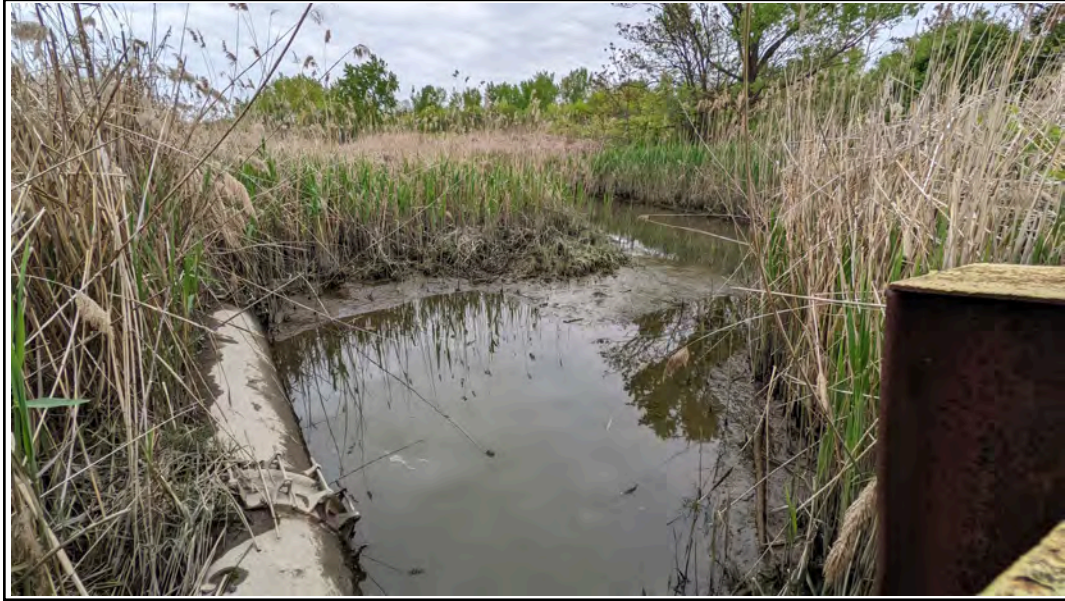
Figure 1: Upstream view of ditch at bridge

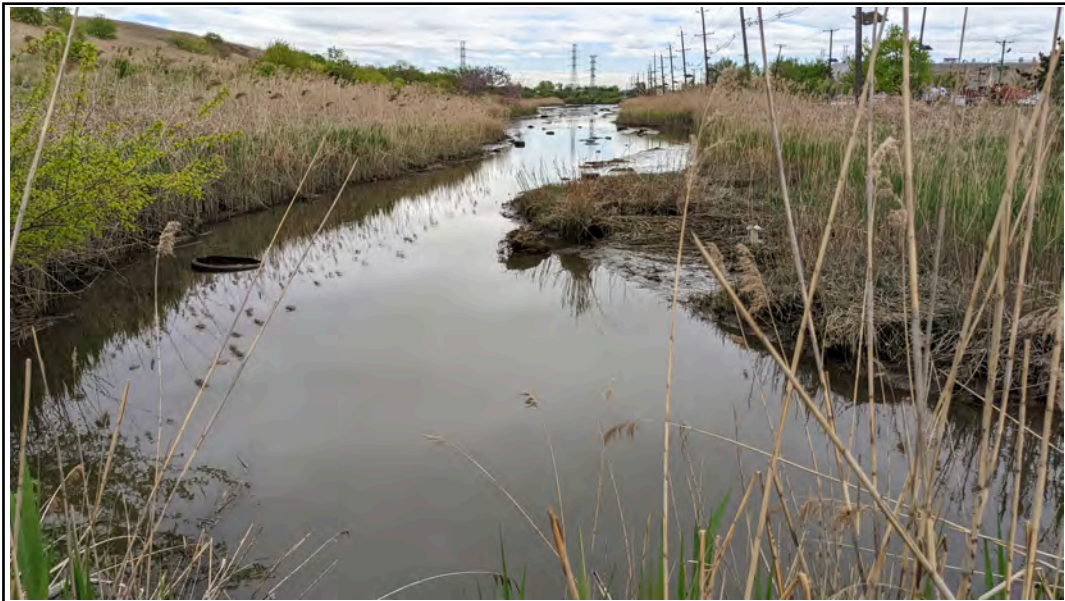
Figure 2: Downstream view of ditch at bridge

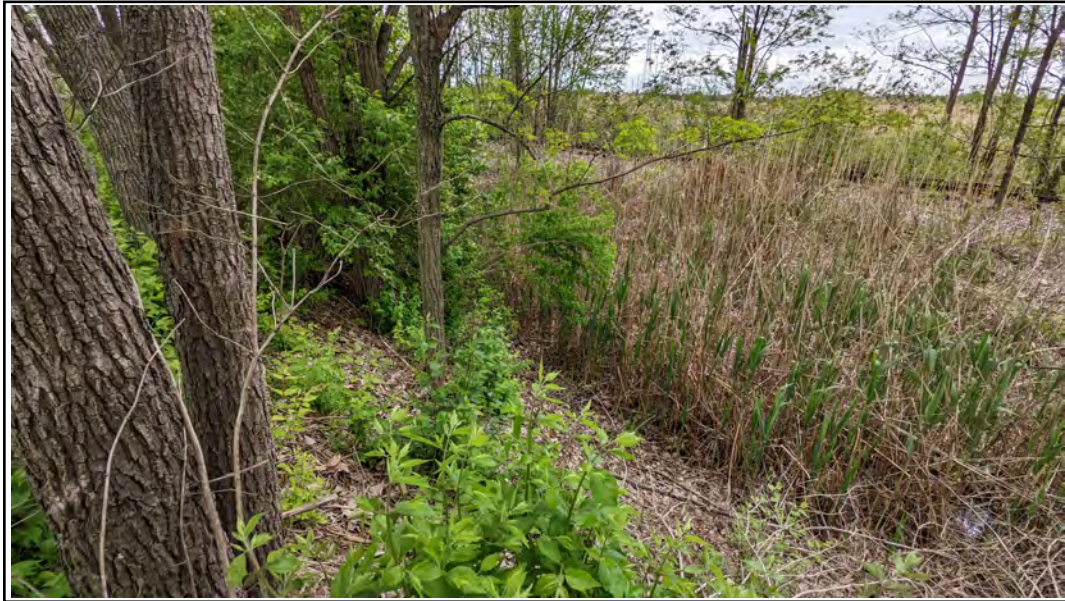
Figure 1: Upstream view of ditch

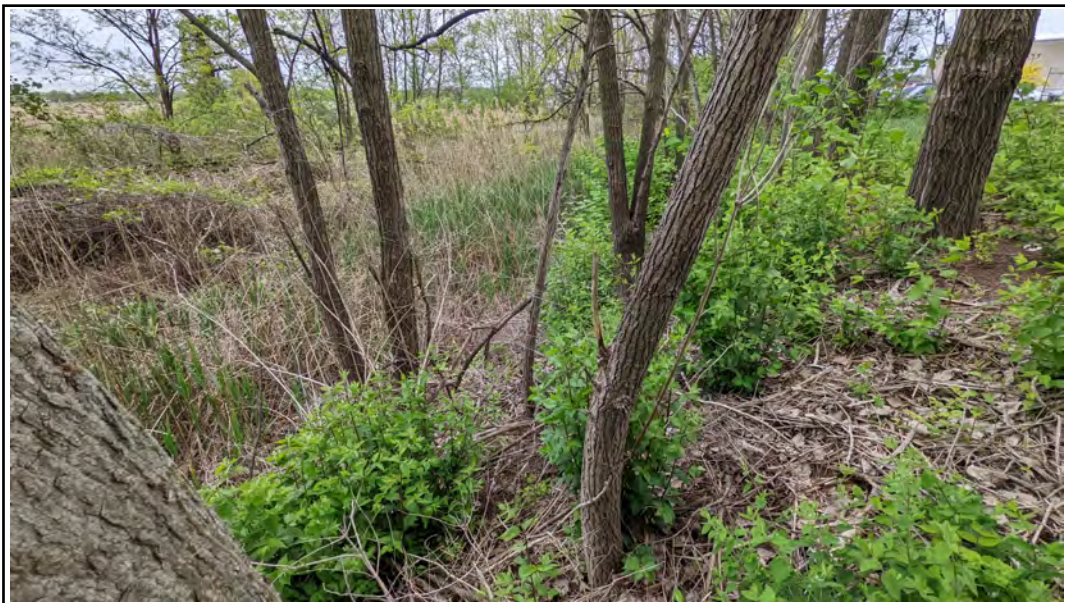
Figure 2: Downstream view of ditch

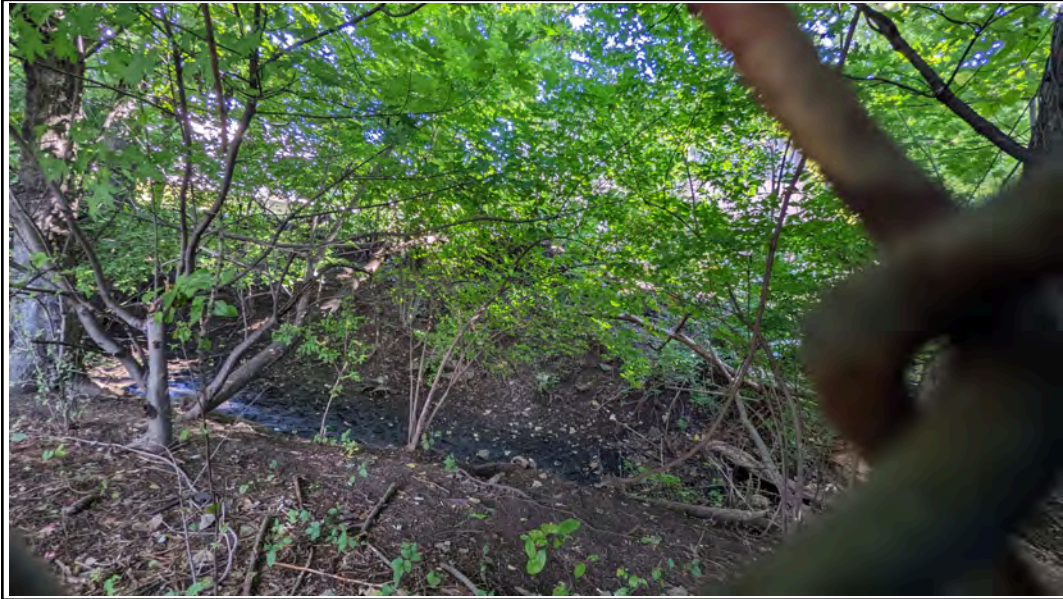
Figure 1: Upstream view of ditch

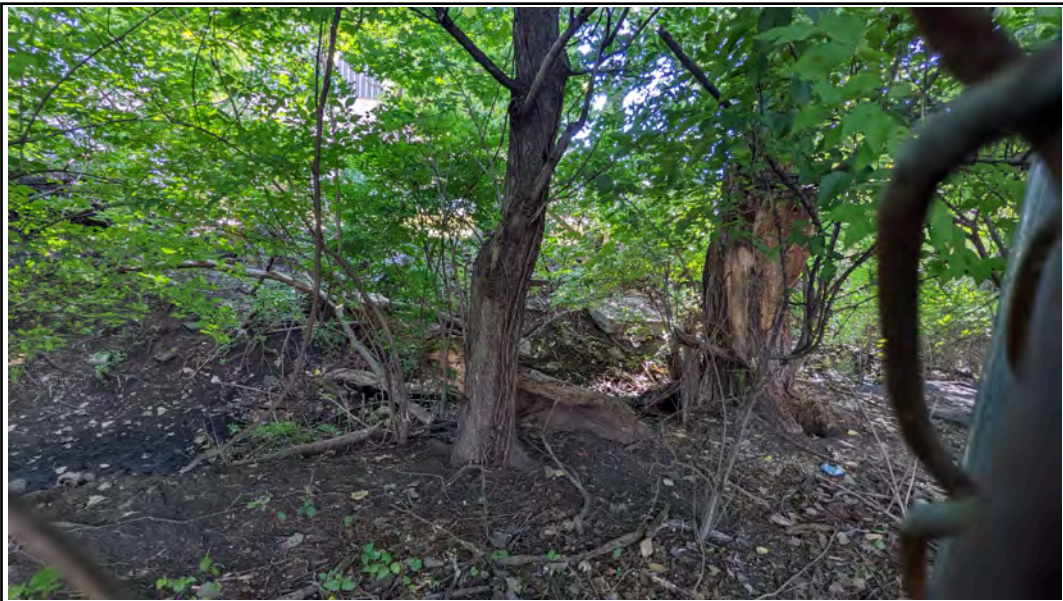
Figure 2: Downstream view of ditch
