New Jersey Sports & Exposition Authority Drainage Ditch Inspection Report

**The National Flood Insurance Program
Community Rating System**

The New Jersey Sports and Exposition Authority

October 13, 2022

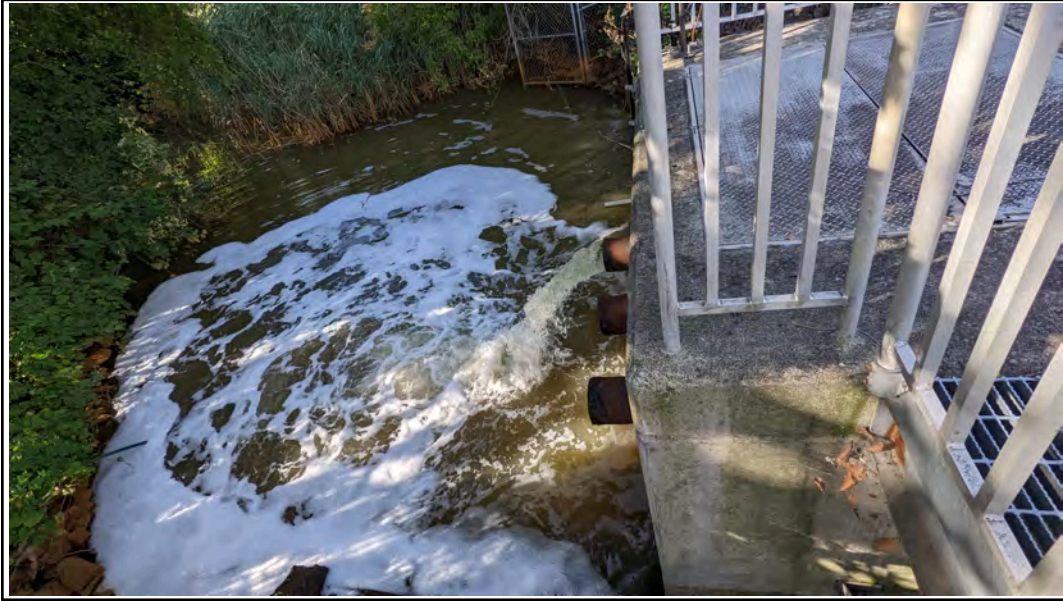
Type of Inspection: <input checked="" type="checkbox"/> Yearly <input type="checkbox"/> Post-Storm <input type="checkbox"/> Complaint <input checked="" type="checkbox"/> Ditch <input type="checkbox"/> Tide Gate <input checked="" type="checkbox"/> Pump System	Notes on Condition / Problems: Ditch is flowing clear downstream. Ditch is not accessible upstream. Pump station is functioning.
System Designation: <input checked="" type="checkbox"/> Natural Stream <input type="checkbox"/> Manmade Channel <input type="checkbox"/> Catch Basin <input type="checkbox"/> Culvert <input type="checkbox"/> Outfall <input type="checkbox"/> Other:	Notes on Maintenance: Little Ferry DPW regularly maintains the equipment.
Overall Functionality: <input checked="" type="checkbox"/> Fully Functional <input type="checkbox"/> Functional with Restrictions <input type="checkbox"/> Non-Functional	Other Notes: 3 pumps and generator are operational.

Figure 1: Upstream view at pump station

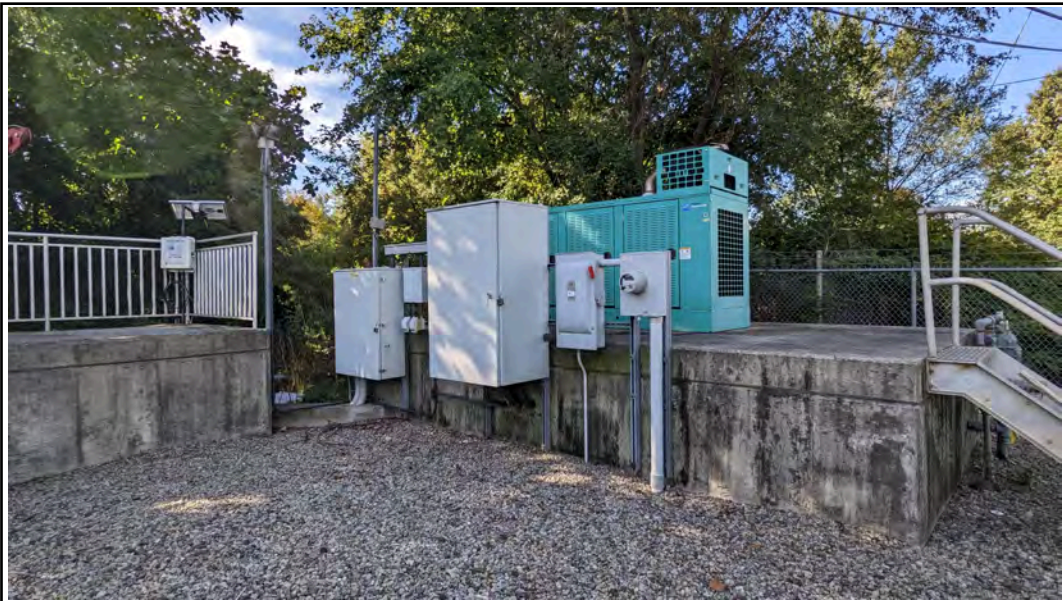
Figure 2: View at pump station

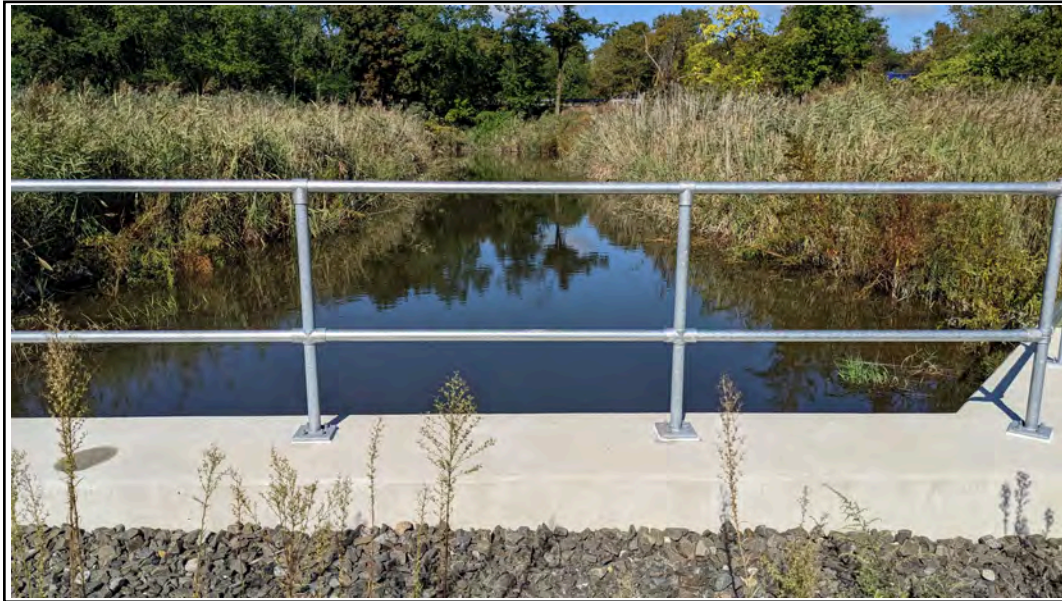
Figure 1: Upstream view of ditch at culvert

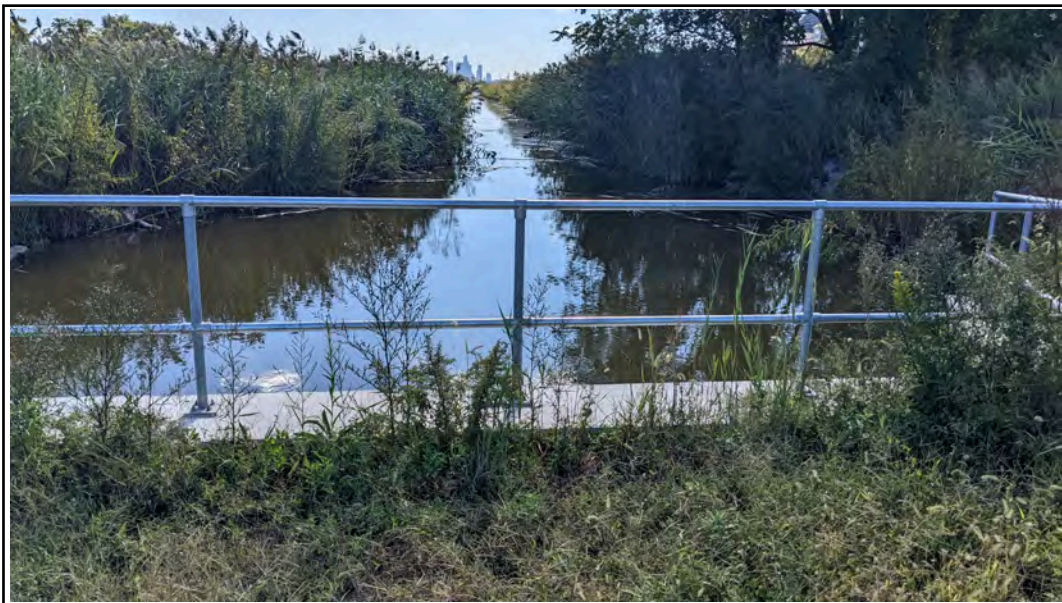
Figure 2: Downstream view of ditch at culvert

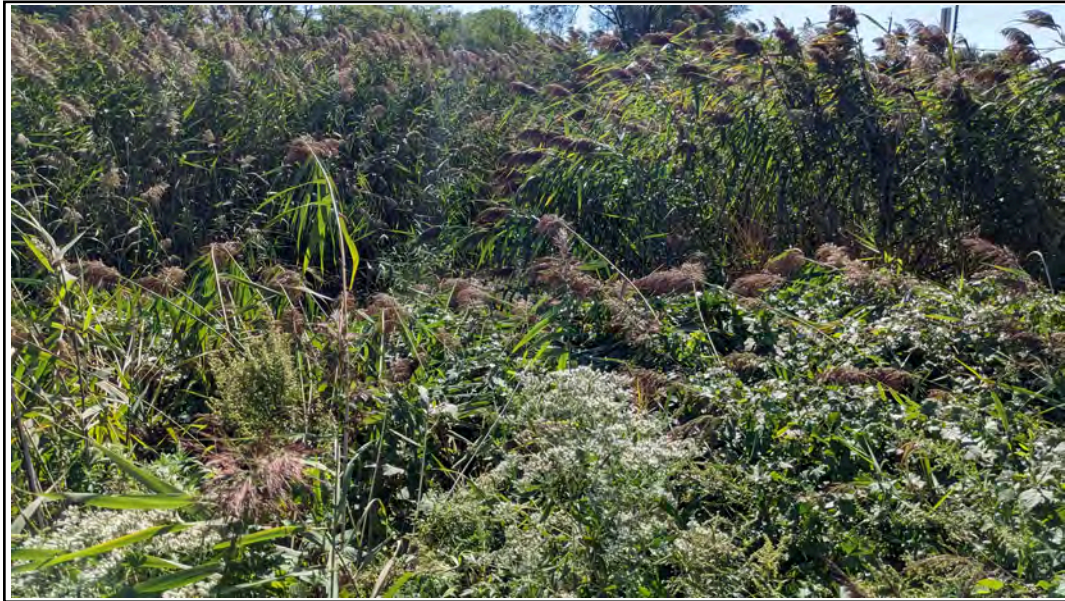
Figure 1: Upstream view of ditch

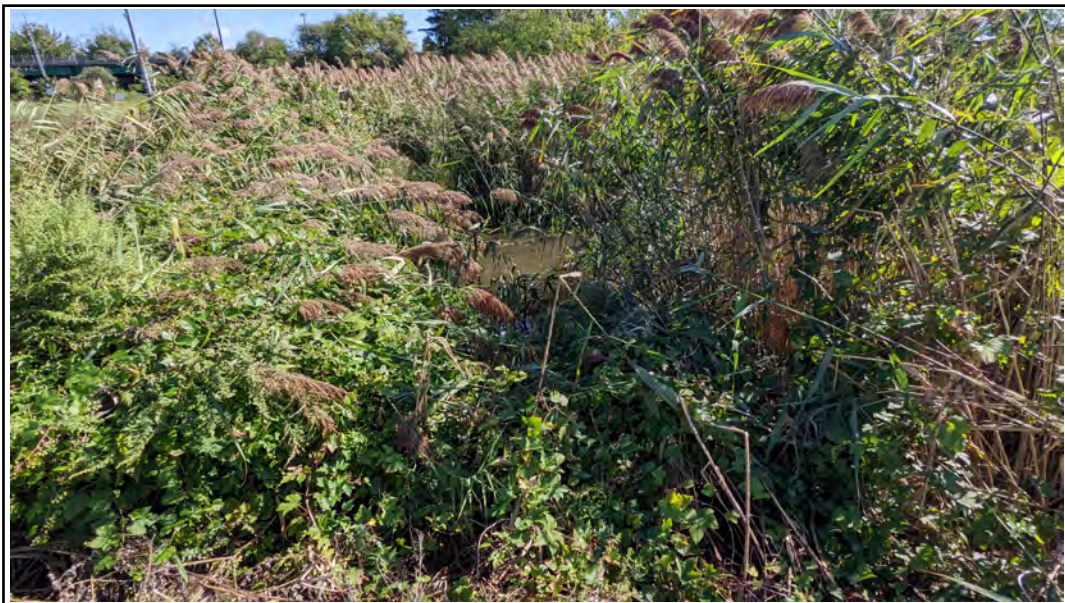
Figure 2: Downstream view of ditch

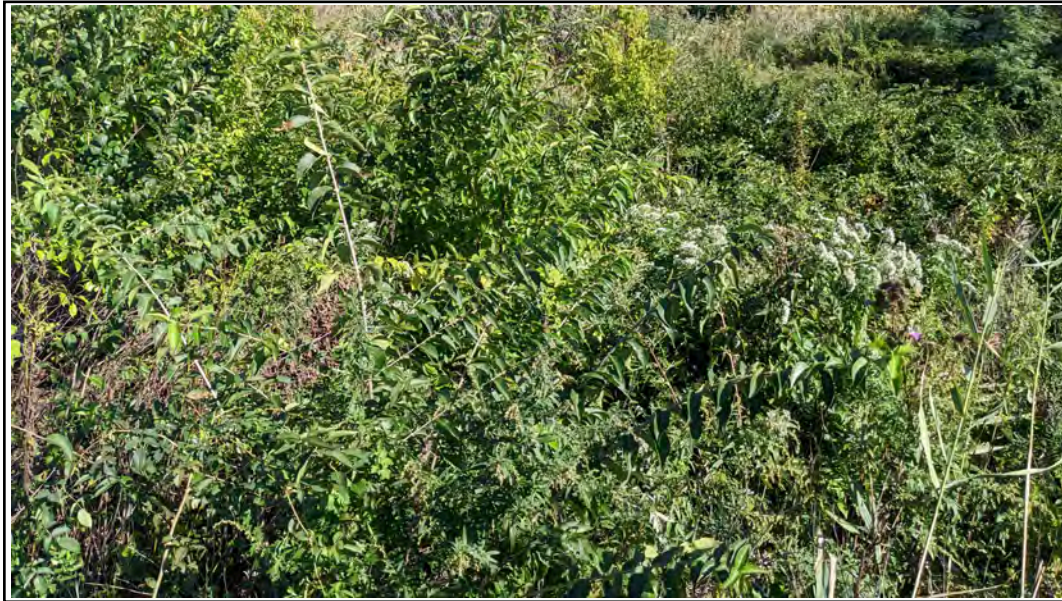
Figure 1: Upstream view of ditch

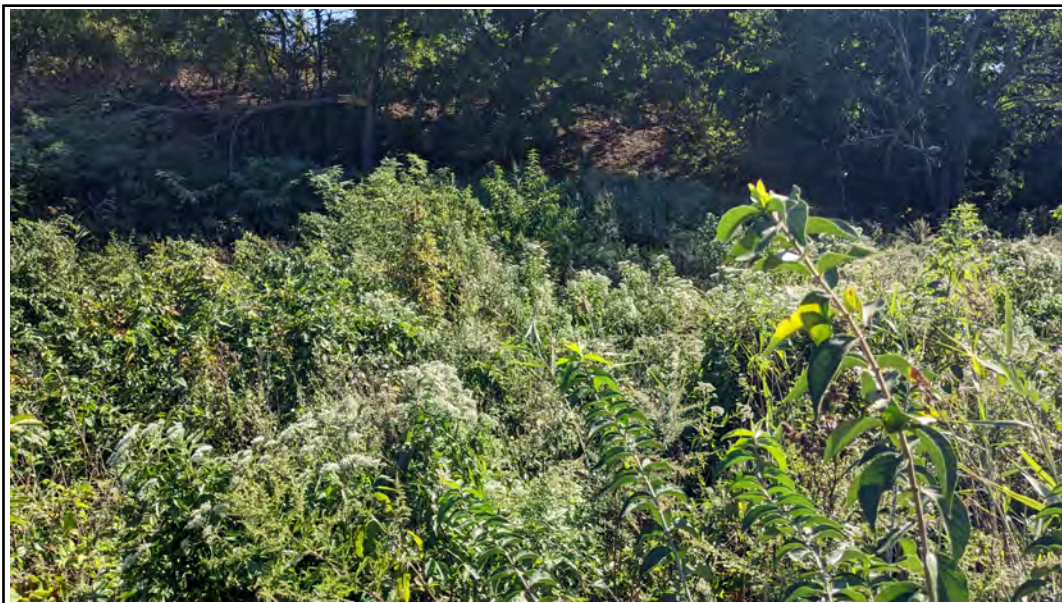
Figure 2: Downstream view of ditch

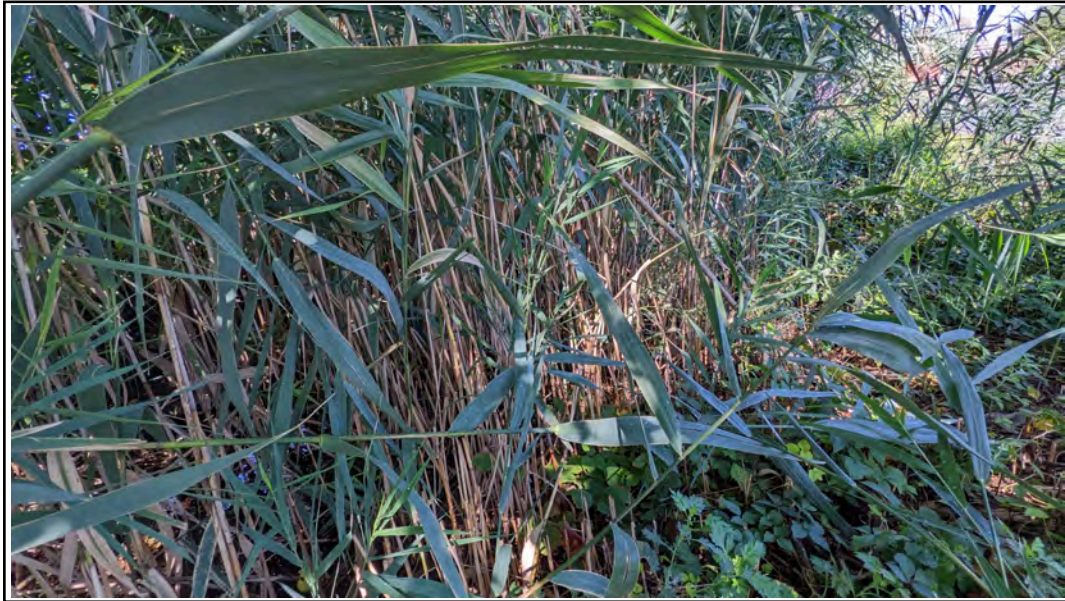
Figure 1: Upstream view of ditch at culvert

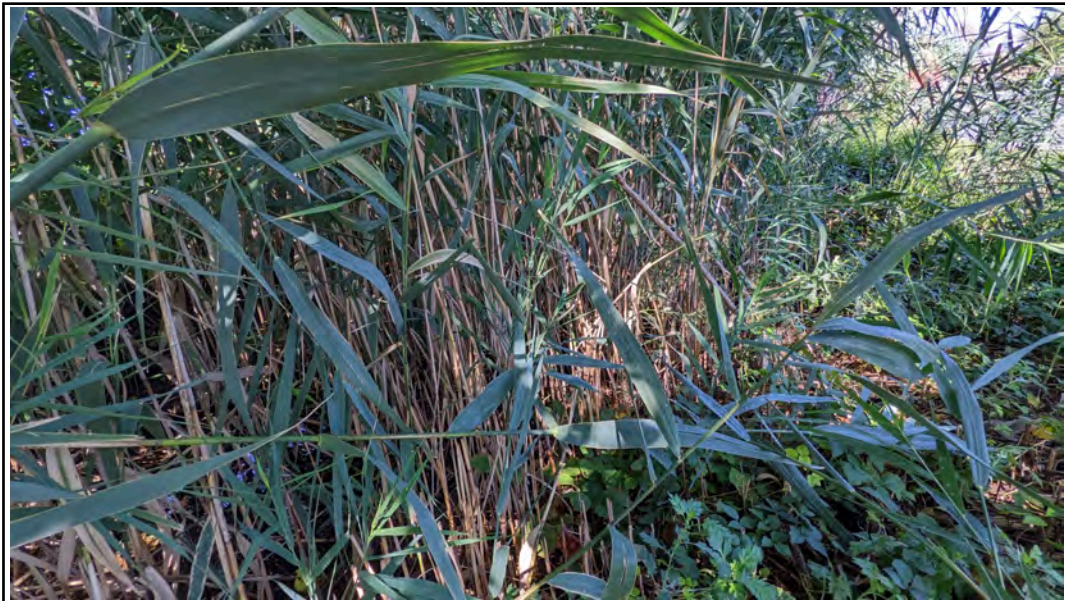
Figure 2: Downstream view of ditch

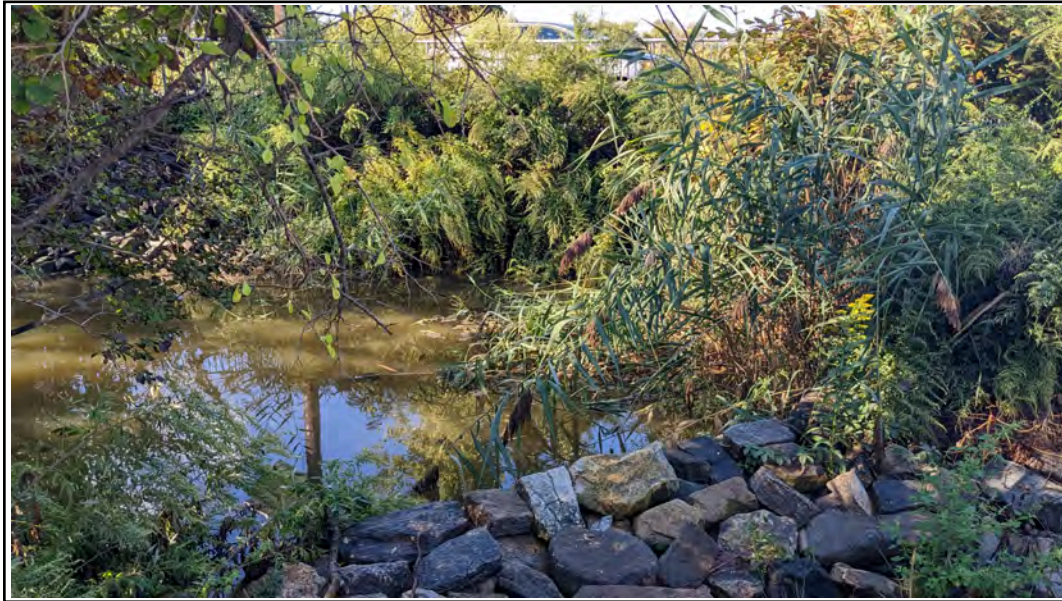
Figure 1: Upstream view of ditch at culvert

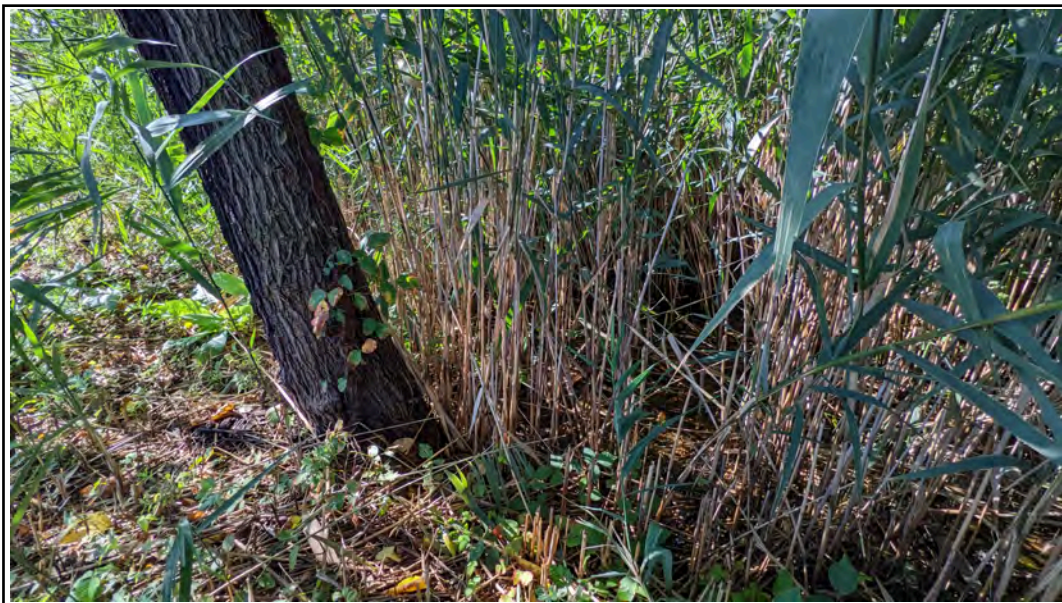
Figure 2: Downstream view of ditch

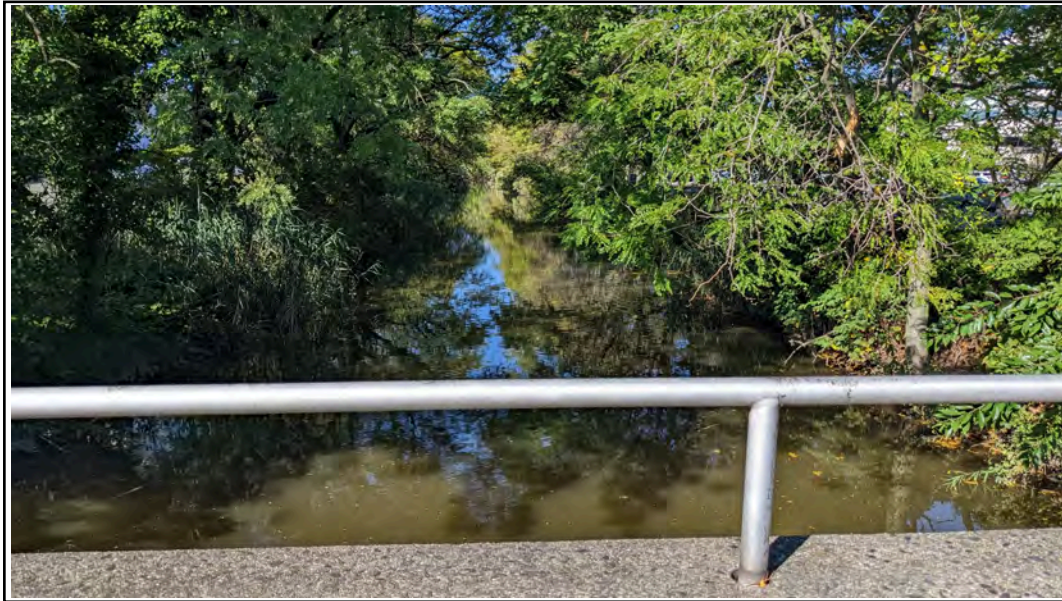
Figure 1: Upstream view of ditch at bridge

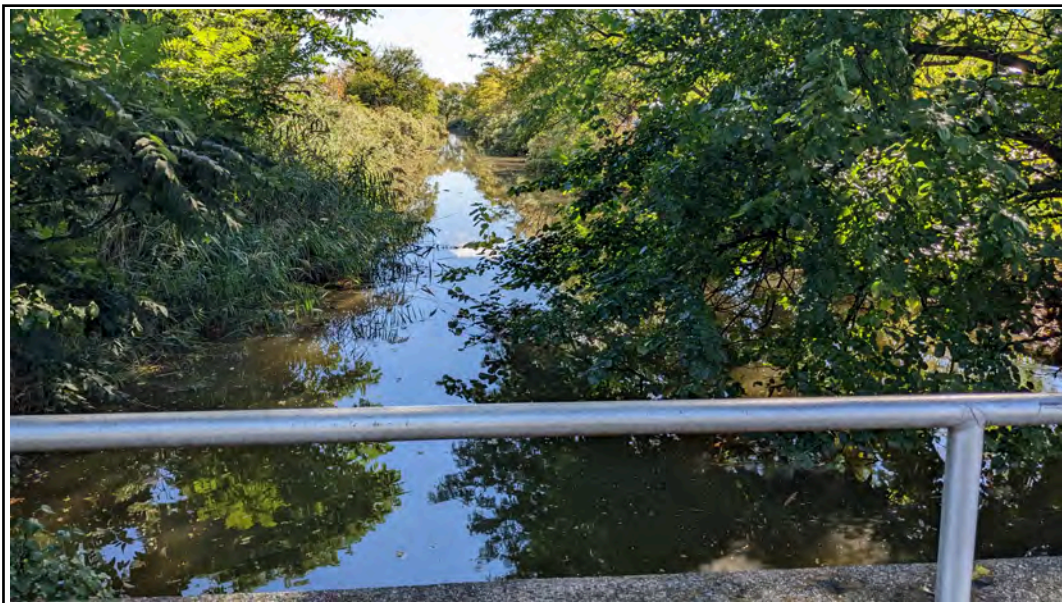
Figure 2: Downstream view of ditch at bridge

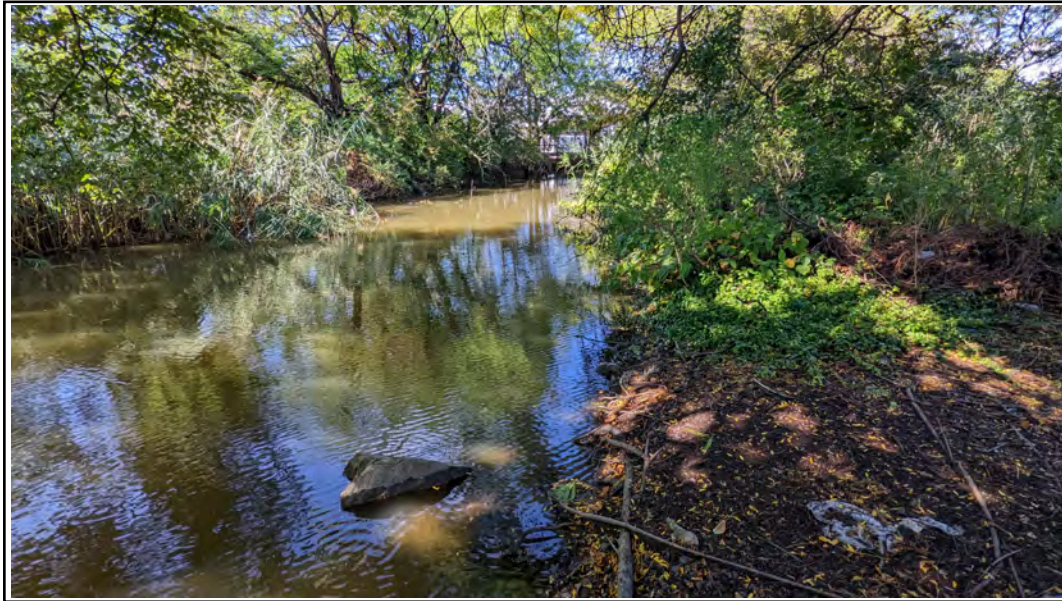
Figure 1: Upstream view of ditch at bridge

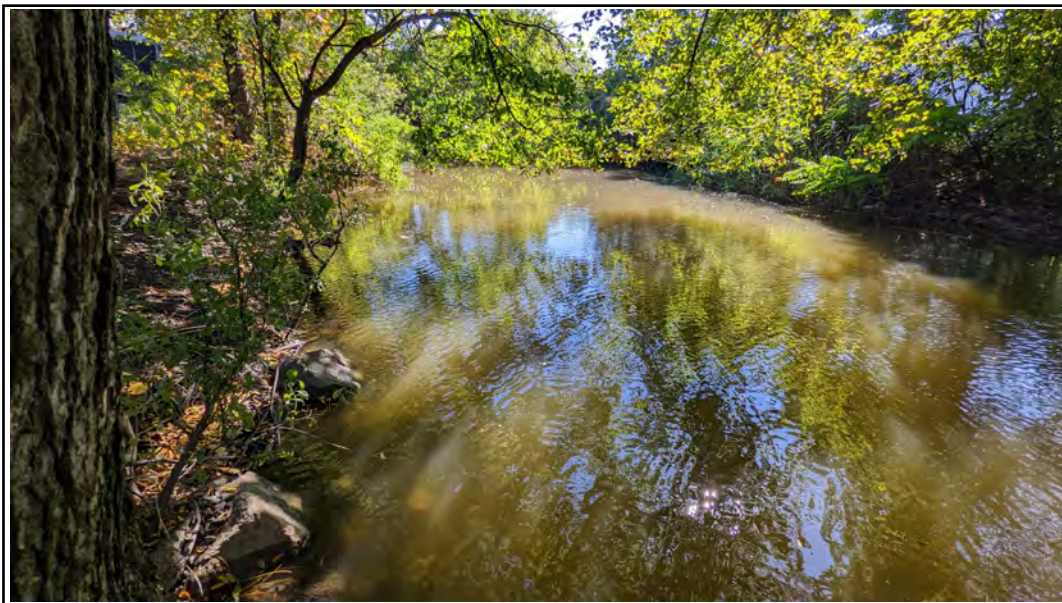
Figure 2: Downstream view of ditch at bridge

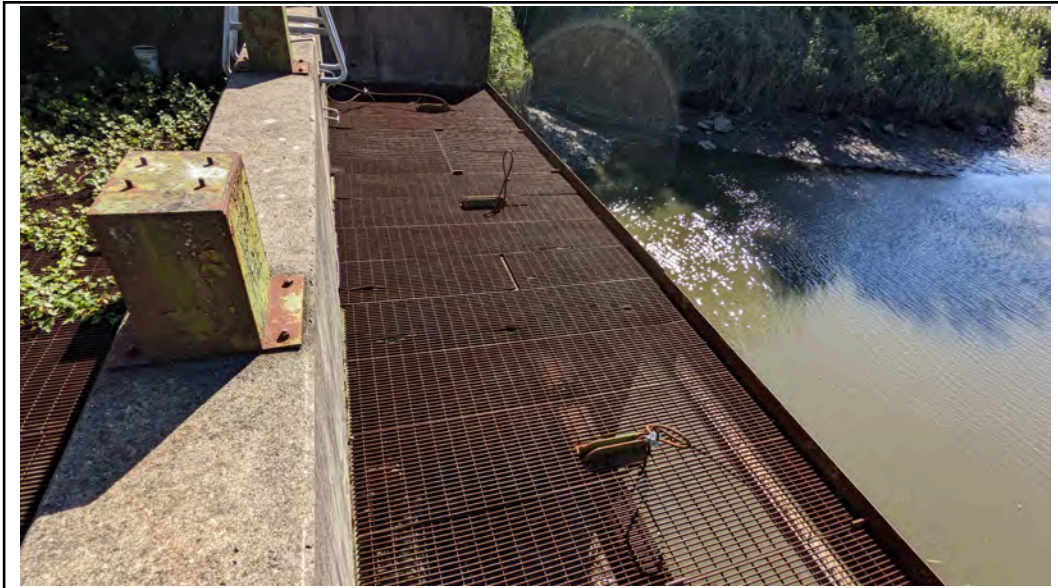
Figure 1: Upstream view at tide gate

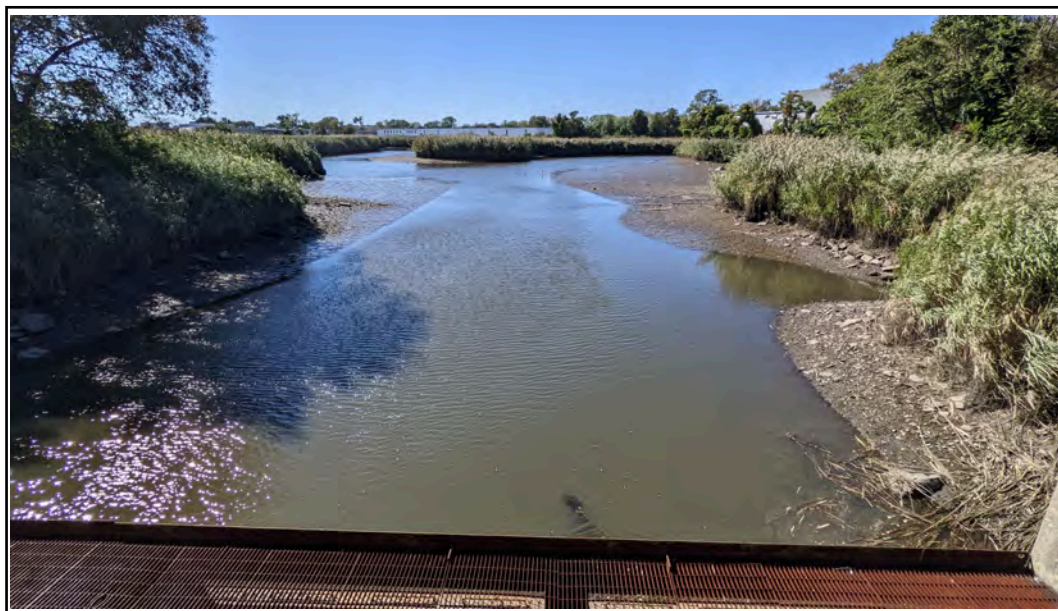
Figure 2: Downstream view at tide gate

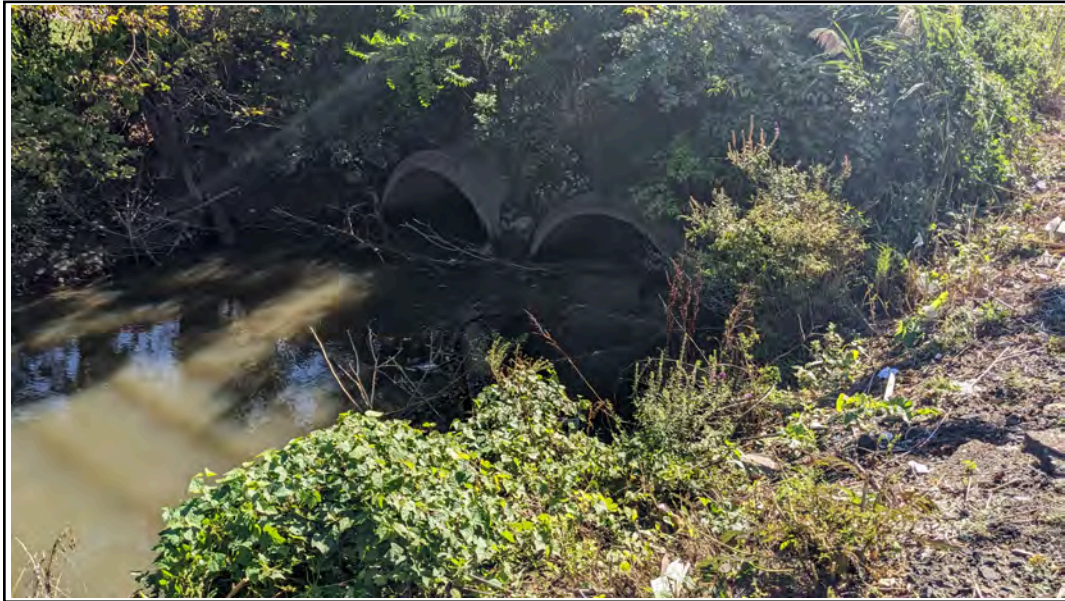
Figure 1: Upstream view of ditch at bridge

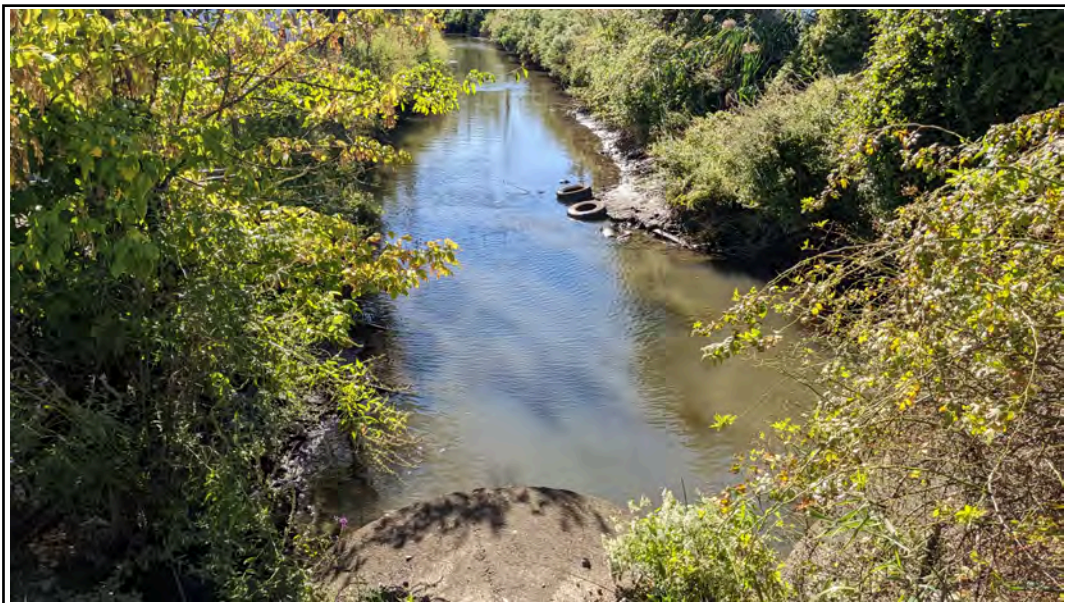
Figure 2: Downstream view of ditch at bridge

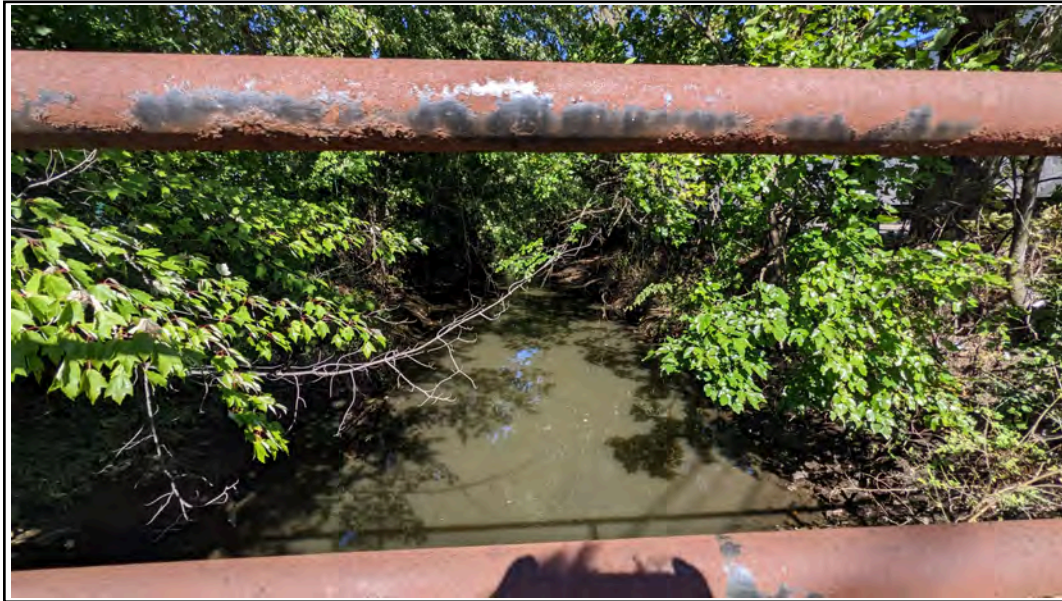
Figure 1: Upstream view of ditch at bridge

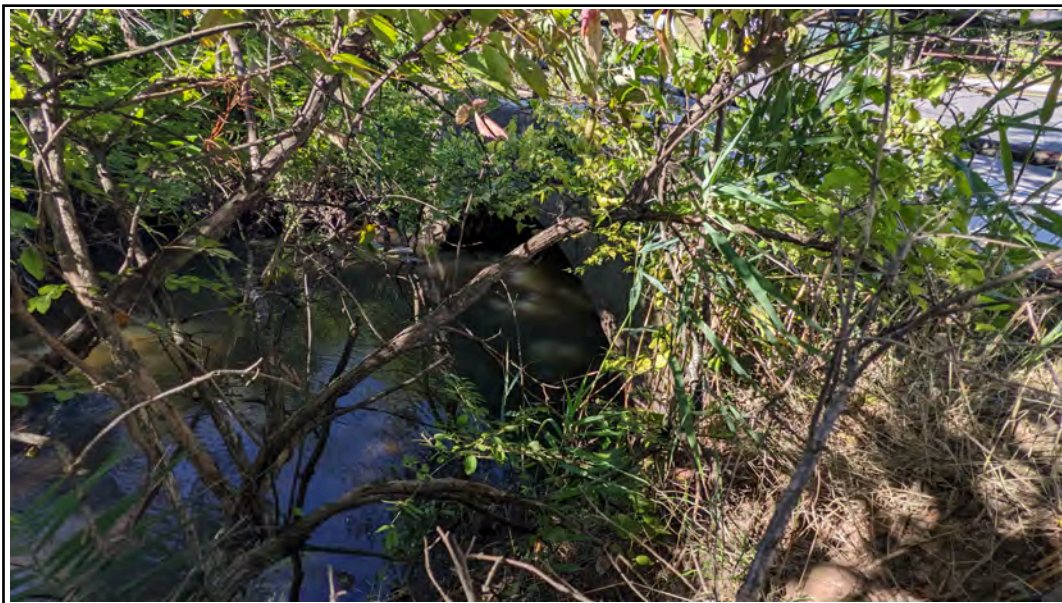
Figure 2: Downstream view of ditch at culvert

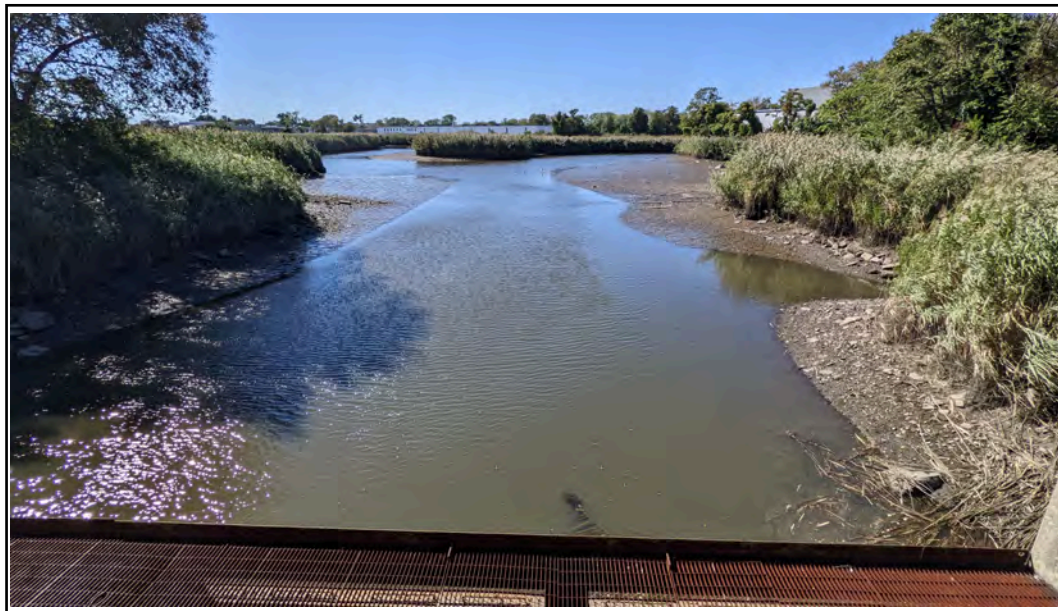
Figure 2: Downstream view of ditch at culvert

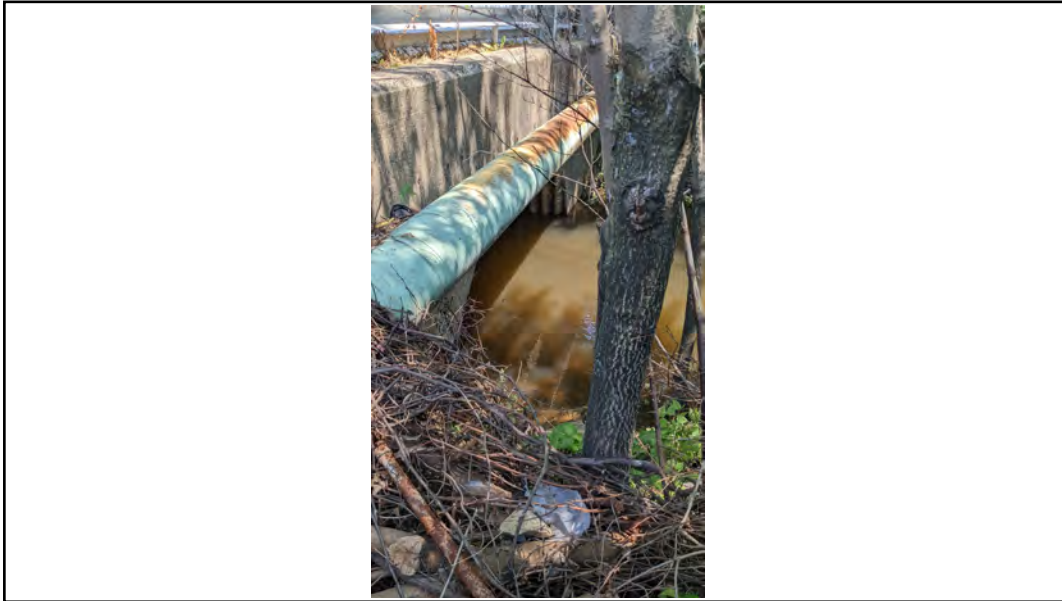
Figure 1: Upstream view of ditch at culvert

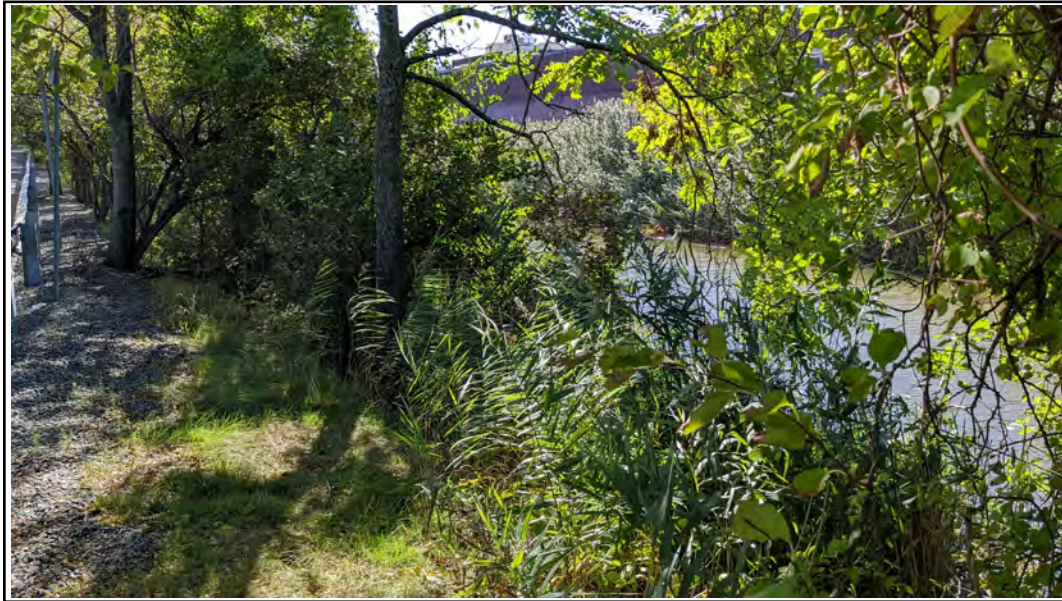
Figure 1: Upstream view of ditch

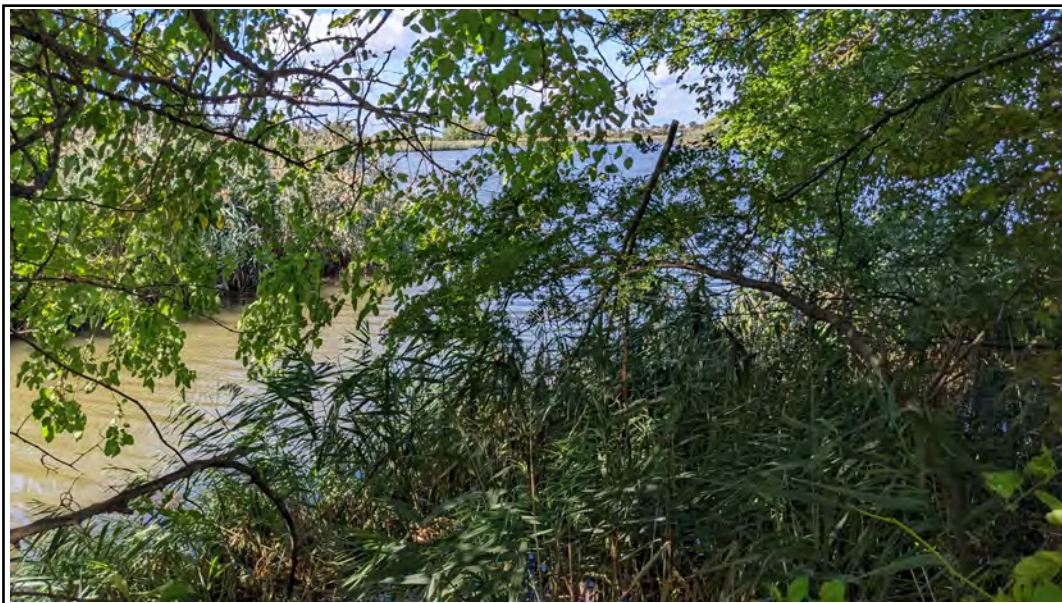
Figure 2: Downstream view of ditch

Type of Inspection:		Notes on Condition / Problems:	
<input checked="" type="checkbox"/> Yearly	<input checked="" type="checkbox"/> Ditch	The ditch is clear of debris.	
<input type="checkbox"/> Post-Storm	<input type="checkbox"/> Tide Gate	The banks are overgrown.	
<input type="checkbox"/> Complaint	<input type="checkbox"/> Pump System		
System Designation:			
<input type="checkbox"/> Natural Stream	<input type="checkbox"/> Culvert		
<input checked="" type="checkbox"/> Manmade Channel	<input type="checkbox"/> Outfall		
<input type="checkbox"/> Catch Basin	<input type="checkbox"/> Other: _____	Notes on Maintenance:	
Overall Functionality:			
<input checked="" type="checkbox"/> Fully Functional			
<input type="checkbox"/> Functional with Restrictions			
<input type="checkbox"/> Non-Functional			
Maintenance Required:		Other Notes:	
<input type="checkbox"/> Immediate			
<input type="checkbox"/> Repair			
<input type="checkbox"/> Continued Upkeep

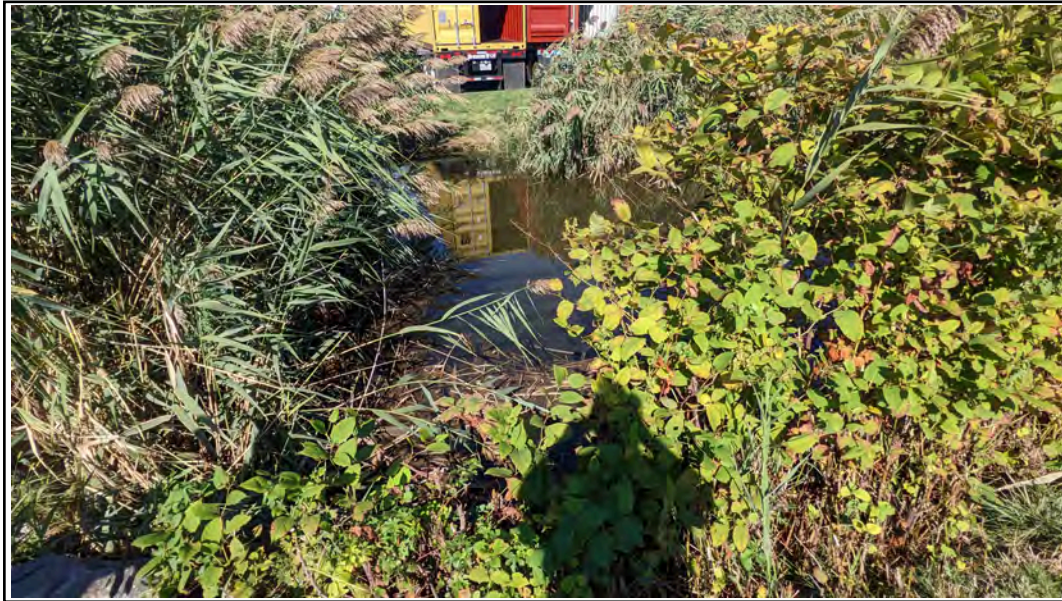
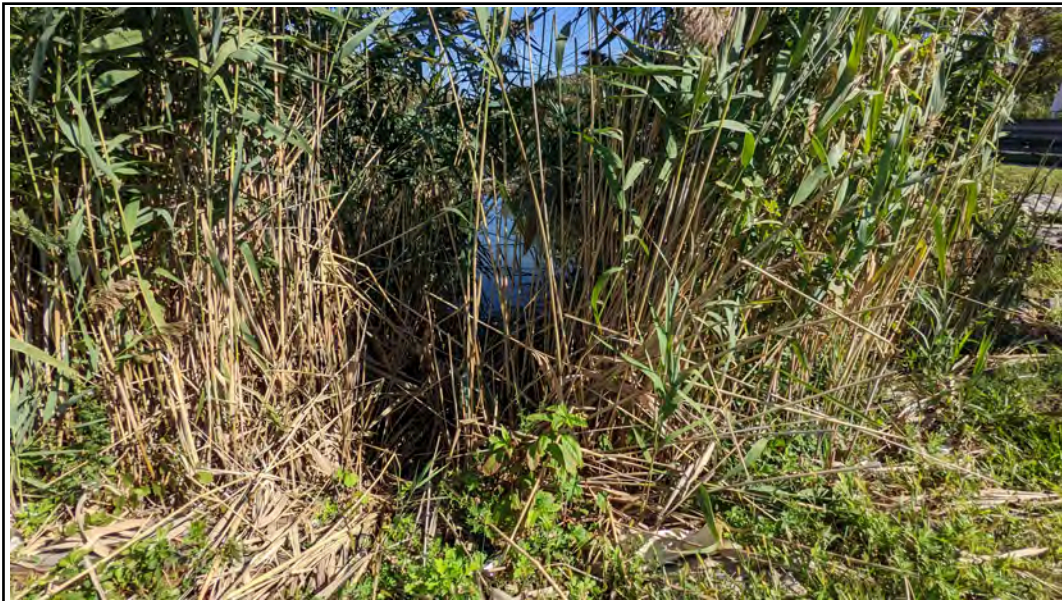
Figure 1: Upstream view of ditch

Figure 2: Downstream view of ditch

Type of Inspection:		Notes on Condition / Problems:	
<input checked="" type="checkbox"/> Yearly	<input checked="" type="checkbox"/> Ditch	Ditch is clear.	
<input type="checkbox"/> Post-Storm	<input type="checkbox"/> Tide Gate		
<input type="checkbox"/> Complaint	<input type="checkbox"/> Pump System		
System Designation:			
<input type="checkbox"/> Natural Stream	<input type="checkbox"/> Culvert		
<input checked="" type="checkbox"/> Manmade	<input type="checkbox"/> Outfall	Notes on Maintenance:	
<input type="checkbox"/> Channel	<input type="checkbox"/> Other:		
<input type="checkbox"/> Catch Basin			
Overall Functionality:			
<input checked="" type="checkbox"/> Fully Functional			
<input type="checkbox"/> Functional with Restrictions		Other Notes:	
<input type="checkbox"/> Non-Functional			
Maintenance Required:			
<input type="checkbox"/> Immediate			
<input type="checkbox"/> Repair			
<input type="checkbox"/> Continued Upkeep

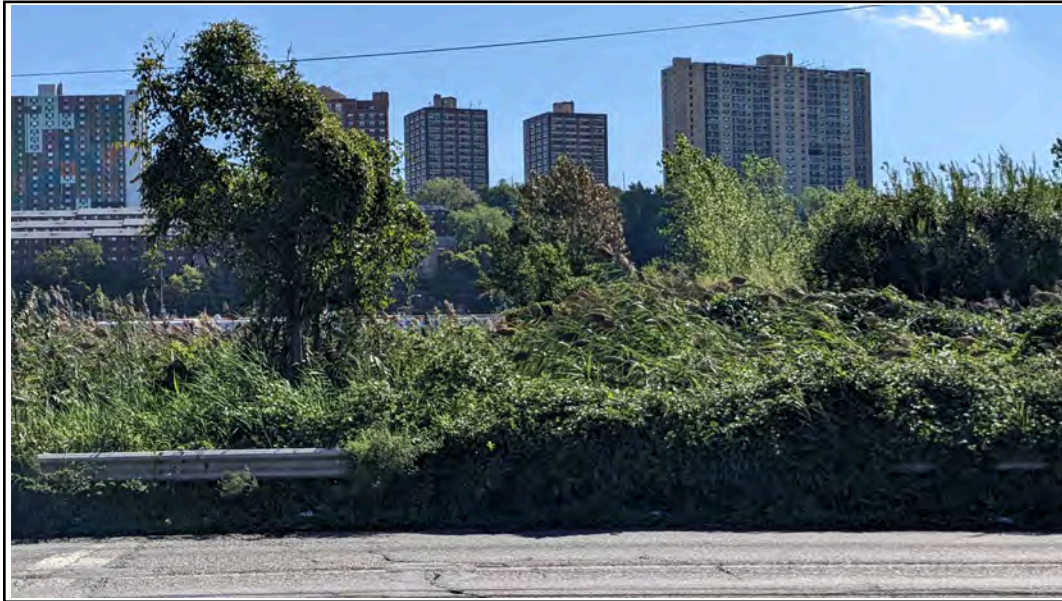
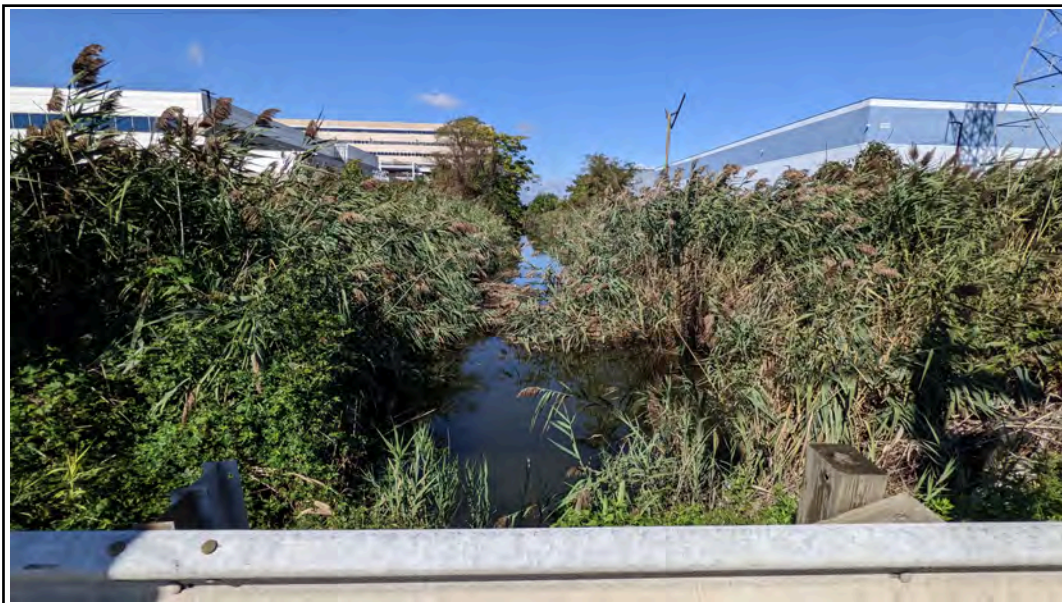
Figure 1: Downstream view of ditch

Figure 2: Downstream view of ditch

Type of Inspection:		Notes on Condition / Problems:	
<input checked="" type="checkbox"/> Yearly	<input checked="" type="checkbox"/> Ditch	Ditch is clear of debris.	
<input type="checkbox"/> Post-Storm	<input type="checkbox"/> Tide Gate		
<input type="checkbox"/> Complaint	<input type="checkbox"/> Pump System		
System Designation:			
<input type="checkbox"/> Natural Stream	<input type="checkbox"/> Culvert		
<input checked="" type="checkbox"/> Manmade	<input type="checkbox"/> Outfall		
Channel	<input type="checkbox"/> Other:	Notes on Maintenance:	
<input type="checkbox"/> Catch Basin			
Overall Functionality:			
<input checked="" type="checkbox"/> Fully Functional			
<input type="checkbox"/> Functional with Restrictions			
<input type="checkbox"/> Non-Functional			
Maintenance Required:			
<input type="checkbox"/> Immediate		Other Notes:	
<input type="checkbox"/> Repair		Photos taken from footbridge.	
<input type="checkbox"/> Continued Upkeep

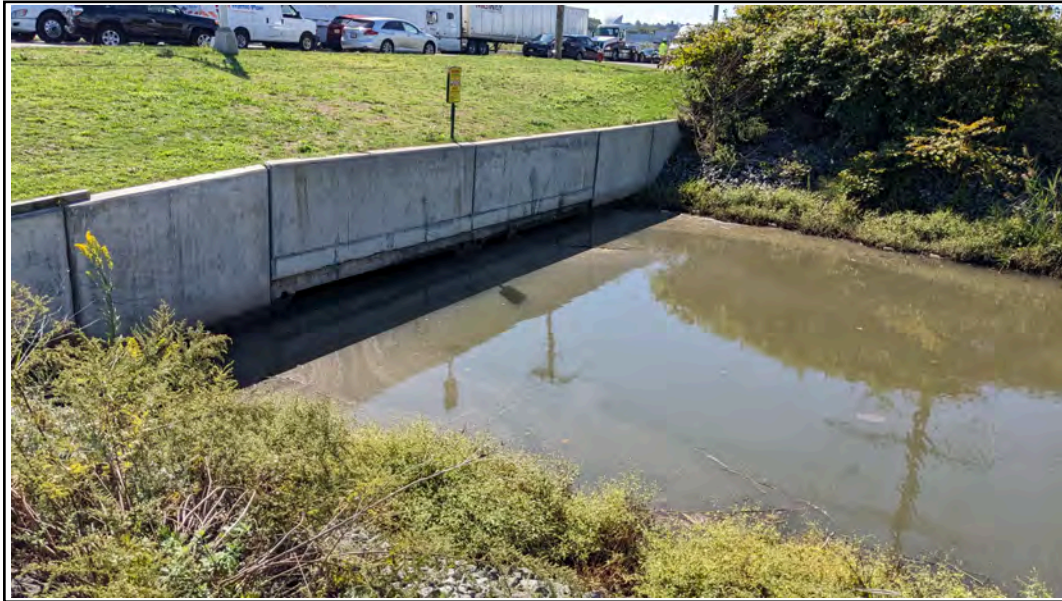
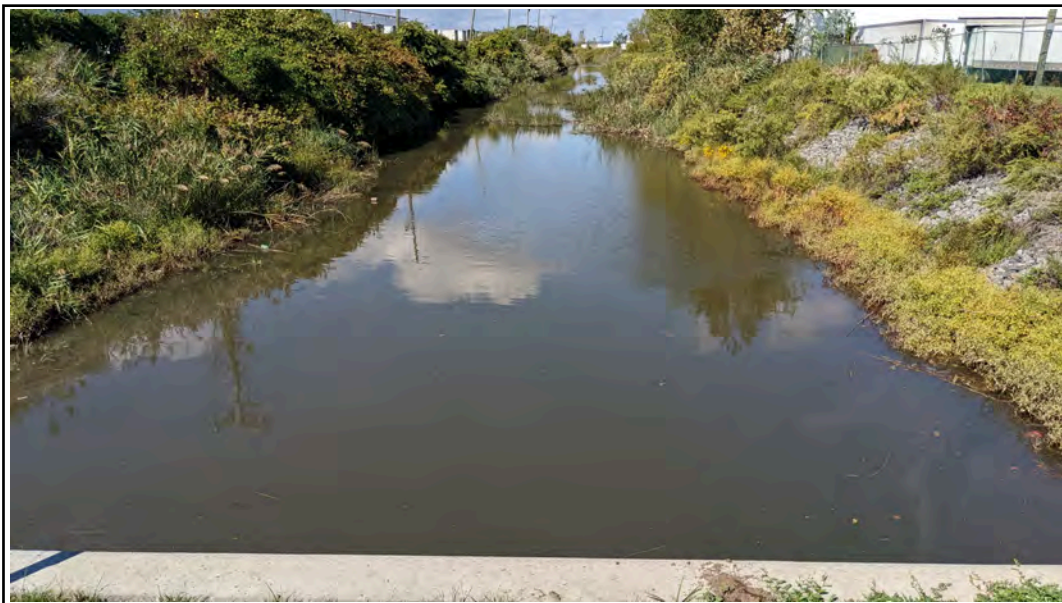
Figure 1: Upstream view of ditch at headwall

Figure 2: Downstream view of ditch at headwall

Type of Inspection:		Notes on Condition / Problems:	
<input checked="" type="checkbox"/> Yearly	<input checked="" type="checkbox"/> Ditch	Heavy brush along the banks.	
<input type="checkbox"/> Post-Storm	<input type="checkbox"/> Tide Gate	There is debris in the ditch.	
<input type="checkbox"/> Complaint	<input type="checkbox"/> Pump System		
System Designation:			
<input type="checkbox"/> Natural Stream	<input type="checkbox"/> Culvert		
<input checked="" type="checkbox"/> Manmade	<input type="checkbox"/> Outfall		
Channel	<input type="checkbox"/> Other:	Notes on Maintenance:	
<input type="checkbox"/> Catch Basin			
Overall Functionality:			
<input checked="" type="checkbox"/> Fully Functional			
<input type="checkbox"/> Functional with Restrictions			
<input type="checkbox"/> Non-Functional			
Maintenance Required:		Other Notes:	
<input type="checkbox"/> Immediate			
<input type="checkbox"/> Repair			
<input checked="" type="checkbox"/> Continued Upkeep
