New Jersey Sports & Exposition Authority Drainage Ditch Inspection Report

**The National Flood Insurance Program
Community Rating System**

The New Jersey Sports and Exposition Authority

October 13, 2022

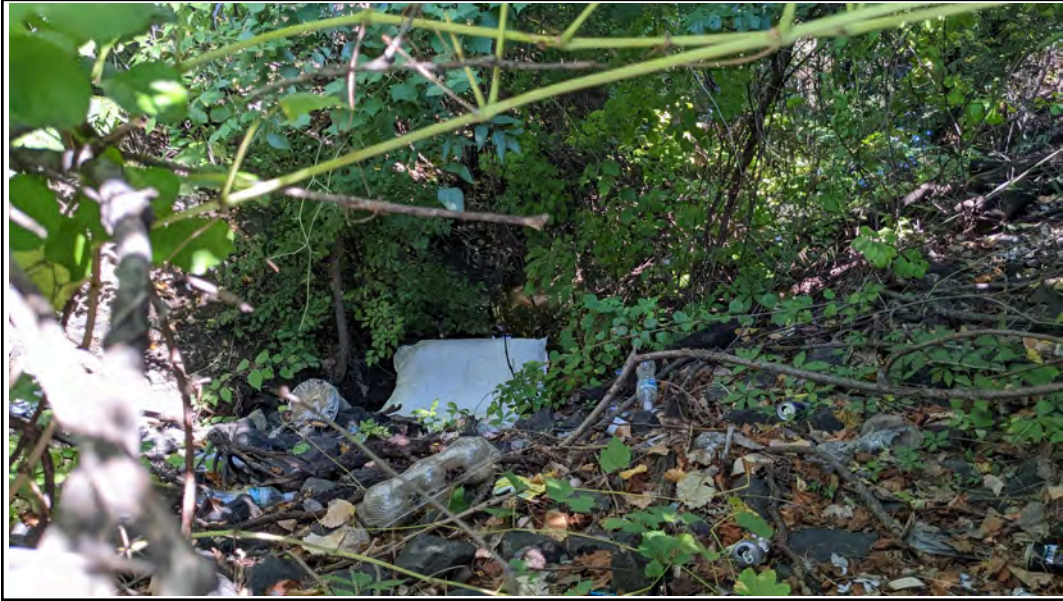
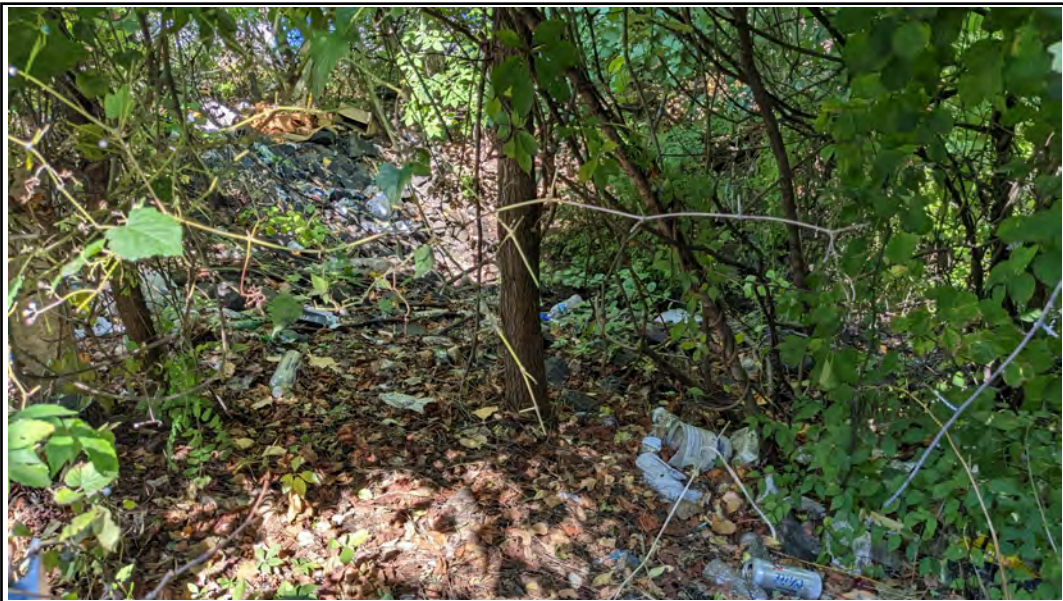
Figure 1: Upstream view of ditch

Figure 2: Downstream view of ditch

Type of Inspection:		Notes on Condition / Problems:	
<input checked="" type="checkbox"/> Yearly	<input checked="" type="checkbox"/> Ditch	Ditch is overgrown and not accessible.	
<input type="checkbox"/> Post-Storm	<input type="checkbox"/> Tide Gate		
<input type="checkbox"/> Complaint	<input type="checkbox"/> Pump System		
System Designation:			
<input type="checkbox"/> Natural Stream	<input type="checkbox"/> Culvert		
<input checked="" type="checkbox"/> Manmade Channel	<input type="checkbox"/> Outfall		
<input type="checkbox"/> Catch Basin	<input type="checkbox"/> Other: _____	Notes on Maintenance:	
Overall Functionality:			
<input checked="" type="checkbox"/> Fully Functional			
<input type="checkbox"/> Functional with Restrictions			
<input type="checkbox"/> Non-Functional			
Maintenance Required:		Other Notes:	
<input type="checkbox"/> Immediate			
<input type="checkbox"/> Repair			
<input checked="" type="checkbox"/> Continued Upkeep

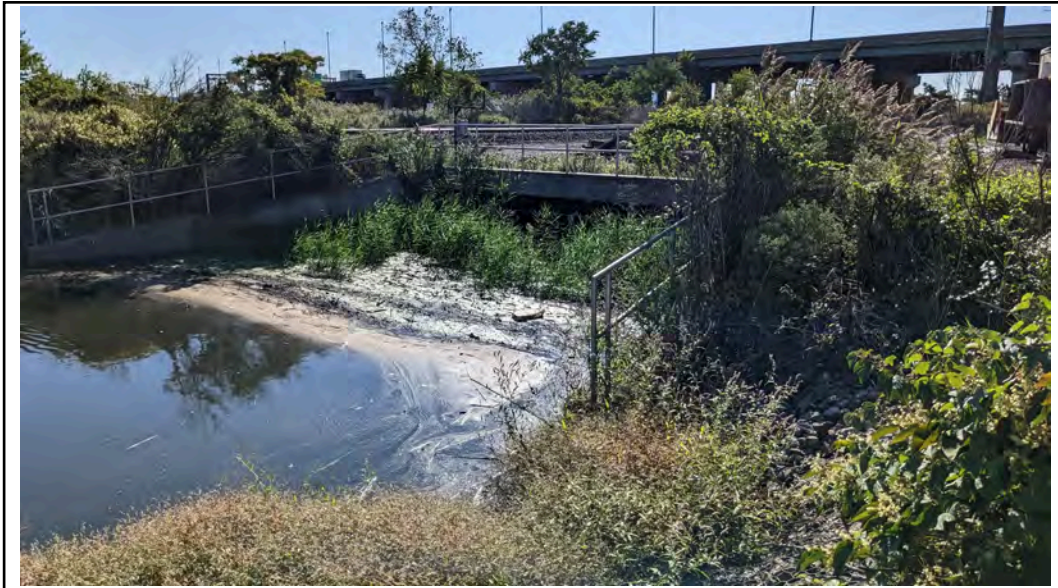
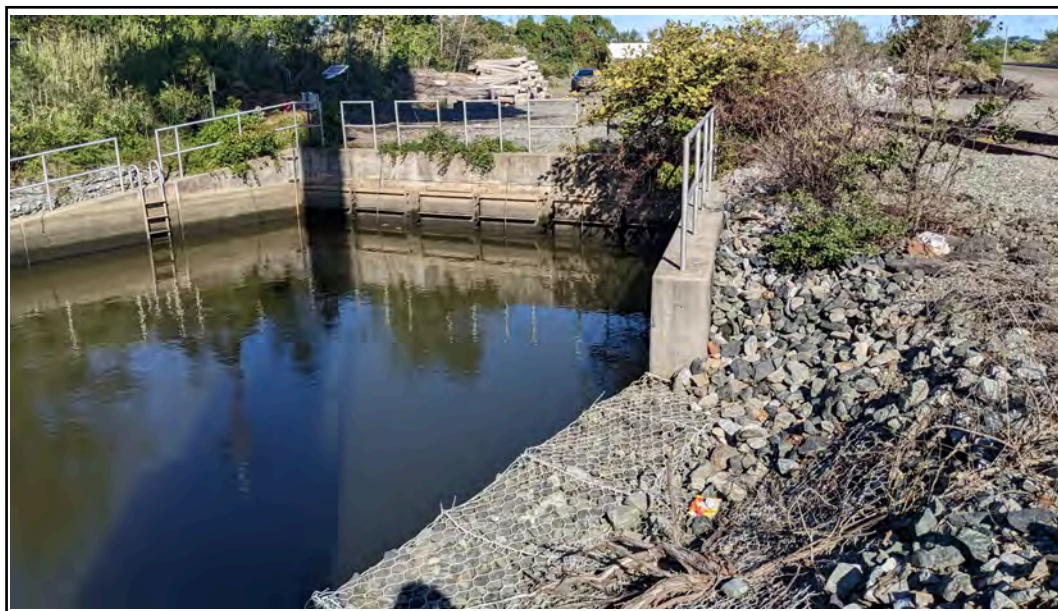
Figure 1: Upstream view at tide gate

Figure 2: Downstream view at tide gate

Type of Inspection:		Notes on Condition / Problems:	
<input checked="" type="checkbox"/> Yearly	<input checked="" type="checkbox"/> Ditch	Ditch is clear.	
<input type="checkbox"/> Post-Storm	<input type="checkbox"/> Tide Gate	Culverts partially submerged at high tide.	
<input type="checkbox"/> Complaint	<input type="checkbox"/> Pump System		
System Designation:			
<input checked="" type="checkbox"/> Natural Stream	<input checked="" type="checkbox"/> Culvert		
<input type="checkbox"/> Manmade Channel	<input type="checkbox"/> Outfall		
<input type="checkbox"/> Catch Basin	<input type="checkbox"/> Other: _____	Notes on Maintenance:	
Overall Functionality:			
<input checked="" type="checkbox"/> Fully Functional			
<input type="checkbox"/> Functional with Restrictions			
<input type="checkbox"/> Non-Functional			
Maintenance Required:		Other Notes:	
<input type="checkbox"/> Immediate			
<input type="checkbox"/> Repair

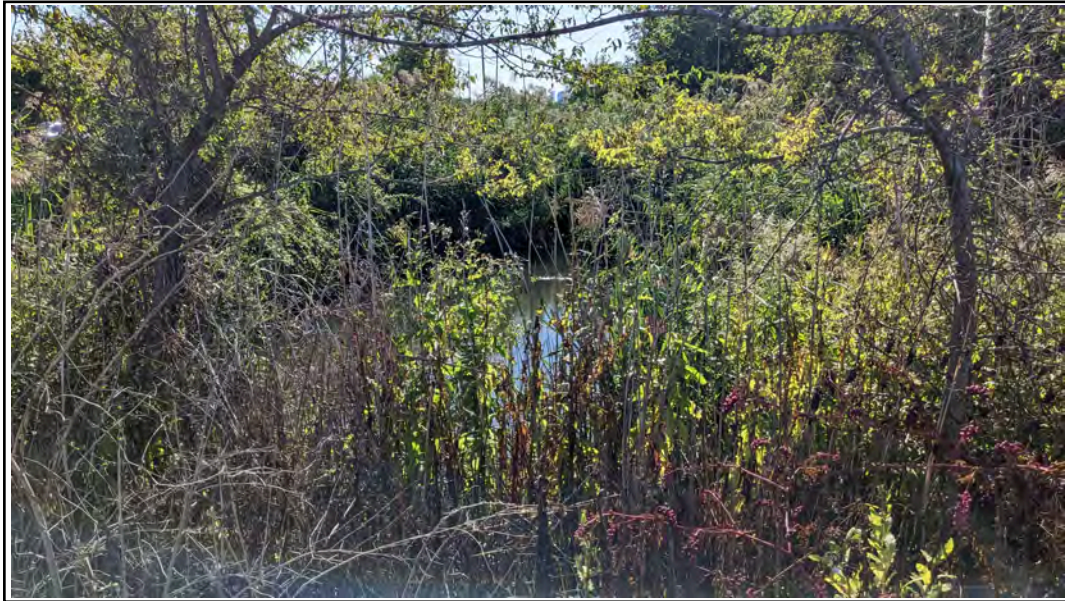
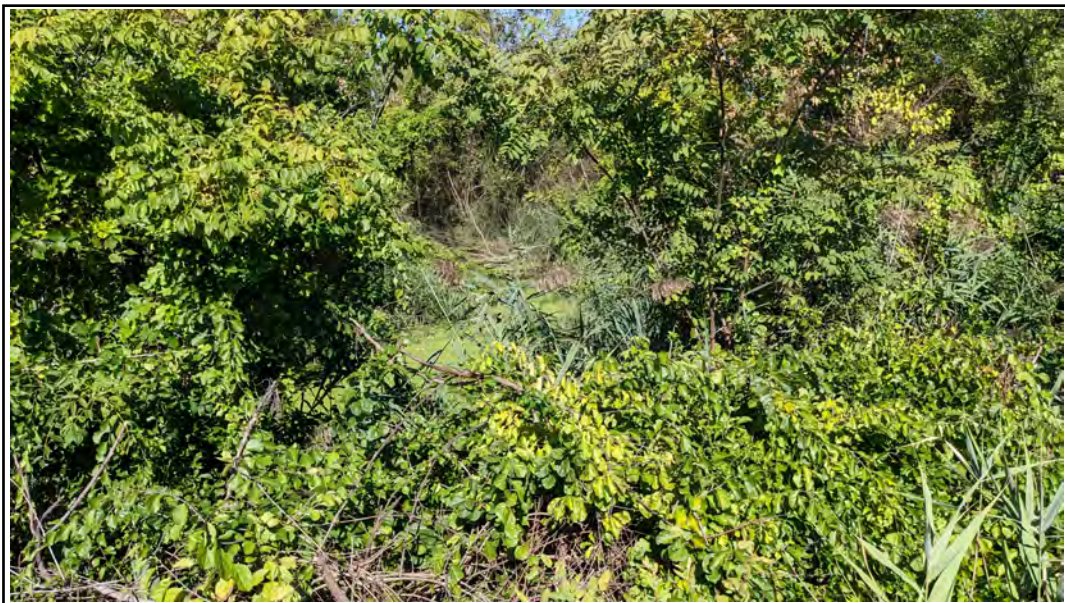
Figure 1: Upstream view of ditch

Figure 2: Downstream view of ditch

Type of Inspection: <input checked="" type="checkbox"/> Yearly <input type="checkbox"/> Post-Storm <input type="checkbox"/> Complaint <input checked="" type="checkbox"/> Ditch <input type="checkbox"/> Tide Gate <input type="checkbox"/> Pump System	Notes on Condition / Problems: No access due to heavy vegetation at this point, but ditch is clear downstream.
System Designation: <input checked="" type="checkbox"/> Natural Stream <input type="checkbox"/> Manmade Channel <input type="checkbox"/> Catch Basin <input type="checkbox"/> Culvert <input type="checkbox"/> Outfall <input type="checkbox"/> Other:	Notes on Maintenance:
Overall Functionality: <input checked="" type="checkbox"/> Fully Functional <input type="checkbox"/> Functional with Restrictions <input type="checkbox"/> Non-Functional	Other Notes:
Maintenance Required: <input type="checkbox"/> Immediate <input type="checkbox"/> Repair <input checked="" type="checkbox"/> Continued Upkeep <input type="checkbox"/> None

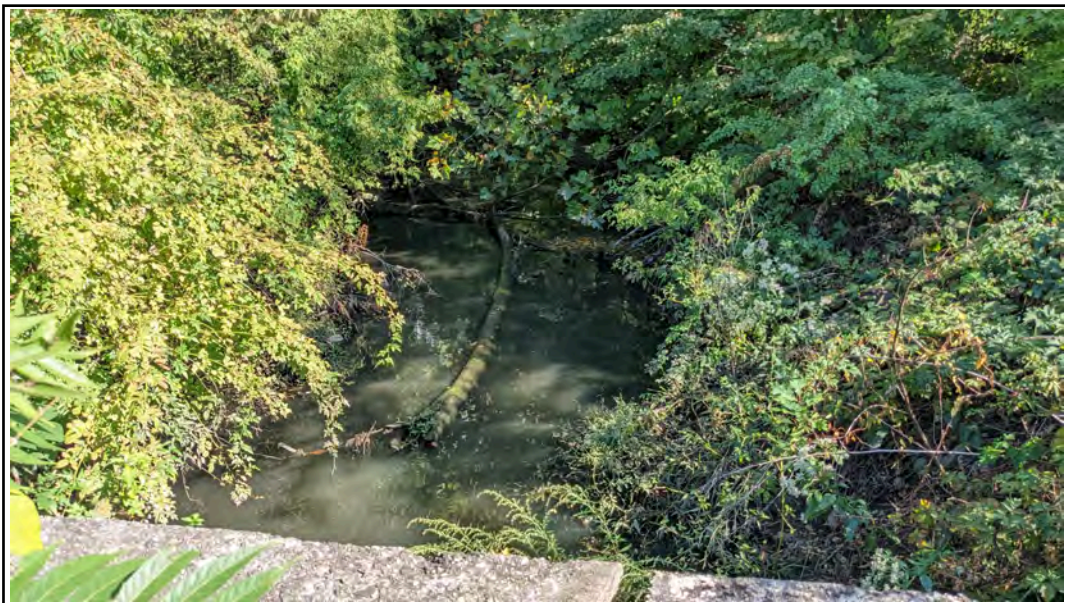
Figure 2: Downstream view of ditch
