New Jersey Sports & Exposition Authority Tide Gate Inspection Report

**The National Flood Insurance Program
Community Rating System**

The New Jersey Sports and Exposition Authority

October 13, 2022

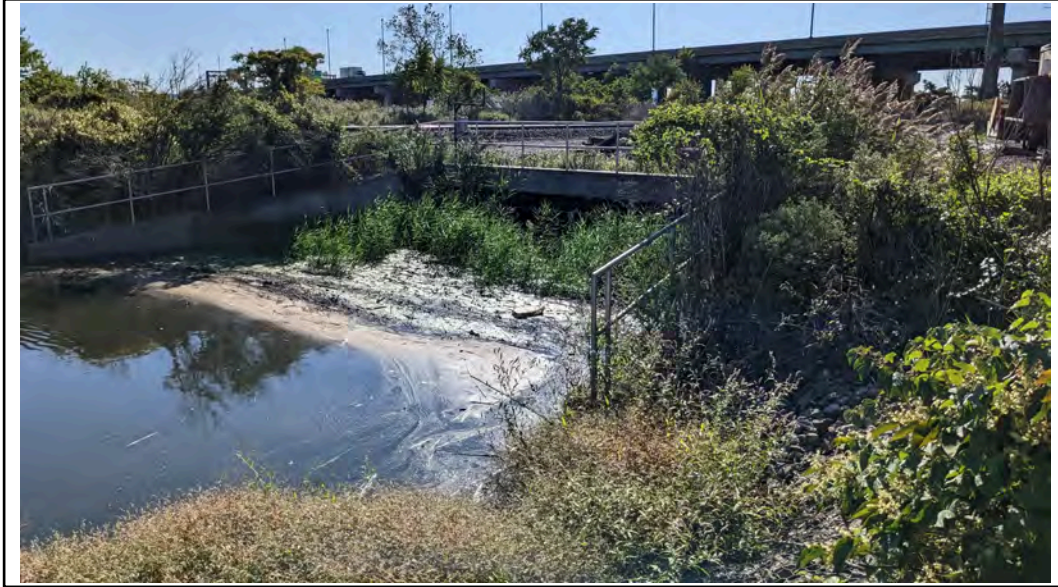
Figure 1: Upstream view at tide gate

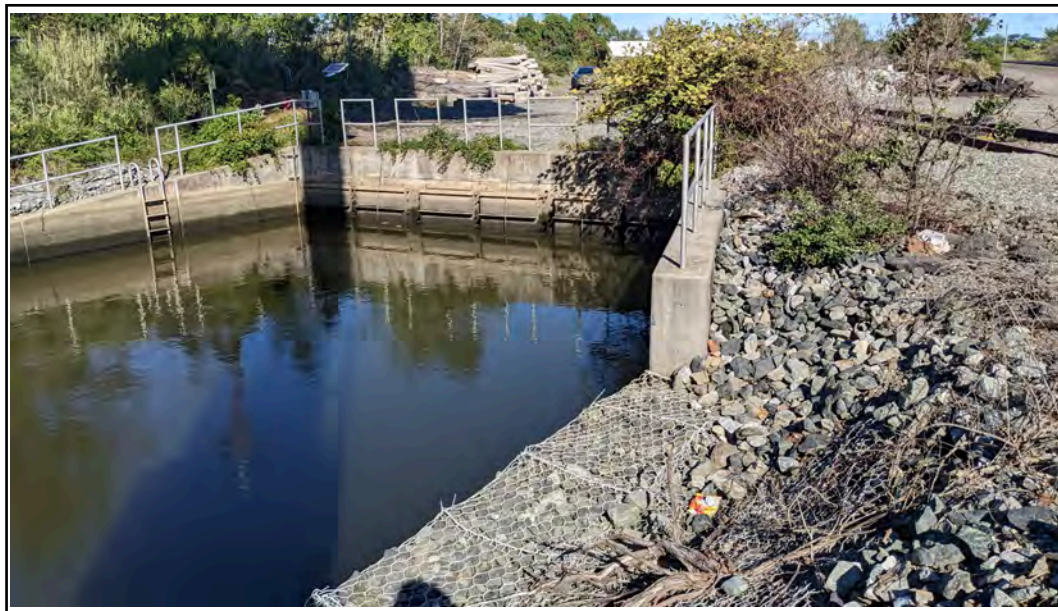
Figure 2: Downstream view at tide gate

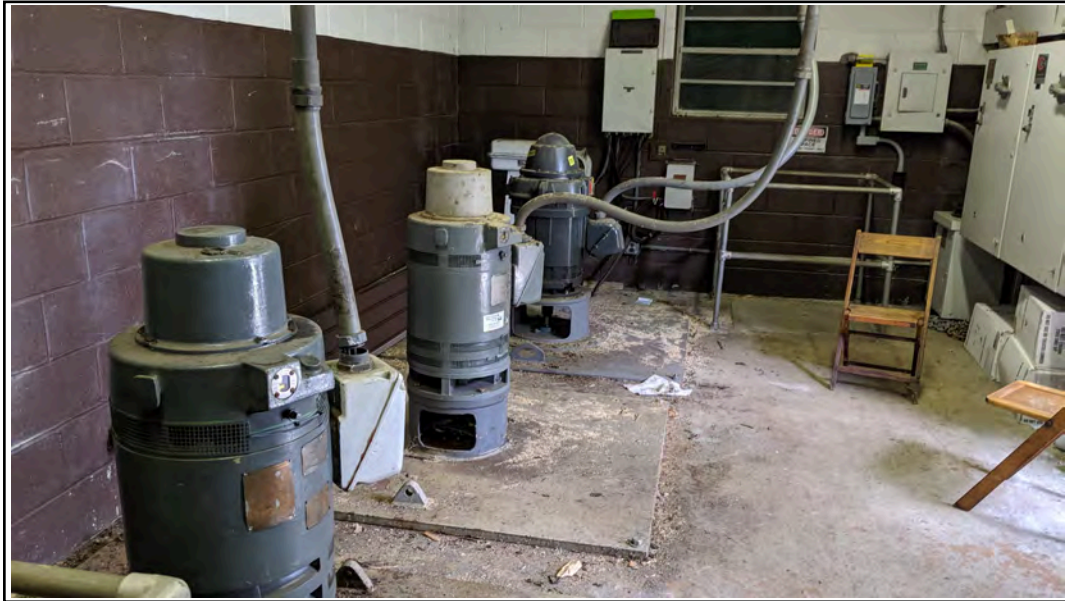
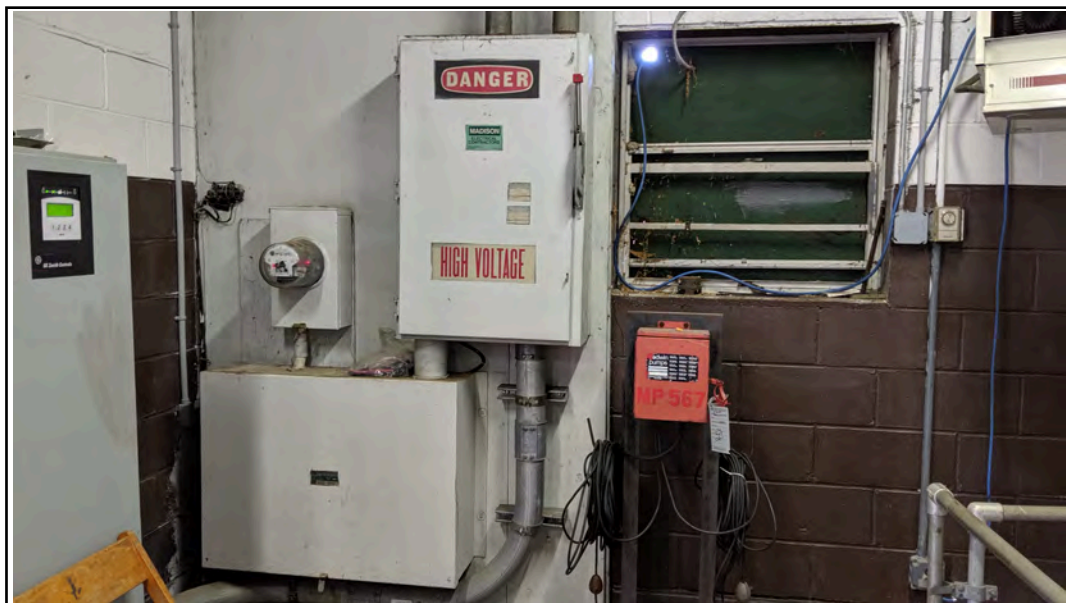
Type of Inspection: <input checked="" type="checkbox"/> Yearly <input type="checkbox"/> Post-Storm <input type="checkbox"/> Complaint <input checked="" type="checkbox"/> Ditch <input checked="" type="checkbox"/> Tide Gate <input checked="" type="checkbox"/> Pump System	Notes on Condition / Problems: Three vertical pumps, one pit pump and one Godwin backup pump are fully functional.
System Designation: <input checked="" type="checkbox"/> Natural Stream <input type="checkbox"/> Manmade Channel <input type="checkbox"/> Catch Basin <input type="checkbox"/> Culvert <input type="checkbox"/> Outfall <input type="checkbox"/> Other:	Notes on Maintenance: Maintained regularly by Secaucus DPW.
Overall Functionality: <input checked="" type="checkbox"/> Fully Functional <input type="checkbox"/> Functional with Restrictions <input type="checkbox"/> Non-Functional	Other Notes: Redundant TG at this location is not operational. New inline valve installed in pit at Riverside Court.

Figure 1: View at pump station

Figure 2: View at pump station

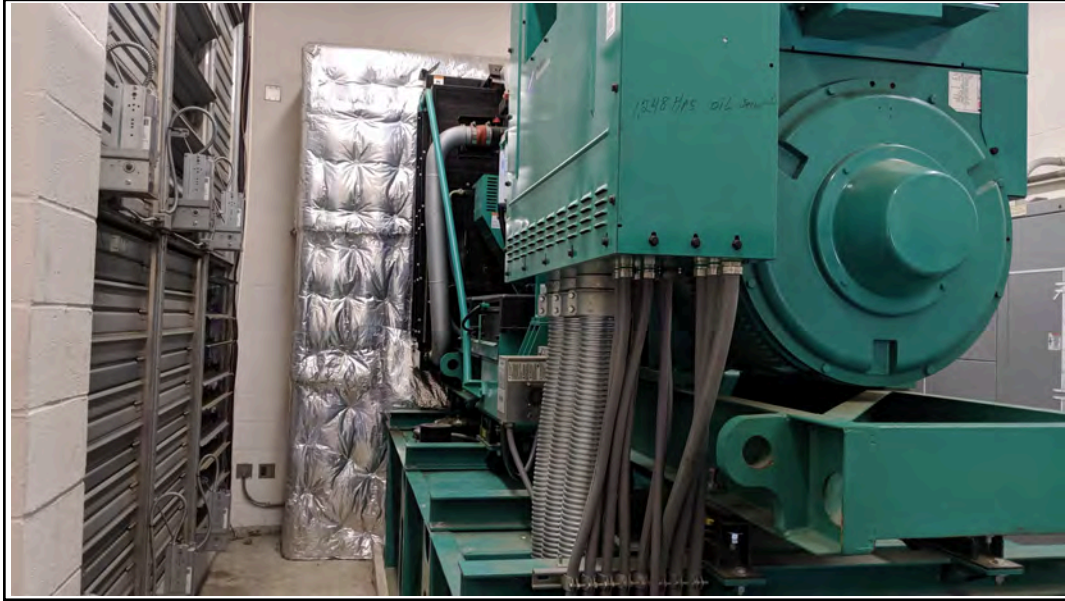
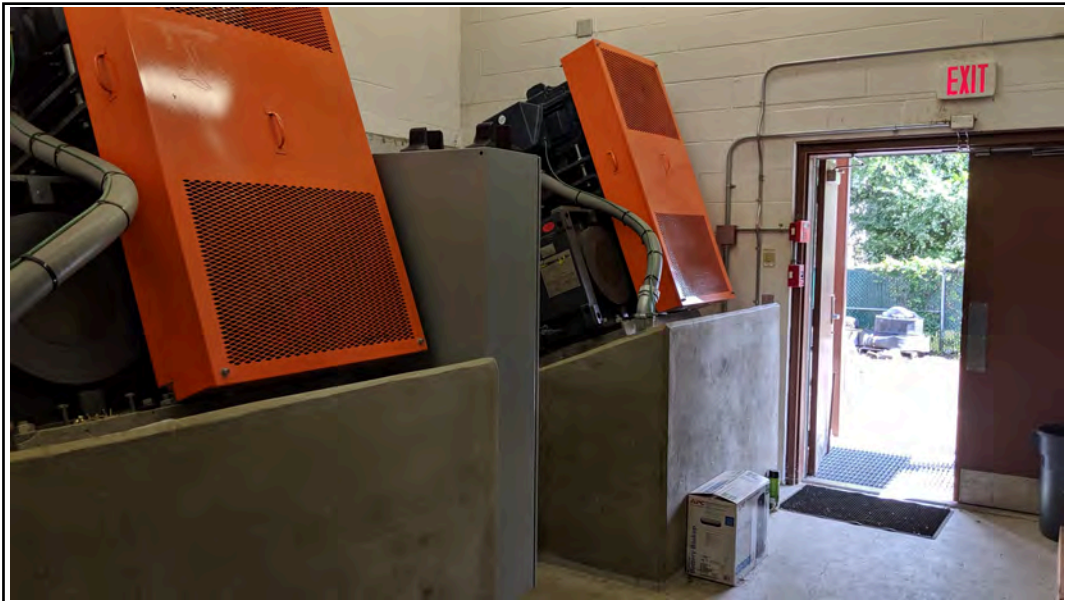
Type of Inspection:		Notes on Condition / Problems:	
<input checked="" type="checkbox"/> Yearly	<input checked="" type="checkbox"/> Ditch	Two screw pumps, three pit pumps, and emergency generator are fully functional.	
<input type="checkbox"/> Post-Storm	<input type="checkbox"/> Tide Gate		
<input type="checkbox"/> Complaint	<input checked="" type="checkbox"/> Pump System		
System Designation:			
<input checked="" type="checkbox"/> Natural Stream	<input type="checkbox"/> Culvert		
<input type="checkbox"/> Manmade Channel	<input type="checkbox"/> Outfall		
<input type="checkbox"/> Catch Basin	<input type="checkbox"/> Other: _____		
Overall Functionality:		Notes on Maintenance:	
<input checked="" type="checkbox"/> Fully Functional		Maintained regularly by Secaucus DPW.	
<input type="checkbox"/> Functional with Restrictions			
<input type="checkbox"/> Non-Functional			
Maintenance Required:			
<input type="checkbox"/> Immediate		Other Notes:

<input type="checkbox"/> Repair		Pump control panel in building with generator.	
<input type="checkbox"/> Continued Upkeep		Existing storm drain line has been tied into pump station during 2020, alleviating flooding in area.	
<input checked="" type="checkbox"/> None

Figure 1: View of pump station

Figure 2: View of pump station

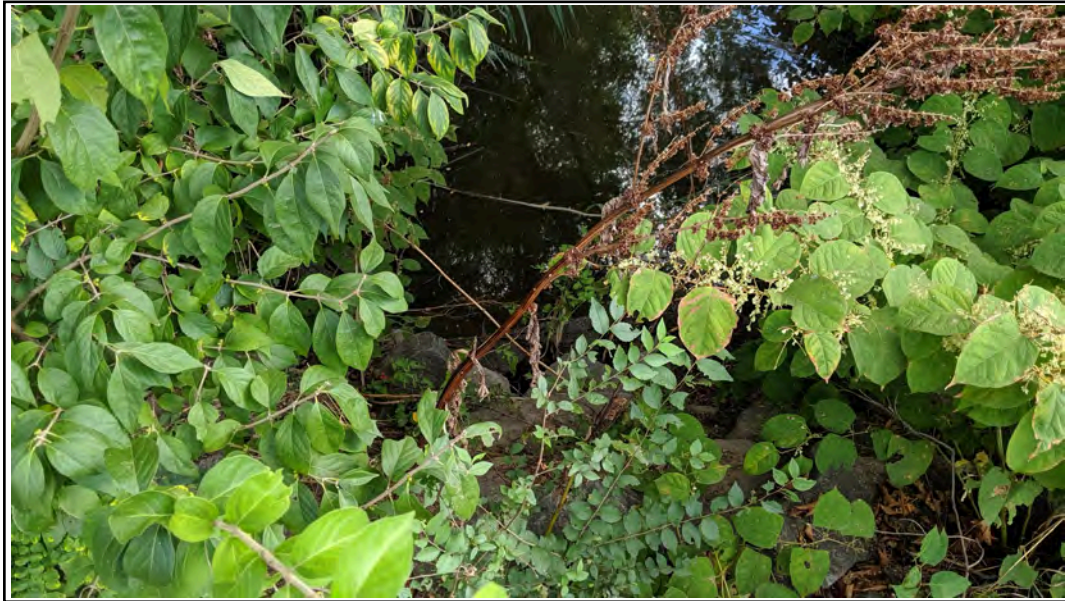
Figure 1: View at tide gate

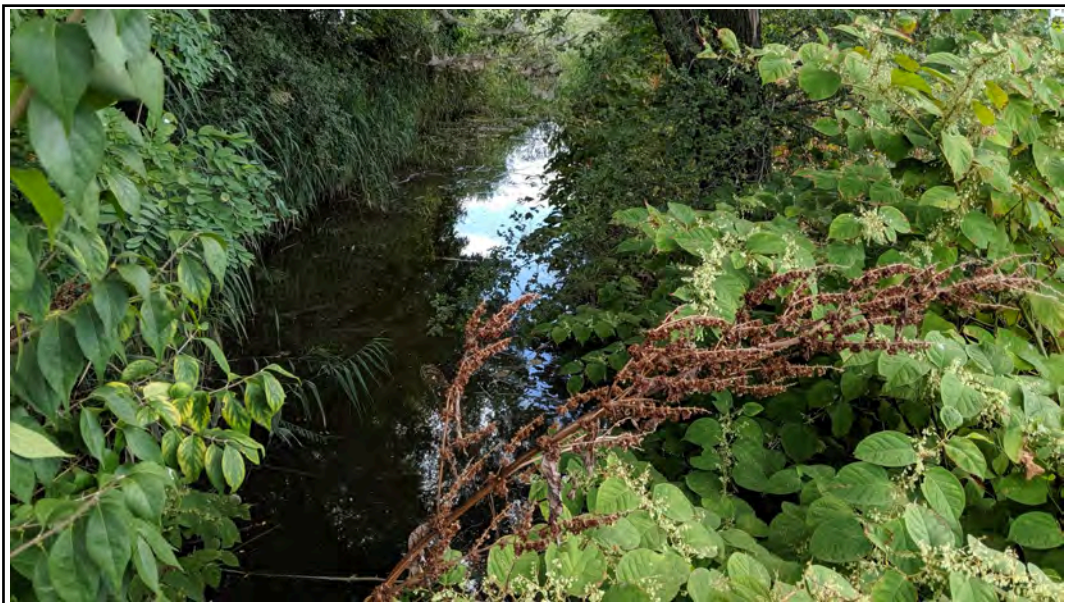
Figure 2: Downstream view at tide gate

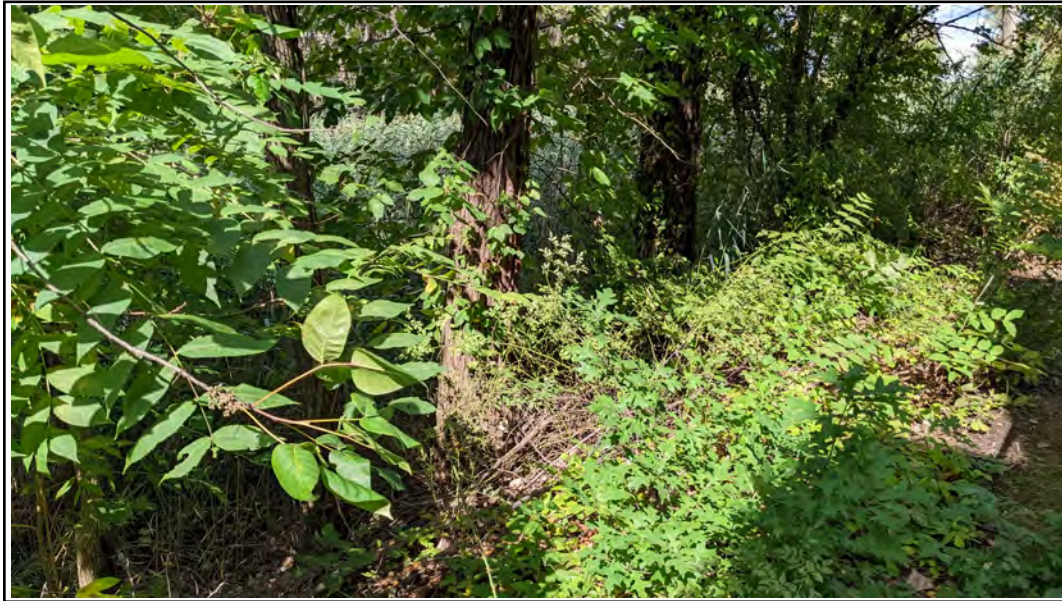
Type of Inspection: <input checked="" type="checkbox"/> Yearly <input type="checkbox"/> Post-Storm <input type="checkbox"/> Complaint <input checked="" type="checkbox"/> Ditch <input checked="" type="checkbox"/> Tide Gate <input type="checkbox"/> Pump System	Notes on Condition / Problems: Ditch is clear of debris. Banks are overgrown. Tide gate is functioning. Duck bill tide gate.
System Designation: <input type="checkbox"/> Natural Stream <input checked="" type="checkbox"/> Manmade Channel <input type="checkbox"/> Catch Basin <input checked="" type="checkbox"/> Culvert <input type="checkbox"/> Outfall <input type="checkbox"/> Other:	Notes on Maintenance:
Overall Functionality: <input checked="" type="checkbox"/> Fully Functional <input type="checkbox"/> Functional with Restrictions <input type="checkbox"/> Non-Functional	Other Notes: Adjacent to Red Roof Inn. New fence has been installed at the headwall.

Figure 1: Upstream view at tide gate

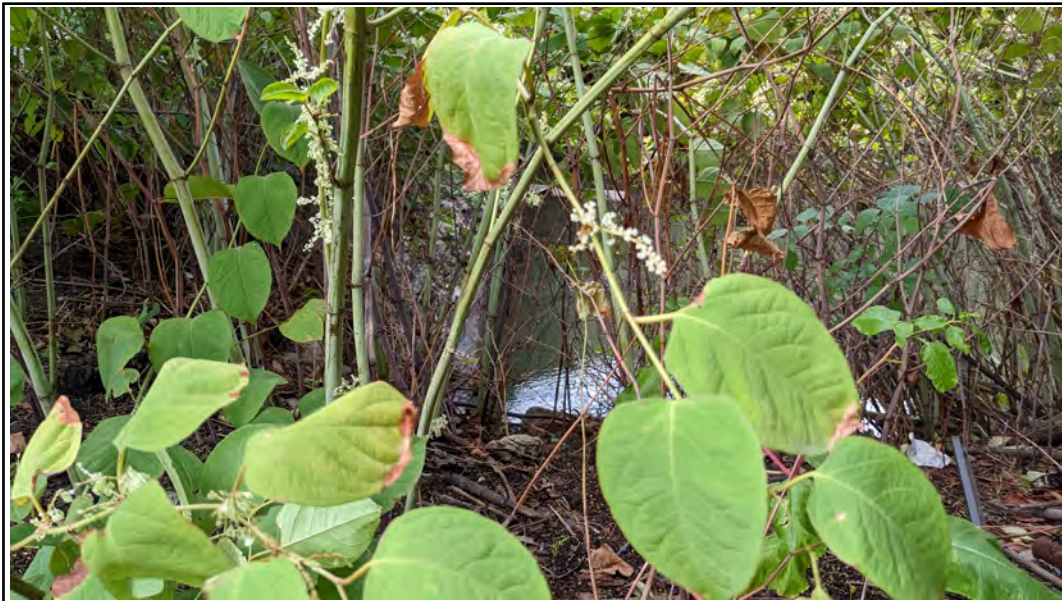
Figure 2: Downstream view of ditch at tide gate

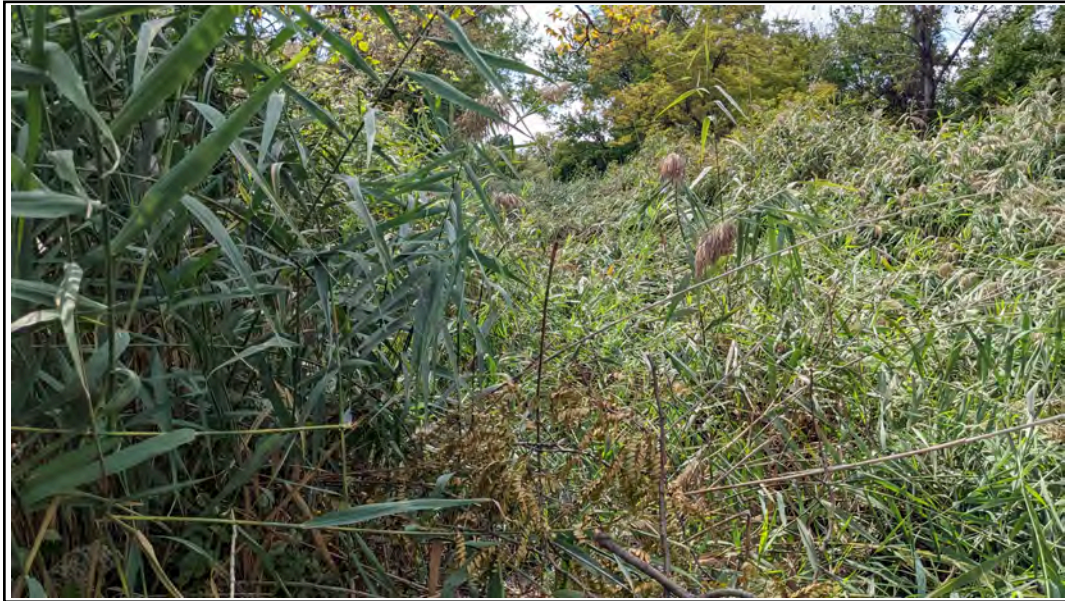
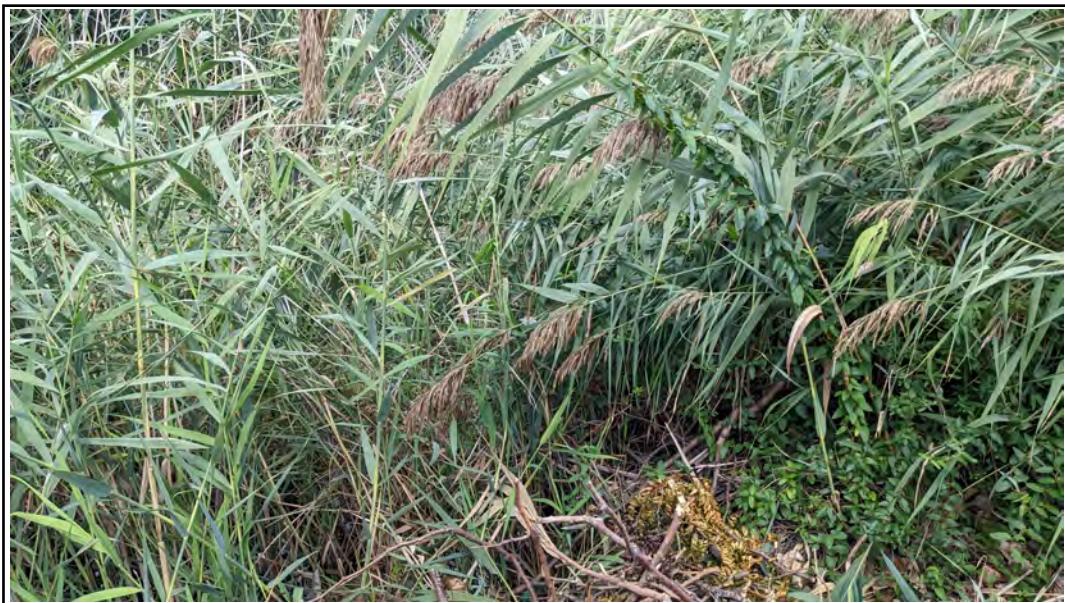
Type of Inspection:		Notes on Condition / Problems:	
<input checked="" type="checkbox"/> Yearly	<input checked="" type="checkbox"/> Ditch	Ditch is clear of debris but overgrown.	
<input type="checkbox"/> Post-Storm	<input checked="" type="checkbox"/> Tide Gate		
<input type="checkbox"/> Complaint	<input type="checkbox"/> Pump System		
System Designation:			
<input type="checkbox"/> Natural Stream	<input checked="" type="checkbox"/> Culvert		
<input checked="" type="checkbox"/> Manmade Channel	<input type="checkbox"/> Outfall		
<input type="checkbox"/> Catch Basin	<input type="checkbox"/> Other: _____	Notes on Maintenance:	
Overall Functionality:			
<input type="checkbox"/> Fully Functional			
<input type="checkbox"/> Functional with Restrictions			
<input checked="" type="checkbox"/> Non-Functional			
Maintenance Required:		Other Notes:	
<input type="checkbox"/> Immediate		Tide gate has been removed and new inlet/pipe installed by DPW.

Figure 1: Downstream view of ditch

Figure 2: Downstream view of ditch
